A case history involving wreckage analysis

Lessons from the Ustica investigations

A. Frank Taylor
Cranfield University – now Visiting Fellow

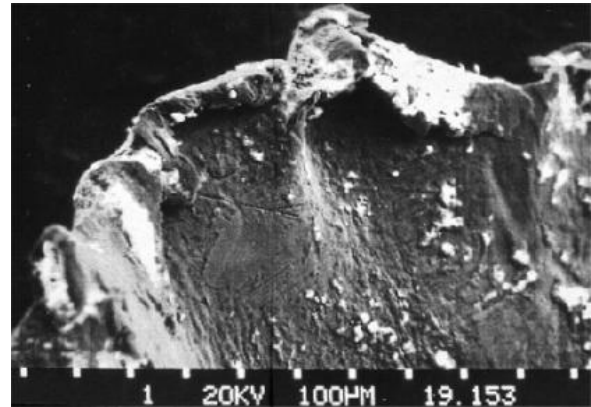
Fragment showing hot gas wash & rolled edges – typical of damage by an explosion

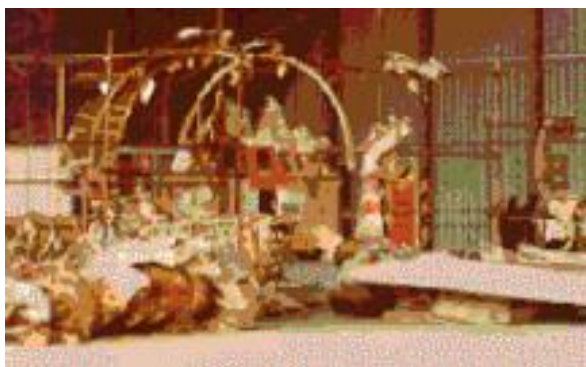
Undamaged frames

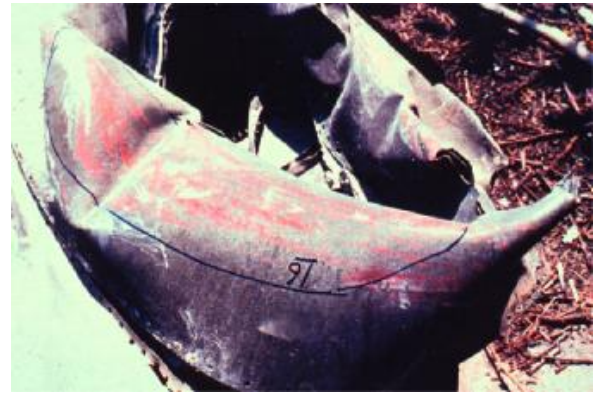
- There were red and white paint marks on the port engine intake (the red already confirmed as being the same paint as on the fuselage side along the window belt), but nothing similar on the starboard intake.

Port engine intake

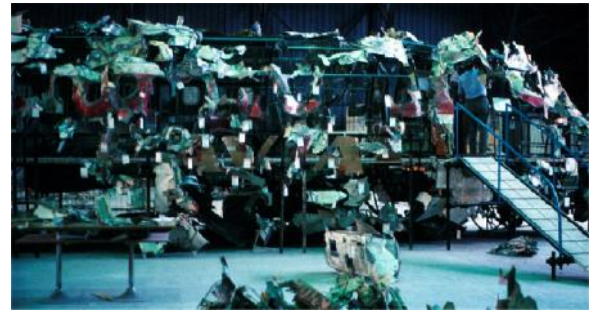
Starboard front fuselage

The buckling of the front fuselage, cockpit windows and the starboard wing clearly showed that these parts had entered the water at high speed, almost straight down, with the wing leading edge parallel with the sea surface and the fuselage just over the vertical.

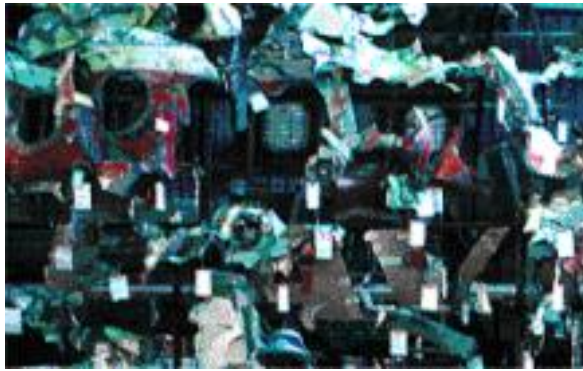
Detail showing tight buckling

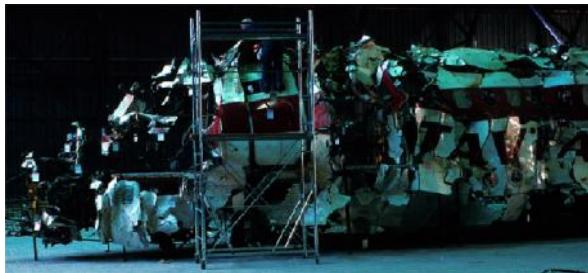
Port front fuselage with gentler buckling but note the severe inward bending of the windscreen supports

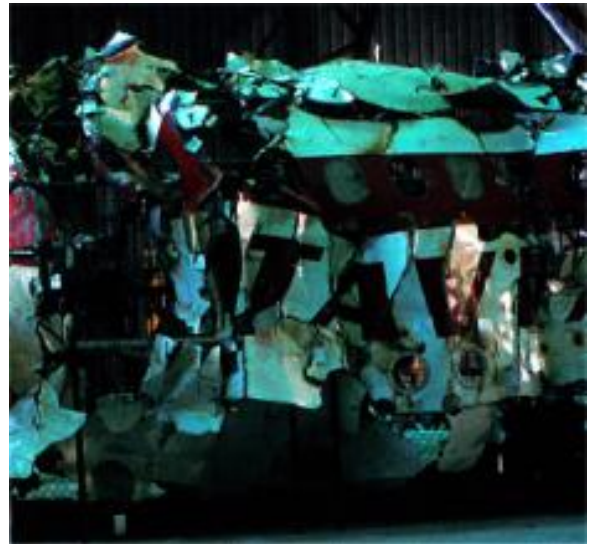
Tight buckling to the rear of stiff door frame, port side

Note that several web sites show a picture similar to this with the claim that there is a large hole aft of the door, through which a missile passed. There is in fact no hole at all as can be seen from the following diagram depicting the pieces of skin as if opened out (unbuckled) to the original shape.

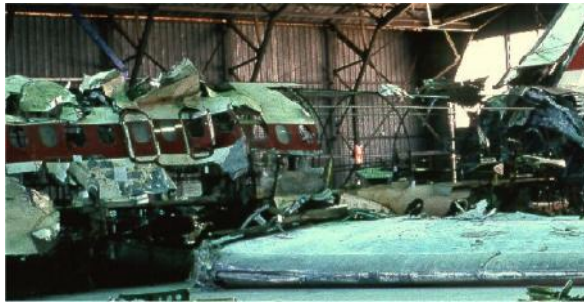
None of the port side of the fuselage ahead of the trailing edge of the wing showed any evidence of it having been in contact with the port engine intake, thus the section that DID make contact must have been from immediately in front of the engine.

No sign of contact with port engine intake cowling

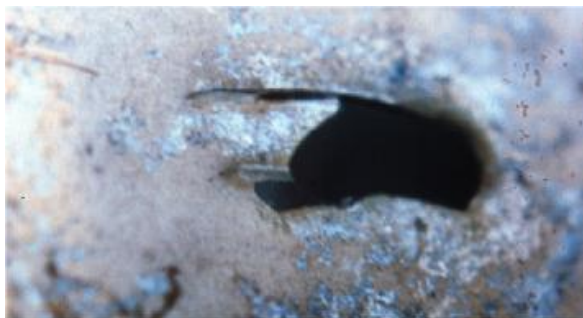
A dent in and penetration of the right engine cowling

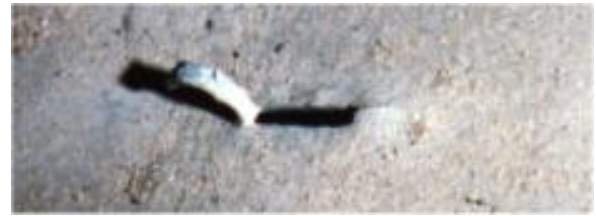
Inside view of the above penetration

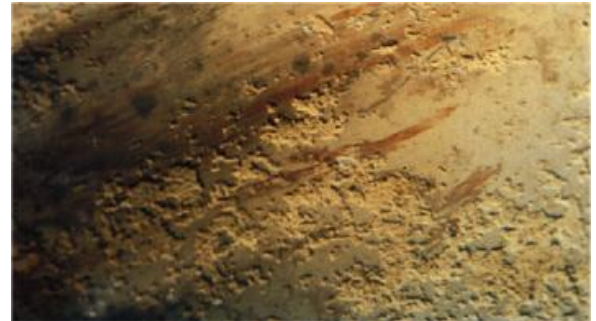
Red paint marks in a depression or groove in the starboard engine cowling

The majority of the dents, holes and scratches are below the pylon. Above the pylon there are several dents and a considerable number of red deposits (nobody suggested anything other than that this was red paint from the fuselage skin). Much of the red deposit is in the recessed 'grooves' of the damage, not only on the 'peaks'.

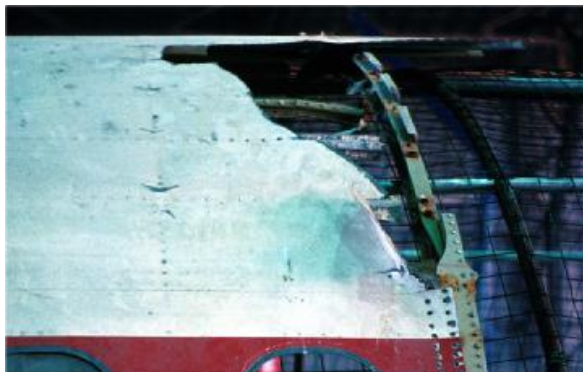
Shortly before the upper rear fuselage became contaminated the rearmost skin panel on the port side, AZ435, from station 630 to 660 at stringer 6, was found to be scratched laterally adjacent to some 22 rivet holes to a distance of from 80 to 30 millimetres.

Skin with scratches is at top of picture

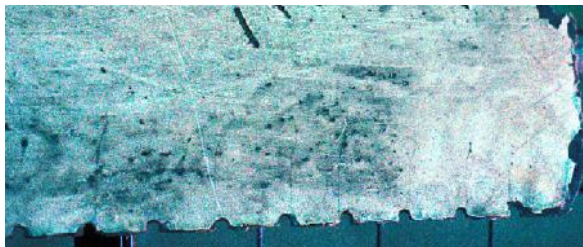
Scratches across upper centre fuselage

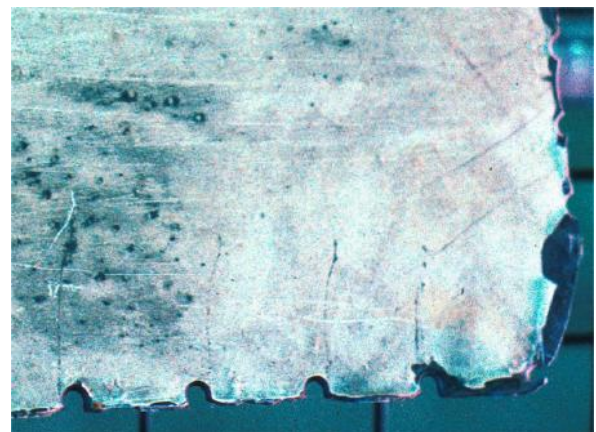
A few of these scratches then continue rearwards at an angle of approximately 30° to the aircraft centre line, to the rear edge of the panel at station 660.

Diagonal scratches to rear of panel

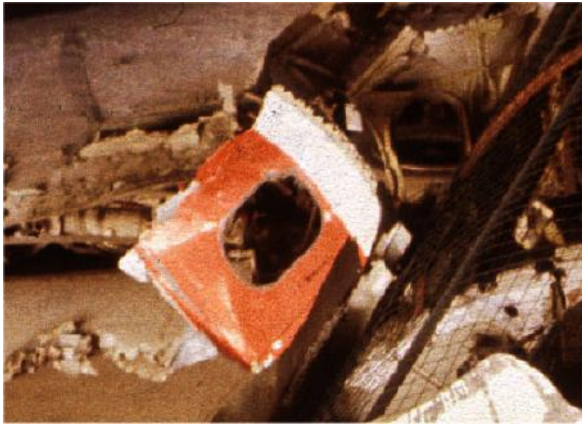
intake was confirmed on recovery of AZ523 and AZ522. These had the curved impression of the intake across them, showing that they had folded down as one piece and broken in two after hitting the intake.

Port skin showing contact with engine intake

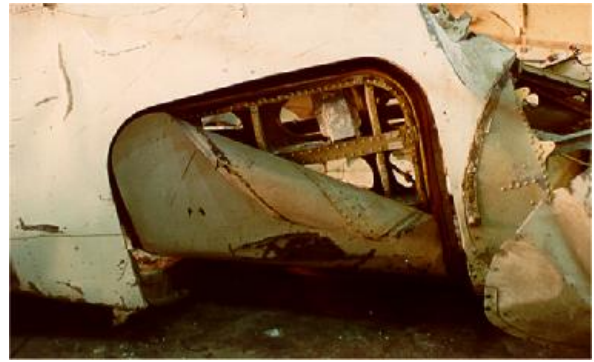
Damage in this area was all consistent with an explosion nearby. The similar nature of the curvature of the aft cargo door and its frame suggested that the door was closed on impact with the water and that it moved inwards as a result of this impact. The

rolling back of the cargo door skin was most likely to have been caused by over-pressure in the rear cargo bay.

Rear cargo door

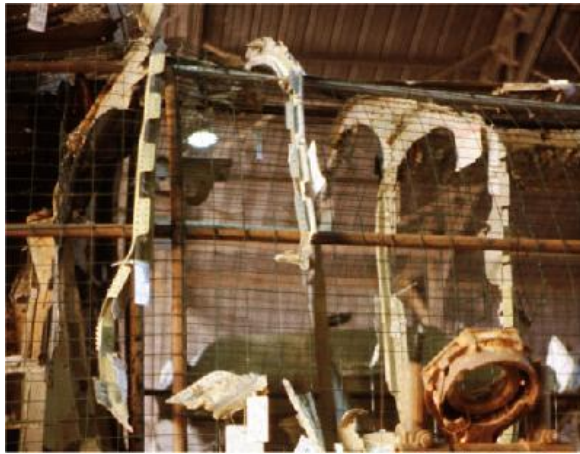
Distorted frames adjacent to starboard engine

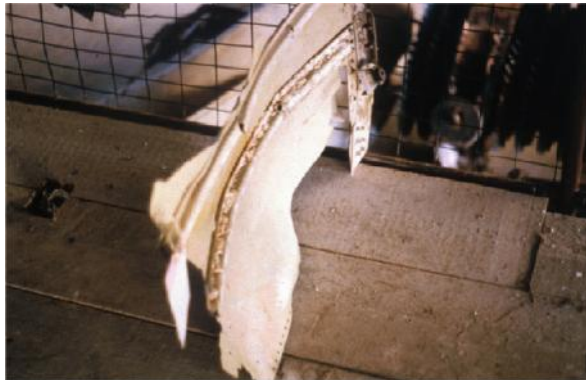
Forward bulging of lower front wall of toilet

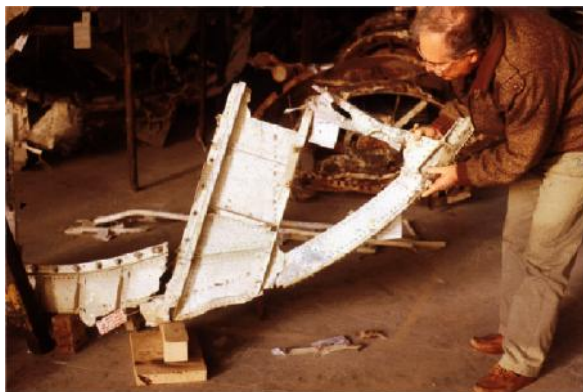
- The downward bending and severe buckling of the floor beam AZ539 (F44), at station 817

Structure beneath toilet

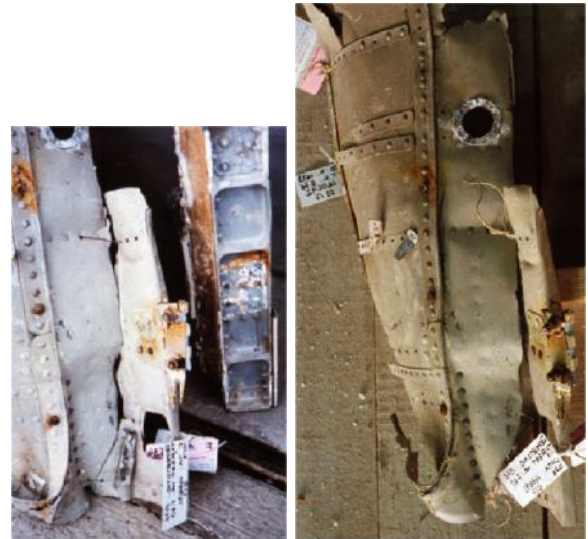
Impressions in the ventral door frame

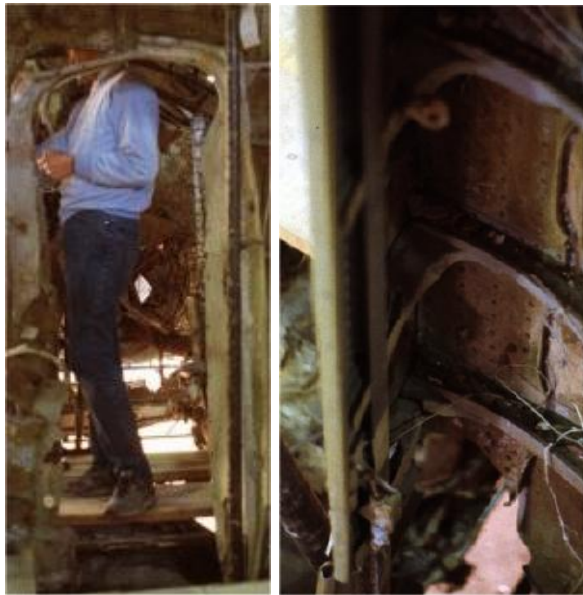
- The tearing down and across to the port side of the whole door frame and the upward bending of the frame and skin in the roof at station 817

Distortion to ventral door frame

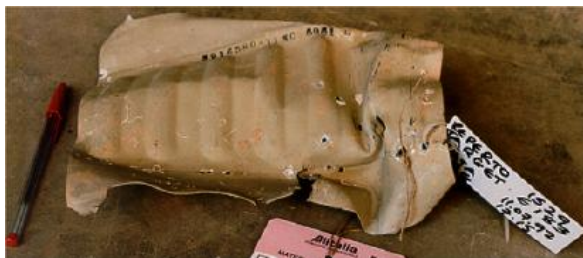
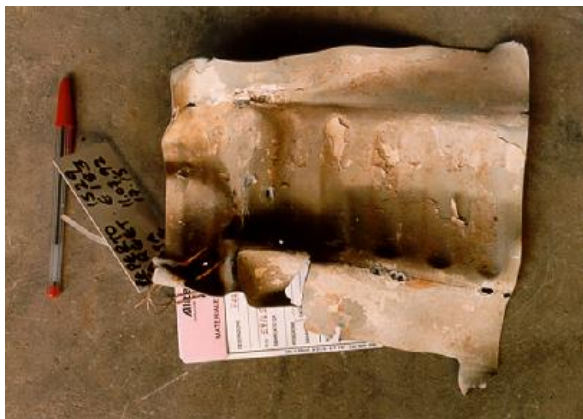
Furthermore the flattened box or tissue holder, AZ511 (E183), on the toilet wall

'Opened out' tissue holder from the outside or back

'Opened out' tissue holder from inside toilet

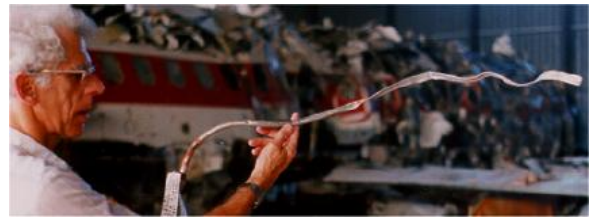
and the flattened spray pipe AZ453 (E12) from within and to the rear of the toilet waste

Spray pipe from toilet waste tank

tank suggest that an explosion occurred in this area probably in or just above the waste tank or somewhere to the rear of the toilet and close to the fuselage skin and rear pressure bulkhead.

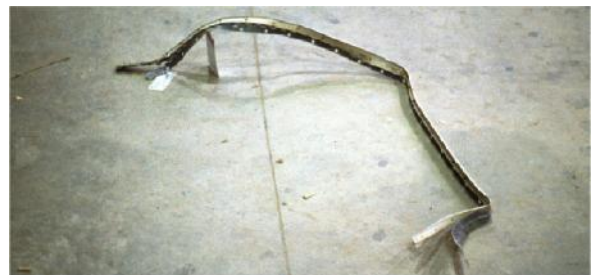
Toilet door hinge – opened through 180° then bent

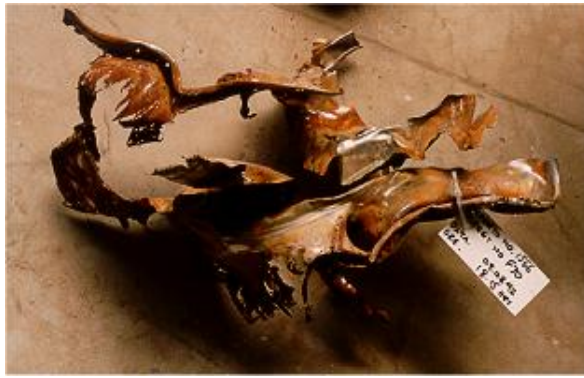
Wash basin with corrosion and unfolding
