# SOUTH AFRICAN CIVIL AVIATION AUTHORITY

## ACCIDENT REPORT – EXECUTIVE SUMMARY

# AIRCRAFT ACCIDENT REPORT

Ref : J10/2/7133

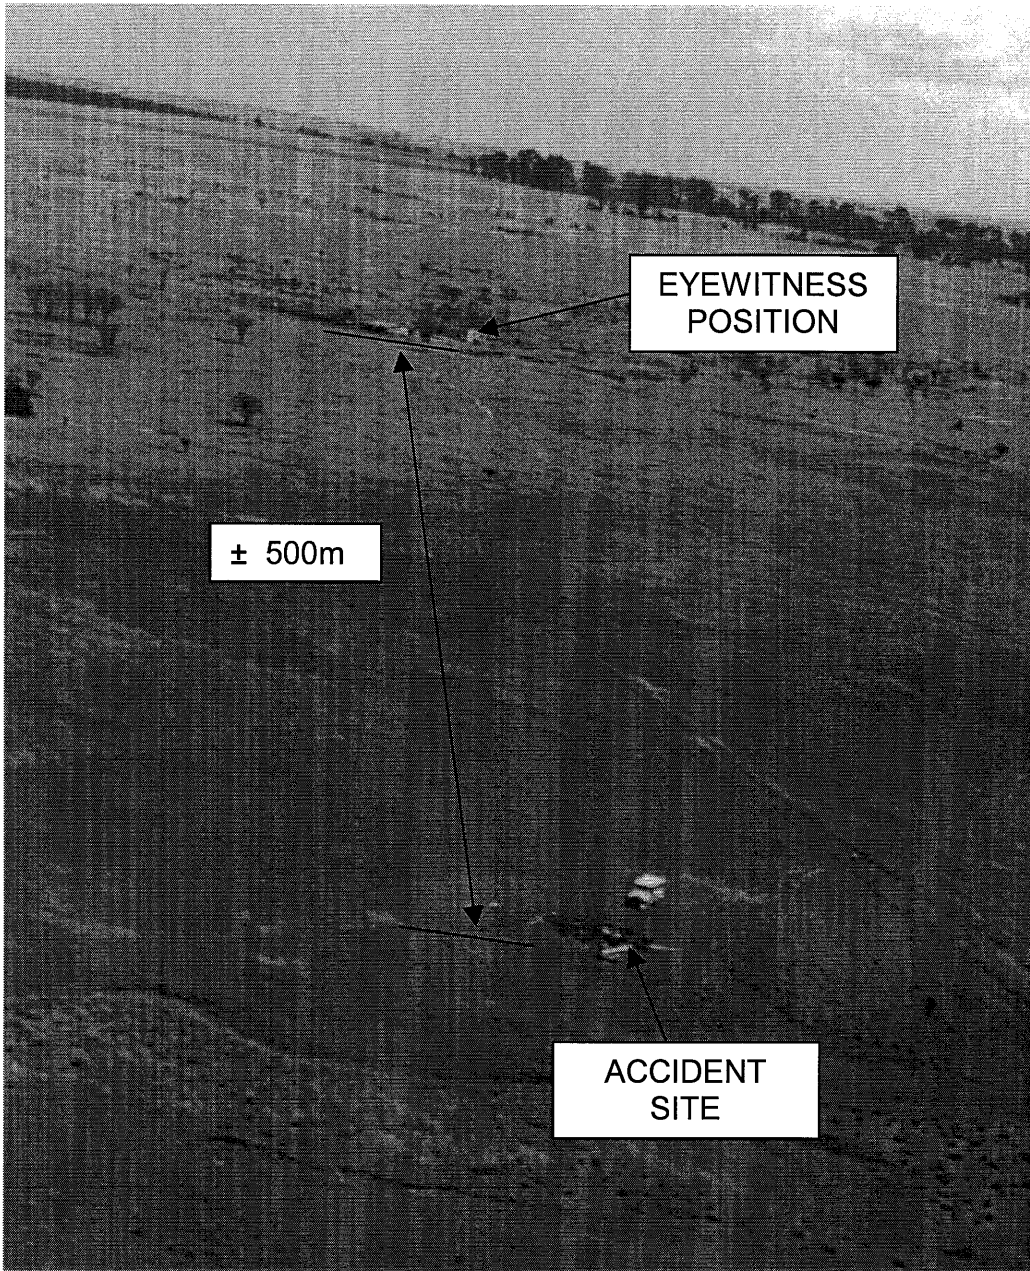
**Figure 1.** Aerial photo of the accident site also indicating eyewitness position.

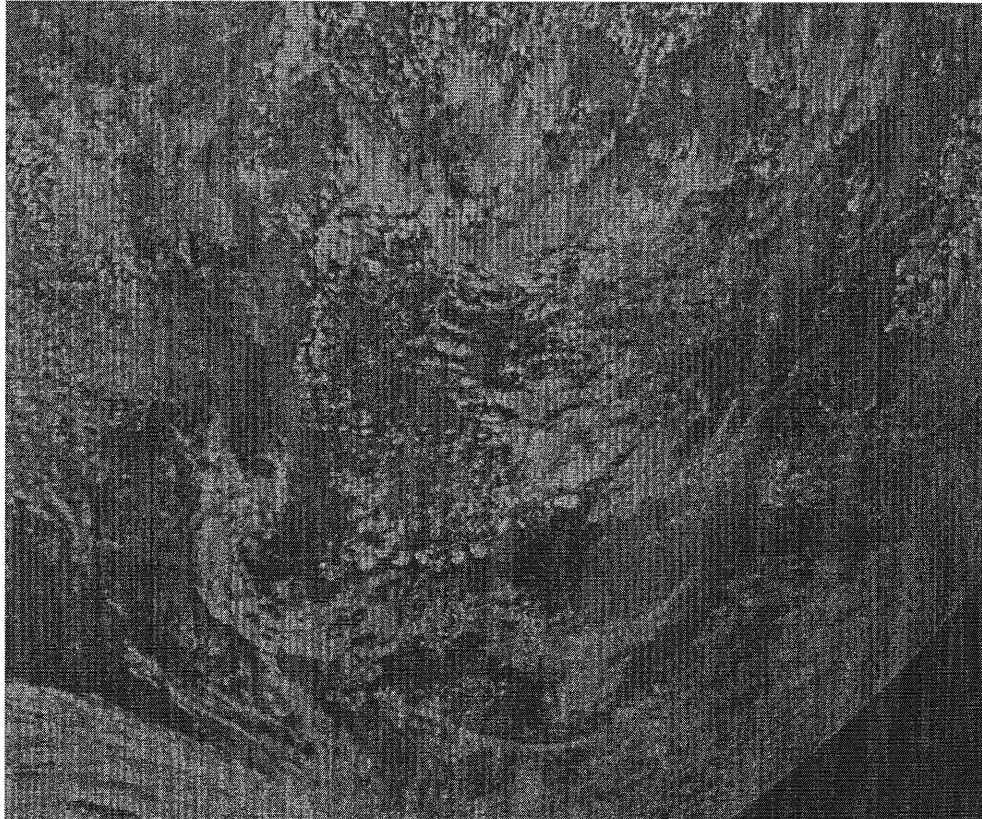
The satellite image was taken on 10 December 1999 at 1400Z, showing convective development over the eastern part of the country.

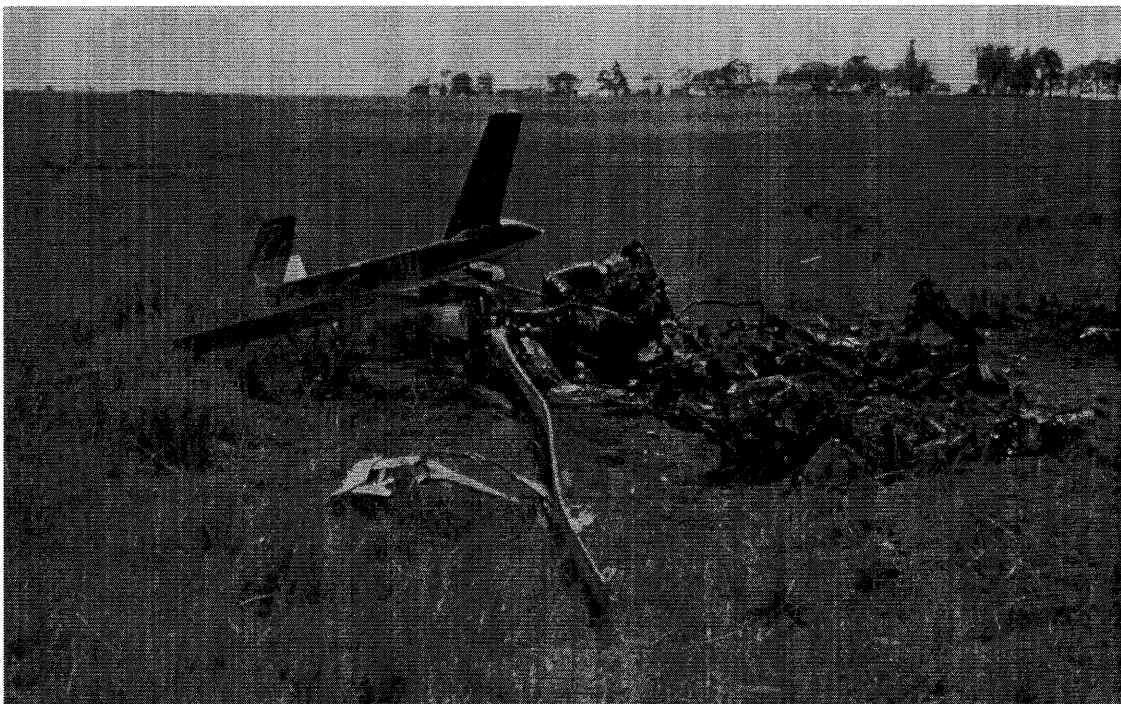
**Fig 2.** A general view of the accident site, with the main wreckage destroyed by the post-impact fire.

- 1.12.1 The accident occurred in a grassy open field area. Components and structural pieces of the helicopter were scattered over an area of not more than 10 meters in diameter along an axis which was oriented on a Northerly heading from the initial ground impact point.

- 1.12.2 The initial ground contact by the helicopter was a ground scar probably caused by one of the main rotor blades. A few meters down the wreckage path from the initial impact point was, an area of heavy ground scrub, which contained components from the skids, the baggage door situated on the left-hand side of the helicopter as well as the left front cabin door. The major portions of the tail boom including the tail rotor were located further down and to the right of the wreckage path. The main fuselage wreckage was at the end of the wreckage path to the left of the tail boom assembly. The main fuselage had been exposed to an intense post-impact fire and was completely destroyed by the impact forces and post impact fire.

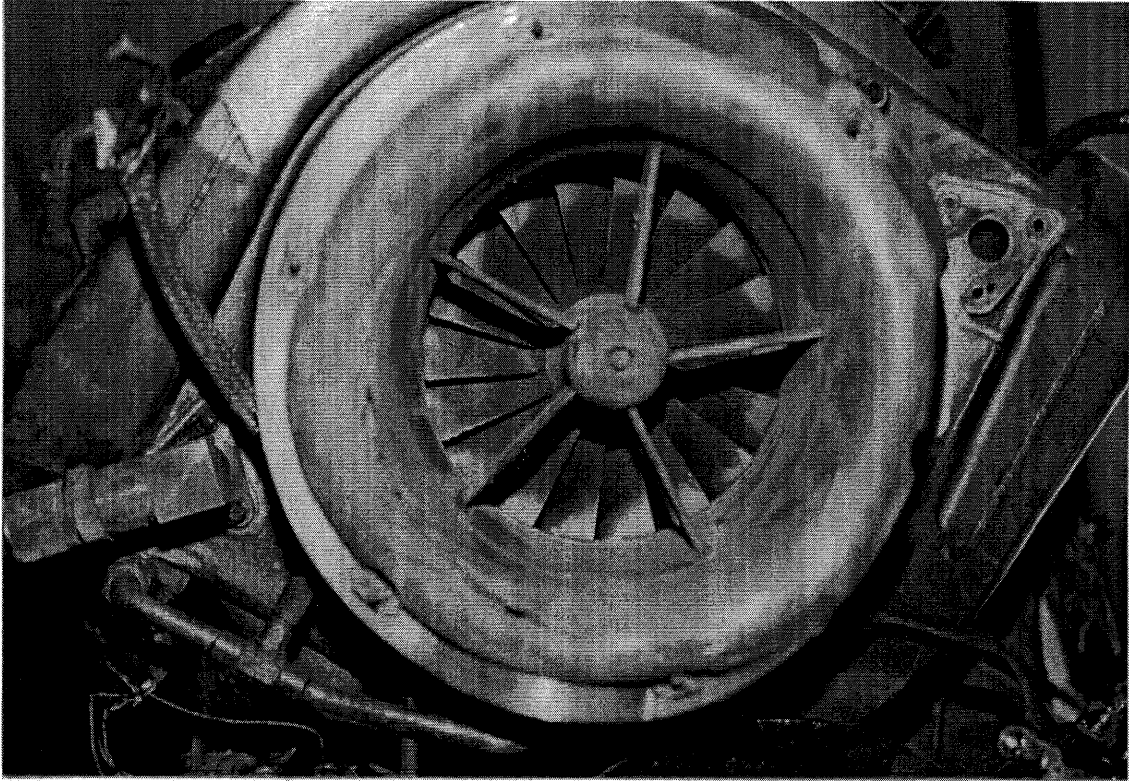
- 1.12.7 The engine was lying on its right-hand side in the fuselage wreckage. The exterior of the engine was heavily scorched from the post-impact fire. The engine air inlet appeared clear and the centrifugal compressor appeared intact when viewed through the inlet.

**Fig 3.** A view through the air inlet with the first stage centrifugal compressor visible.

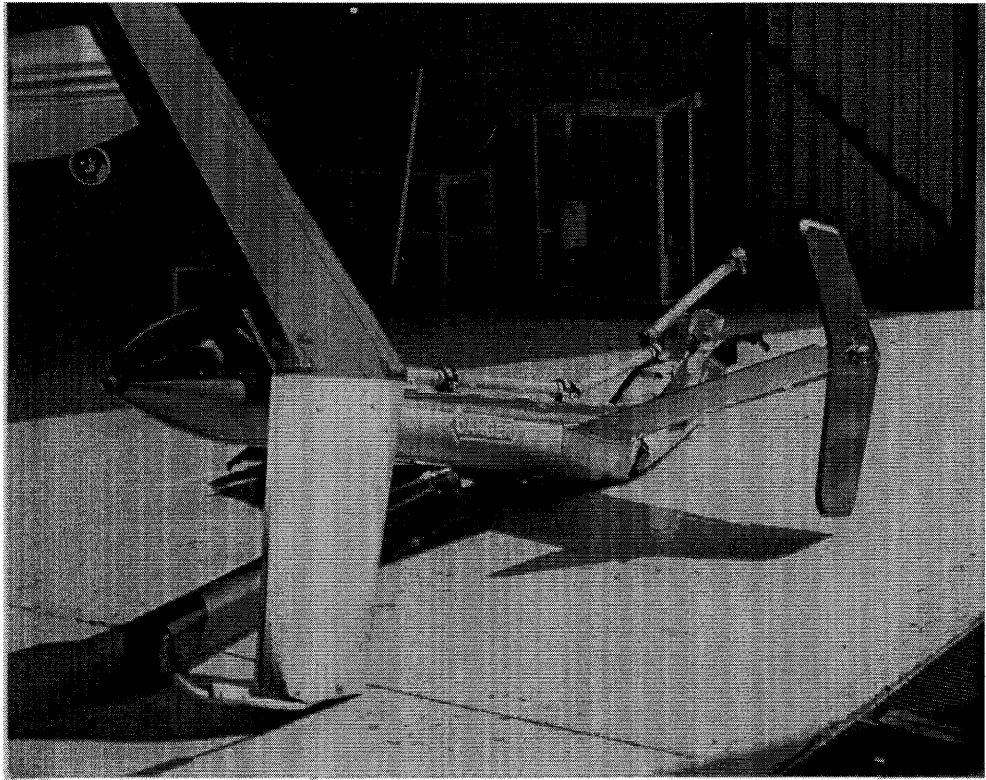
- 1.12.8 The tail rotor drive shafting was heavily damaged from impact, post-impact fire and overload separation of the tail boom. All the sections of the drive shafting on the tail boom failed in torsional overload. The tail rotor gearbox failed from its attachment during the impact sequence and was located next to the tail boom, drive continuity was established from the input of the gearbox to the output. Both tail rotor blades were intact with minor damage. The pitch-change mechanism was found to be intact and operable.
- 1.12.9 The tail boom failed during the impact sequence. The right-hand horizontal stabiliser remained attached to the tail boom and the left-hand stabiliser failed during impact. The vertical stabiliser remained attached to the tail boom and sustained very little damage.

**Fig. 4** A view of the tail boom that failed during the impact sequence. Substantially more damage was caused to the horizontal and vertical stabiliser assembly on the left-hand side.
