# SOUTH AFRICAN CIVIL AVIATION AUTHORITY

## ACCIDENT REPORT – EXECUTIVE SUMMARY

# AIRCRAFT ACCIDENT REPORT

**Name of Owner/Operator** : Dr M.S. Kritzinger  
**Manufacturer** : Bell Helicopters Textron  
**Model** : 407  
**Nationality** : South African  
**Registration Marks** : ZS-RHV  
**Place** : Private farm, 20km North of Beaufort West  
**Date** : 28 April 2000  
**Time** : 0410Z

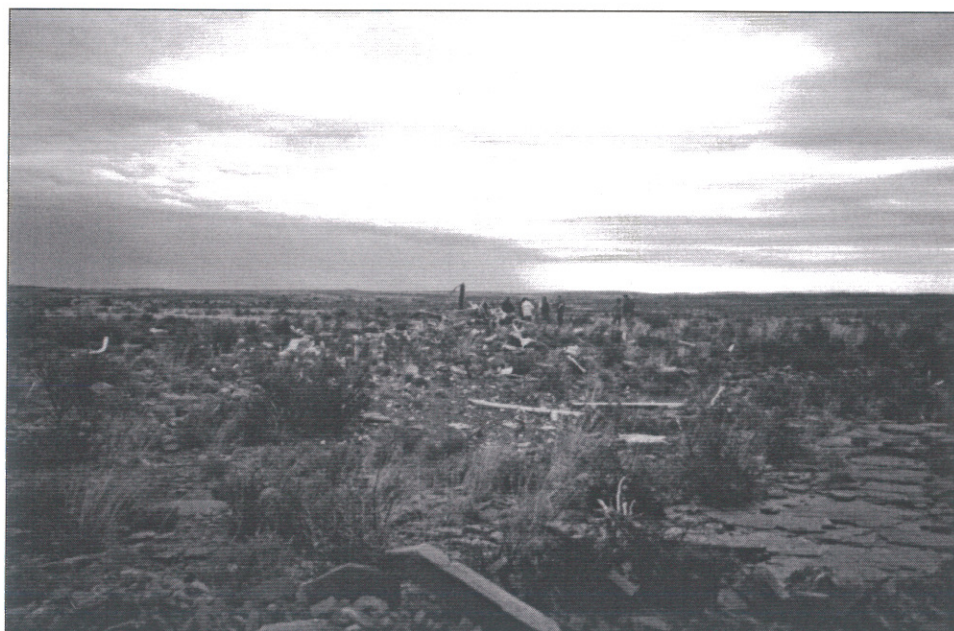
1.3.1 The impact forces during the accident destroyed the helicopter.

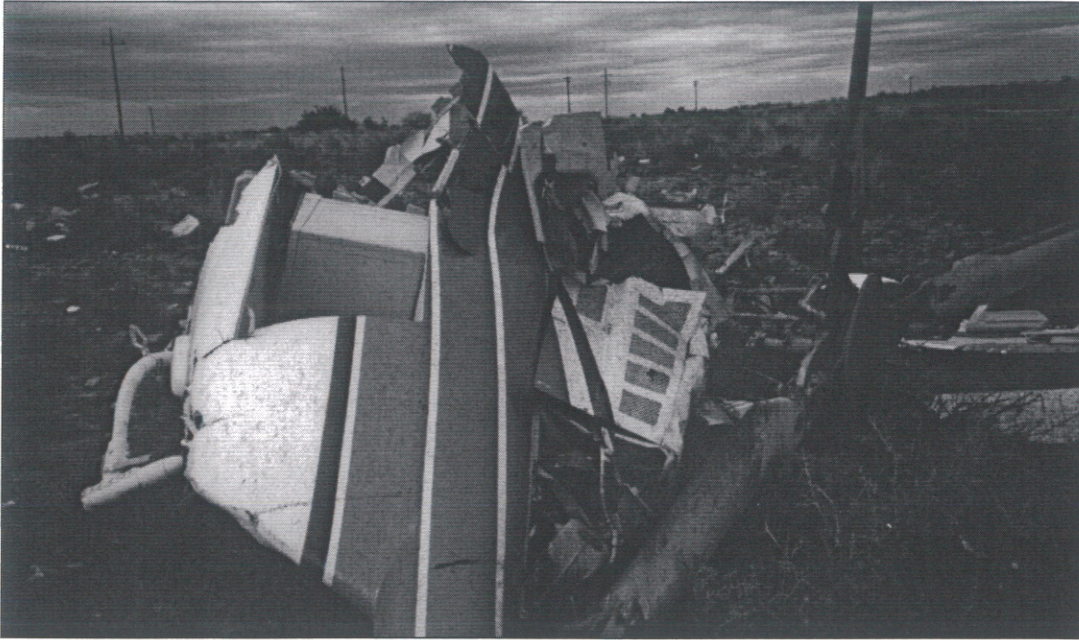
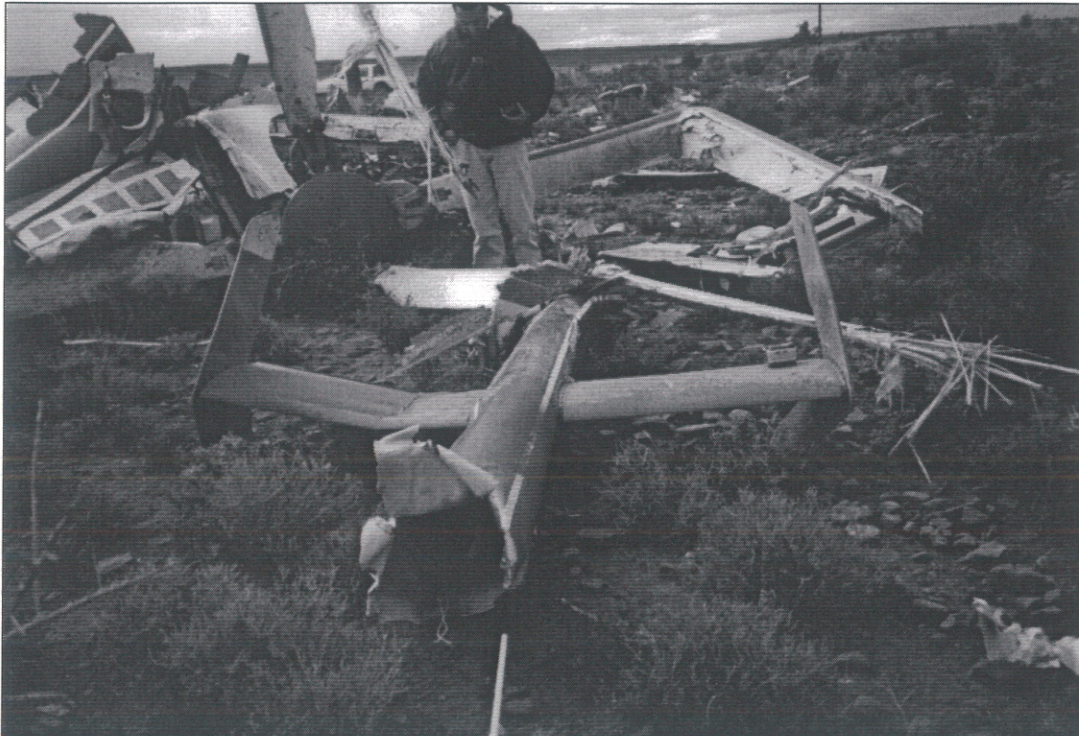
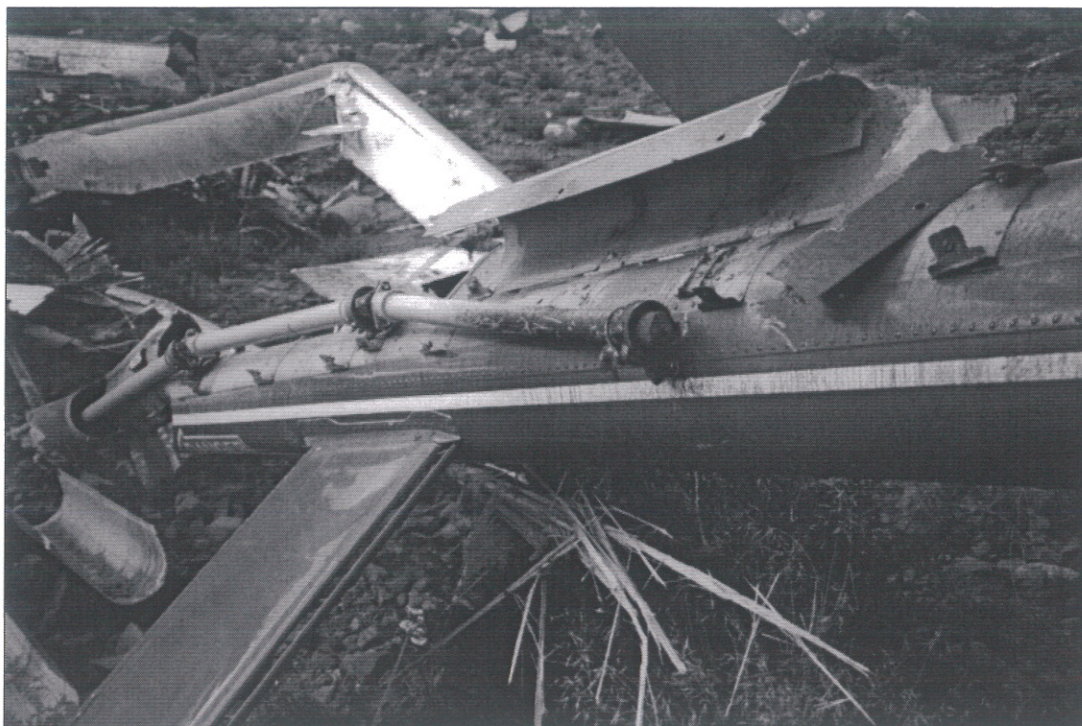
1.12.1 It would appear that the helicopter impacted the ground in a southerly direction with the lateral axis level, but with a nose down attitude of approximately 45°.

1.12.2 From the initial impact point, the terrain rises slightly towards the south and to the east.

1.12.3 The wreckage was spread out over a distance of approximately 60m from the initial impact point to the last piece of debris on the wreckage trail.

1.12.4 The length of the wreckage path, together with the severe break-up of the wreckage, is indicative of high forward speed during impact.

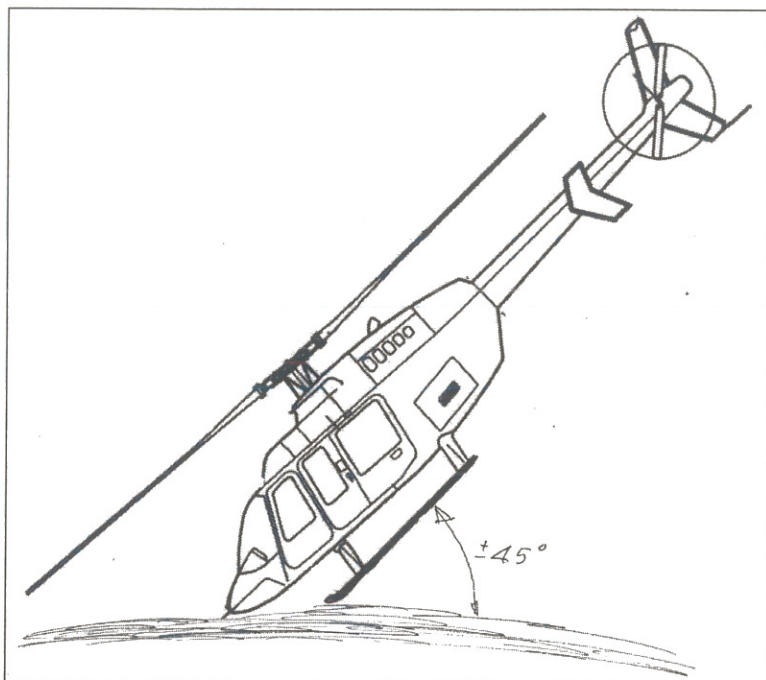
- 1.19.1 The helicopter impacted the ground, with the lateral axis level, but with a nose down attitude of approximately  $45^\circ$ , and at high speed in a southerly direction.
- 1.19.2 The above was concluded from the fact that the forward skid ends and the bottom wire cutter, simultaneously made contact in a straight line. This is only possible if the lateral axis are level and the nose are tilted downwards by an angle of  $45^\circ$ .
