**ROYAL AIR FORCE  
PROCEEDINGS OF A BOARD OF INQUIRY  
INTO AN AIRCRAFT ACCIDENT**

To inquire into an accident involving HARRIER T10 ZH654 on 24 Aug 00.

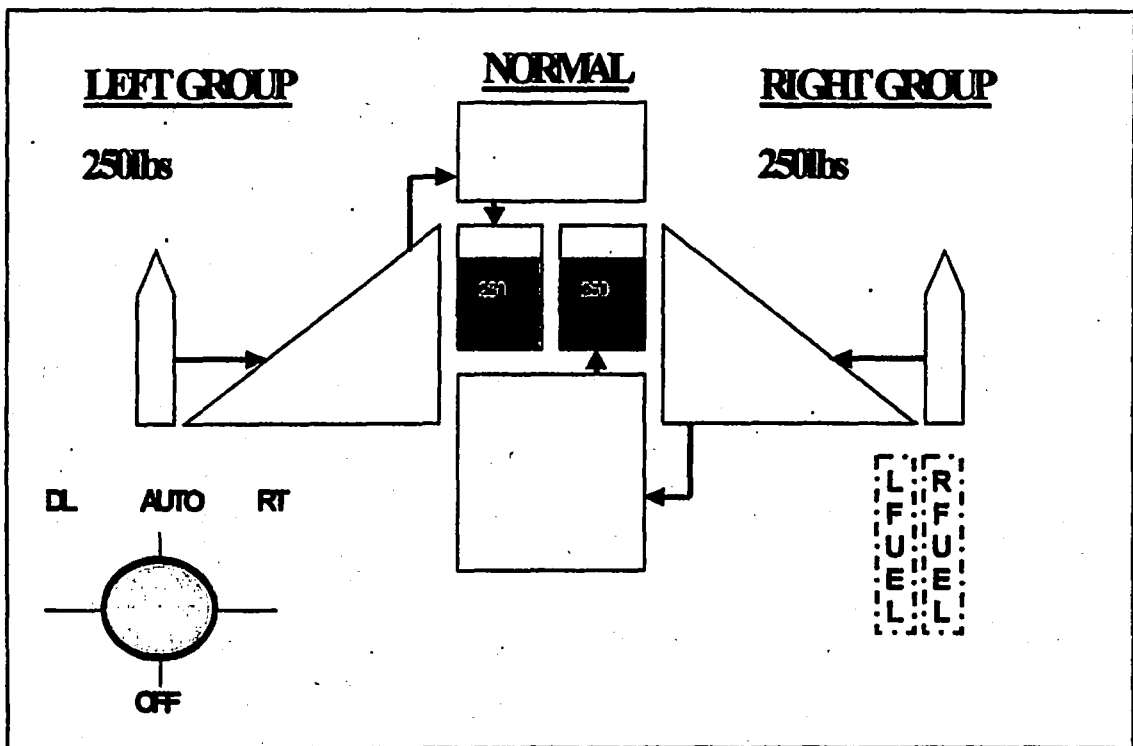
Diagram 5 - L/RFUEL Flashing Caution with Audio.

The fuel starts feeding from both groups again when the rear tank is empty, the rear tank being a part of the right group. When both groups are feeding again the RFEED advisory caution extinguishes. The only fuel now remaining is in the centre tanks and when each side reaches 250lbs of fuel remaining the respective L/RFUEL caution light will start flashing as in diagram 5. An associated audio will also sound with the flashing L/RFUEL but it only lasts for 900 m/secs.

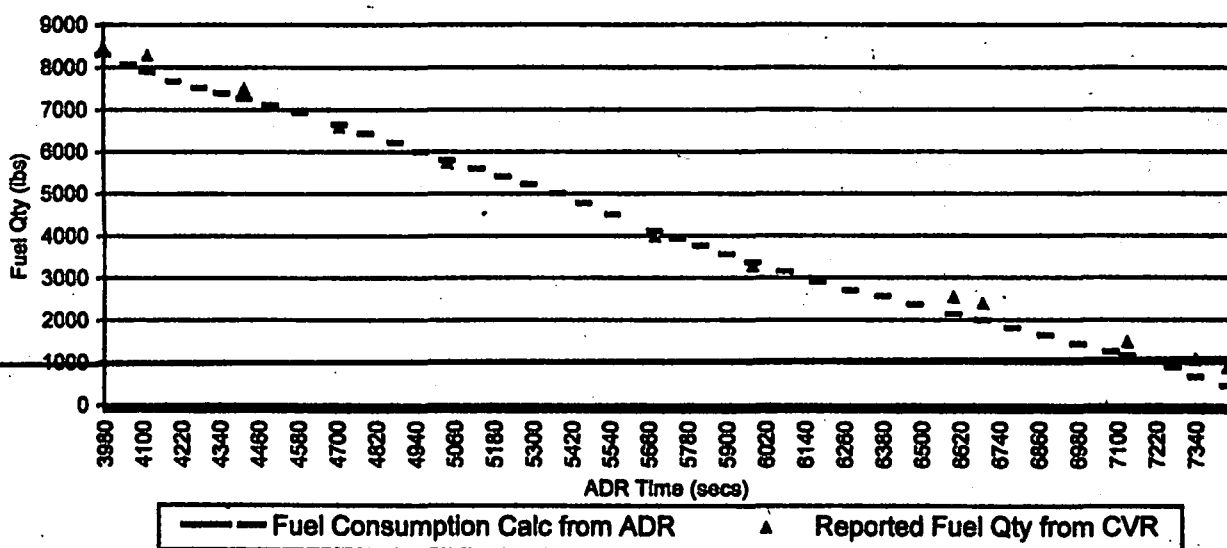
CVR RECORDED FUEL QTYS vs ADR CALCULATED FUEL QTYS

Also, from the above graph, it can be seen that there is another over-read between the times 3980 secs and 4430 secs: This may be an earlier occurrence of the fault, although an alternative theory can be derived by examining the BAES accuracy figures for the Harrier fuel system:

From the table above, with greater fuel loads on board, the Harrier fuel system is biased towards over-reading, and as the fuel quantity reduces this bias decreases before becoming a bias towards under-reading with smaller amounts of fuel on board. This trend mirrors what can be seen in the "Reported Fuel Qty from CVR" line in the above graph, between 3980 secs and 6060 secs, and may account for (some of) the earlier over-read. Regardless of the cause of the early over-read, it is the conclusion of the Board that between the period T-24:18 to T-13:58 a fault occurred in the fuel indication system causing it to over-read on the RHS by around 400lbs until the end of the sortie. The Board concluded that fuel gauge error was a contributory factor in the accident.
