AIRCRAFT ACCIDENT REPORT AND EXECUTIVE SUMMARY

Reference:	CA18/2/3/7952	
Aircraft Registration	ZS-BTO	Date of Accident	24 April 2005		Time of Accident	0850Z
Type of Aircraft	Chipmunk		Type of Operation		Private	
Pilot-in-command Licence Type		Commercial	Age	43	Licence Valid	Yes
Pilot-in-command Flying Experience		Total Flying Hours	1 154.8		Hours on Type	8
Last point of departure		What's Landing (Eastern Cape)				
Next point of intended landing		What's Landing (Eastern Cape)				
Location of the accident site with reference to easily defined geographical points (GPS readings if possible)						
What's Landing (Eastern Cape)						
Meteorological Information		Temperature: 17°C; Wind: 320°/10 kts; Visibility: 10 km+				
Number of people on board	1 + 1	No. of people injured	2	No. of people killed	0	
Synopsis						
<p>On 24 April 2005, the pilot, accompanied by a passenger, took off from What's Landing private aerodrome on a pleasure flight in the area. The pilot stated that after executing a few orbits over the Nature Reserve of Kwelere river mouth, he returned to What's Landing and flew four circuits on runway 30. He then flew up the coast towards Cintsu, climbing to 1 500 feet above m

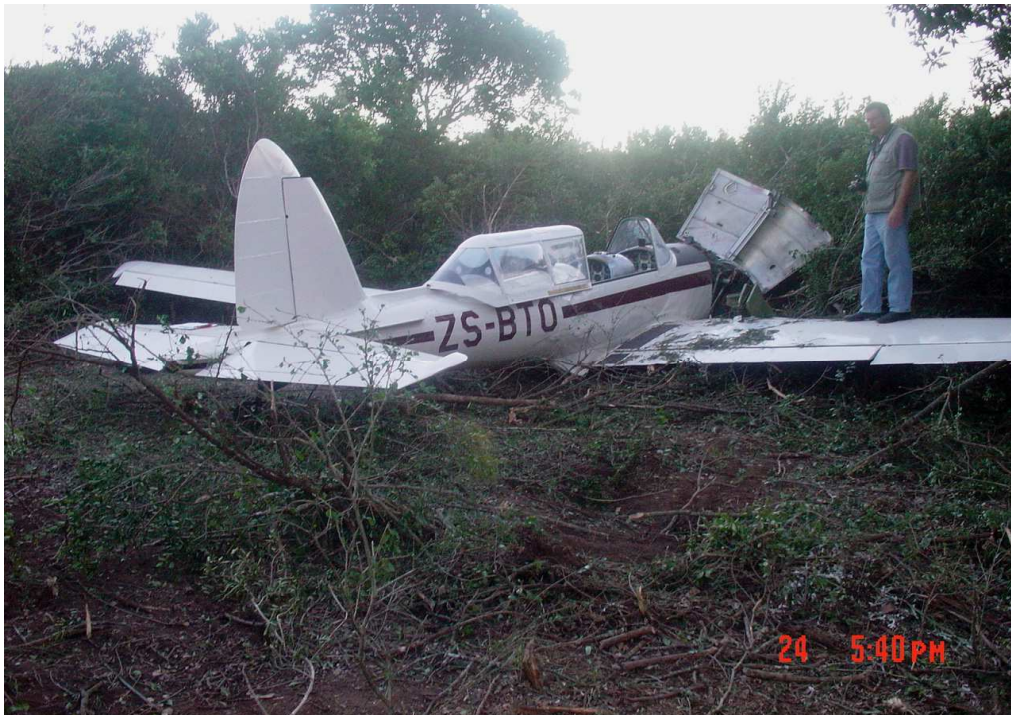
1.3.1 The aircraft sustained damage to the undercarriage, fuselage and engine cowling.

1.12.1 The aircraft mushed into thick bush and stopped within 30 metres at a bearing of 30°M

Figure 1. The aircraft and wreckage site.

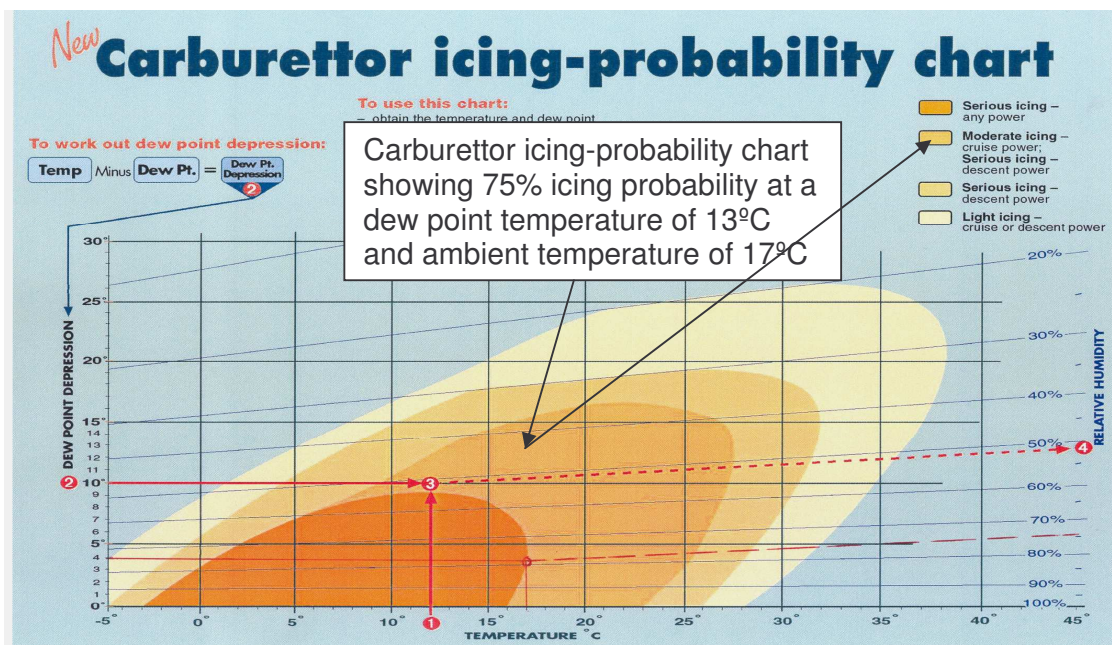
Carburettor icing-probability chart

- 2.4 During the investigation at the accident site, the investigator-in-charge (IIC) could not find any anomalies that might have contributed to the engine failure. However, when considering the meteorological conditions of that day – a dewpoint temperature of 13°C and ambient temperature of 17°C – there was a 75% chance of carburettor icing, as depicted on the carburettor icing probability chart. Although the pilot stated that he had had the carburettor heat ON, it is unlikely that this was the case, because there was no evidence of any carburettor heating system failure. Thus the possibility exists that the pilot did not in fact have the carburettor heat on. This may have led to the engine stopping and the pilot being forced to execute an emergency landing.
