AIRCRAFT ACCIDENT REPORT AND EXECUTIVE SUMMARY
--

Reference:	CA18/2/3/8070	
<b>Aircraft Registration</b>	ZS-IMZ	<b>Date of Accident</b>	15 February 2006		<b>Time of Accident</b>	1245Z
<b>Type of Aircraft</b>	Beech V35B		<b>Type of Operation</b>		Private	
<b>Pilot-in-command Licence Type</b>		Commercial	<b>Age</b>	28	<b>Licence Valid</b>	Yes
<b>Pilot-in-command Flying Experience</b>		Total Flying Hours	314		Hours on Type	Unknown
<b>Last point of departure</b>		Wonderboom Aerodrome (FAWB)				
<b>Next point of intended landing</b>		Ermelo Aerodrome				
<b>Location of the accident site with reference to easily defined geographical points (GPS readings if possible)</b>						
Open field inside a farm in Evander GPS Co-ordinate: S26°27'9.34" E029°08'0.35"						
<b>Meteorological Information</b>		Temperature: 25°C Wind: 03kts/140° Visibility: OK				
<b>Number of people on board</b>	1+0	<b>No. of people injured</b>	0	<b>No. of people killed</b>	1	
<b>Synopsis</b>

**Name of Owner/Operator** : Boshoff FJ & Janse Van Rensburg  
**Manufacturer** : Beechcraft  
**Model** : V35B  
**Nationality** : South African  
**Registration Marks** : ZS-IMZ  
**Place** : Evander  
**Date** : 15 February 20

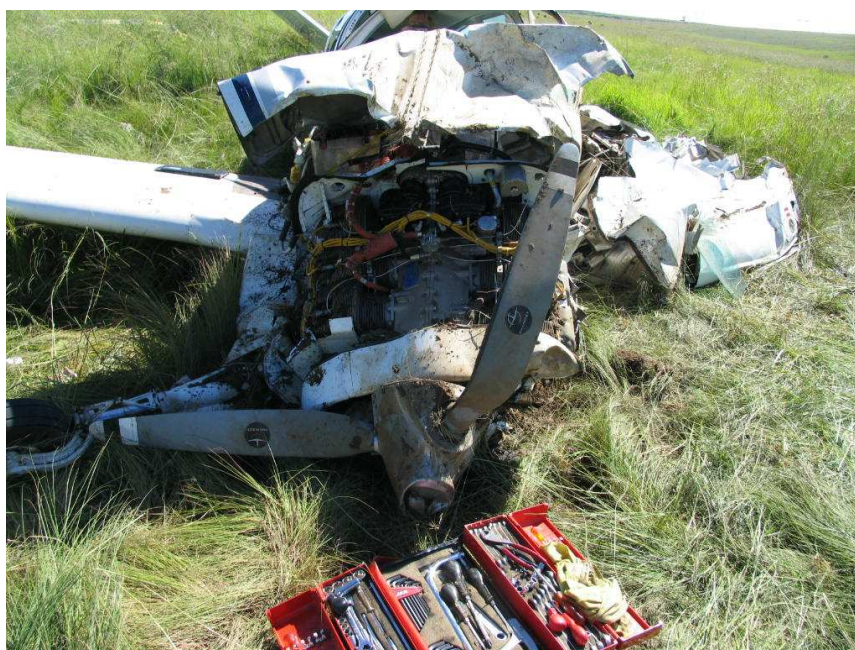
1.3.1 The aircraft was destroyed by impact forces.

Figure 1: showing damage to the aircraft.

1.12.2 The aircraft sustained damage to the undercarriage, propeller, fuselage and to both wings (left wing was destroyed).
