AIRCRAFT ACCIDENT REPORT AND EXECUTIVE SUMMARY

Reference:		CA18/2/3/8109	
Aircraft Registration	ZS-FET	Date of Accident	25 April 2006		Time of Accident	1200Z	
Type of Aircraft	Beech D95A		Type of Operation		Training		
Pilot-in-command Licence Type		Airline Transport	Age	62	Licence Valid	Yes	
Pilot-in-command Flying Experience		Total Flying Hours	9 300		Hours on Type	Unknown	
Last point of departure		Cape Town International Aerodrome (FACT)					
Next point of intended landing		Cape Town International Aerodrome (FACT)					
Location of the accident site with reference to easily defined geographical points (GPS readings if possible)							
Atlantis area near Cape Town (GPS co-ordinates: S33° 35.806' E018° 33.507'), elevation 316 ft							
Meteorological Information		Weather was fine.					
Number of people on board	2 + 1	No. of people injured	0	No. of people killed	3		
Synopsis							
<p>The instructor and pilot accompanied by a passenger (also an instructor) took off on a training flight from Cape Town Aerodrome (FACT). The training to be conducted was indicated on the flight authorisation sheet as "Air Exercises: Asymmetric Circuits (Engine Failure During Missed Approach). The flight

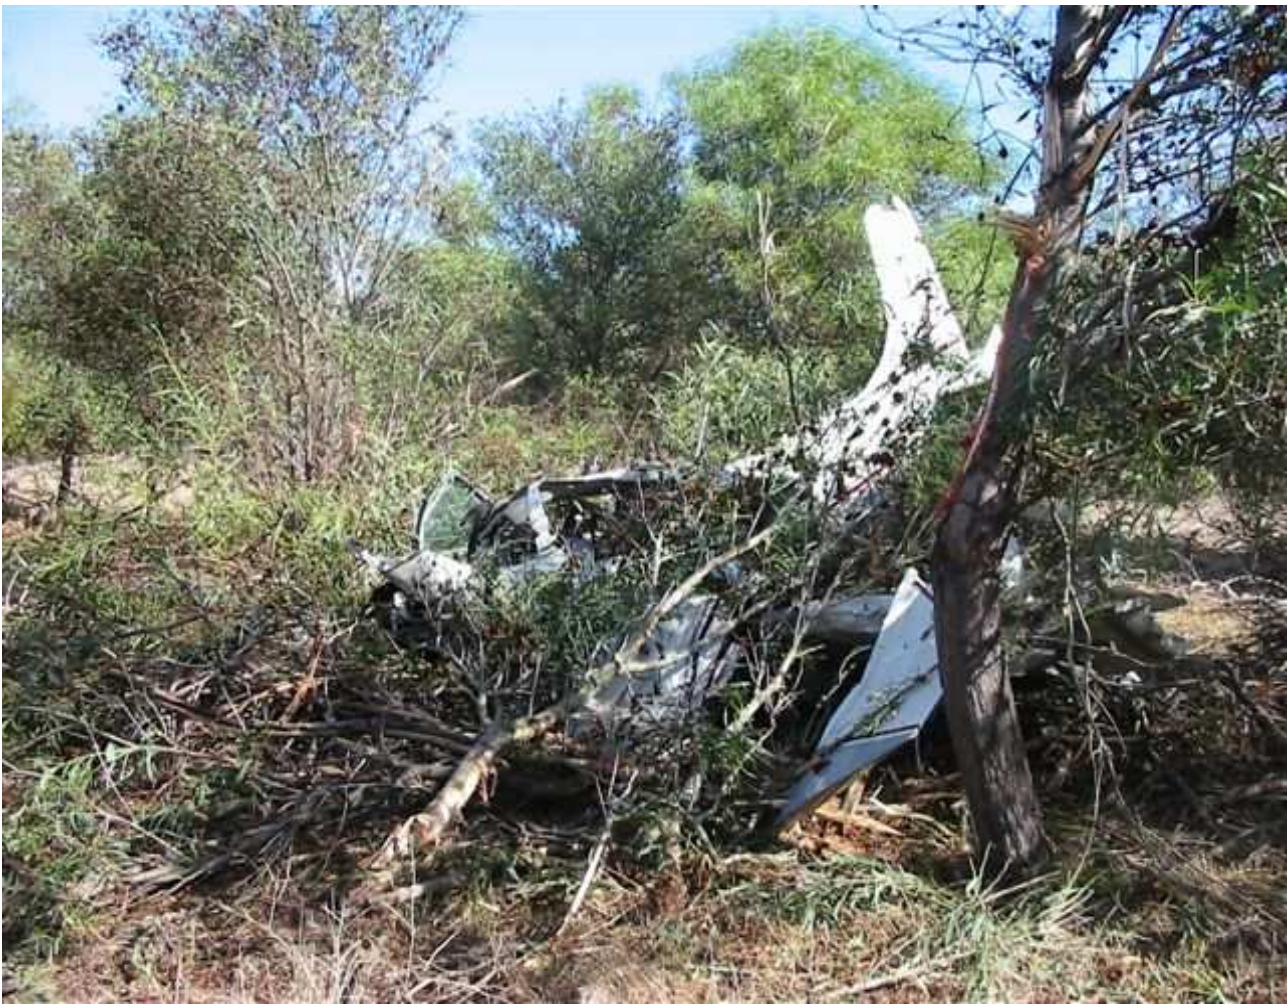
13.1 The aircraft was destroyed during the impact sequence.

Figure 2: Aircraft wreckage

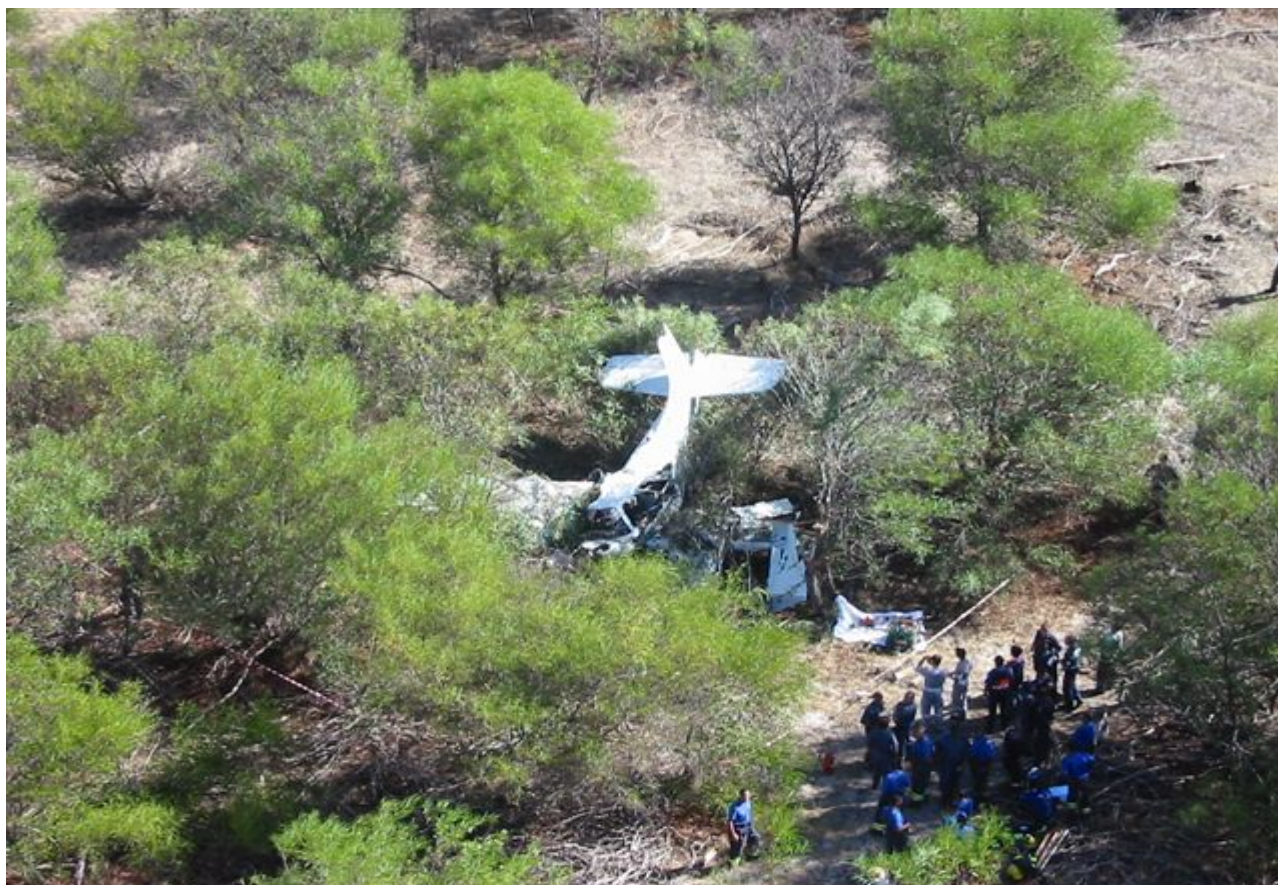
1.12.1 The initial examination of the wreckage revealed that the aircraft was rotating in an anti-clockwise direction on impact. The nose-down pitch angle at impact was determined to be approximately 15°. The impact marks suggested minimal or no horizontal movement of the aircraft, as the wreckage was not scattered. The aircraft was destroyed by the impact forces.

Figure 3: Aerial view of the accident site

- 2.6 The impact indications of the aircraft wreckage displayed the typical impact damage that results during impact in a spin.

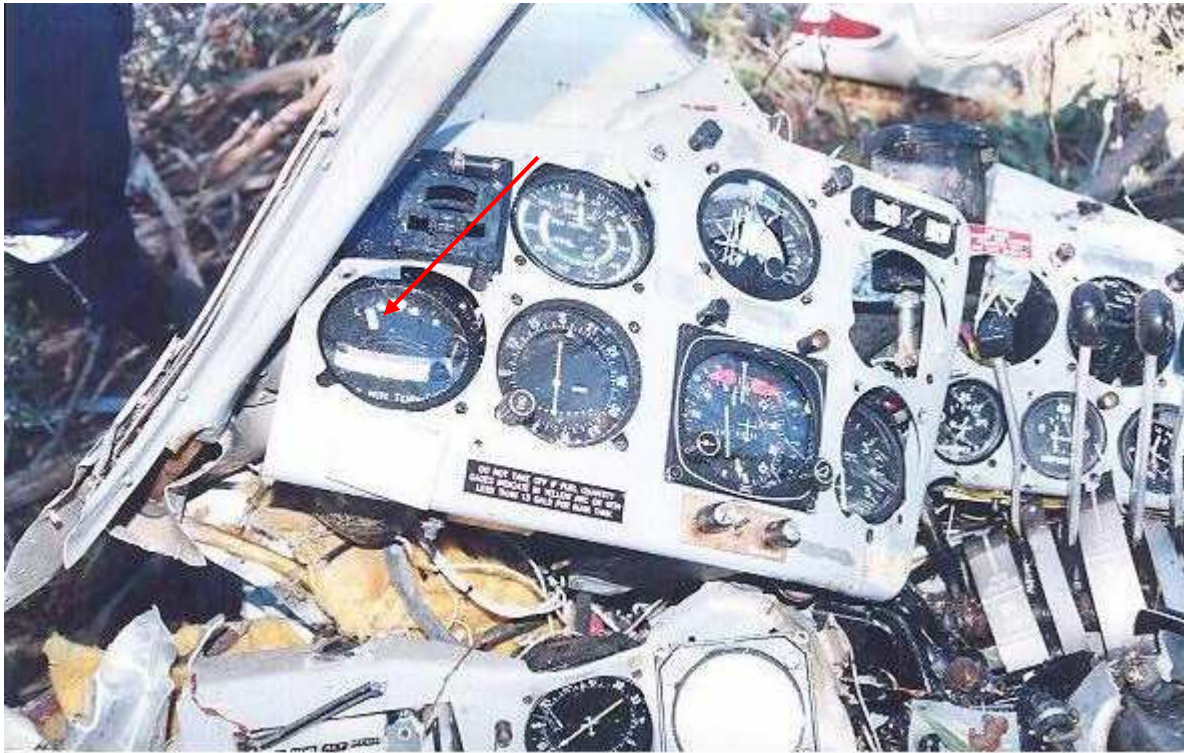
1.12.3 The instrument panel was still intact and it was possible to read some of the indications as they would have been on impact. Of interest was the turn and bank indicator. The indication on the turn and bank instrument showed that the aircraft

was in a left-turn attitude.

Figure 4: The instrument panel, showing the turn and bank indicator

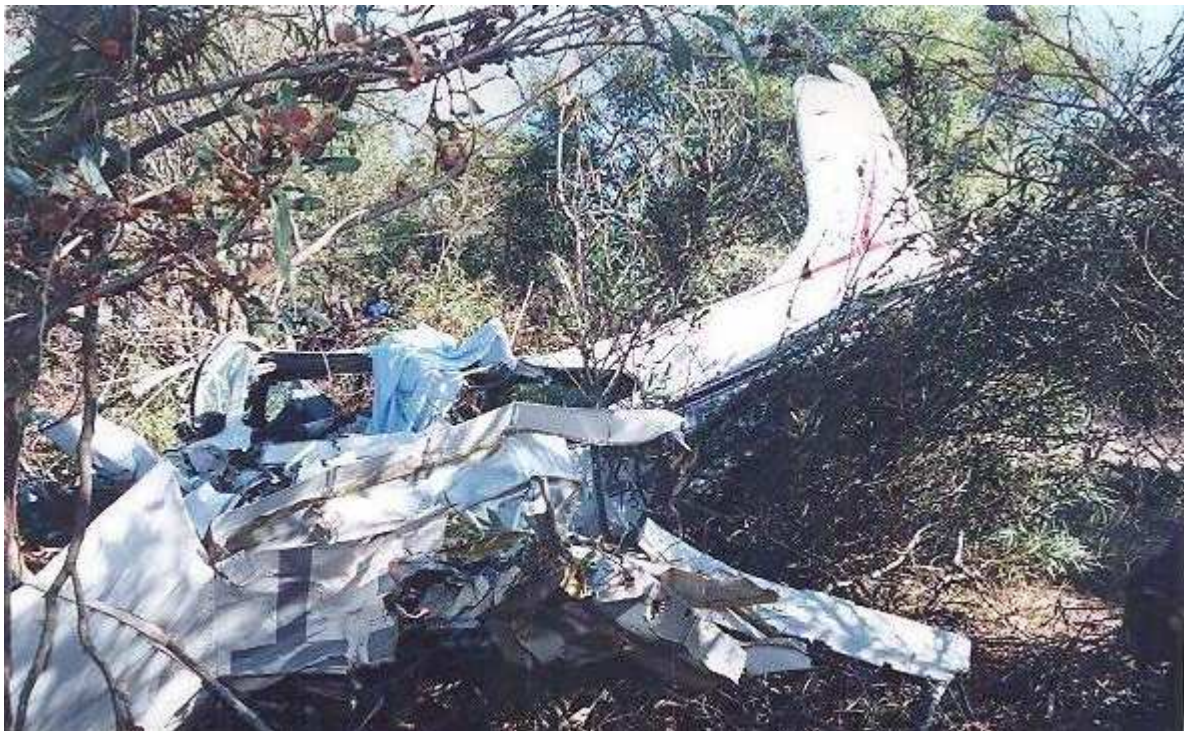
1.12.4 The flap lever was in the 20° position. The landing gear was in an extended position. The control column was in the aft position with the yoke broken. The left-hand wing was destroyed, but the right-hand wing was still intact with wrinkles on the top surface.

Figure 5: Damage to the left-hand wing

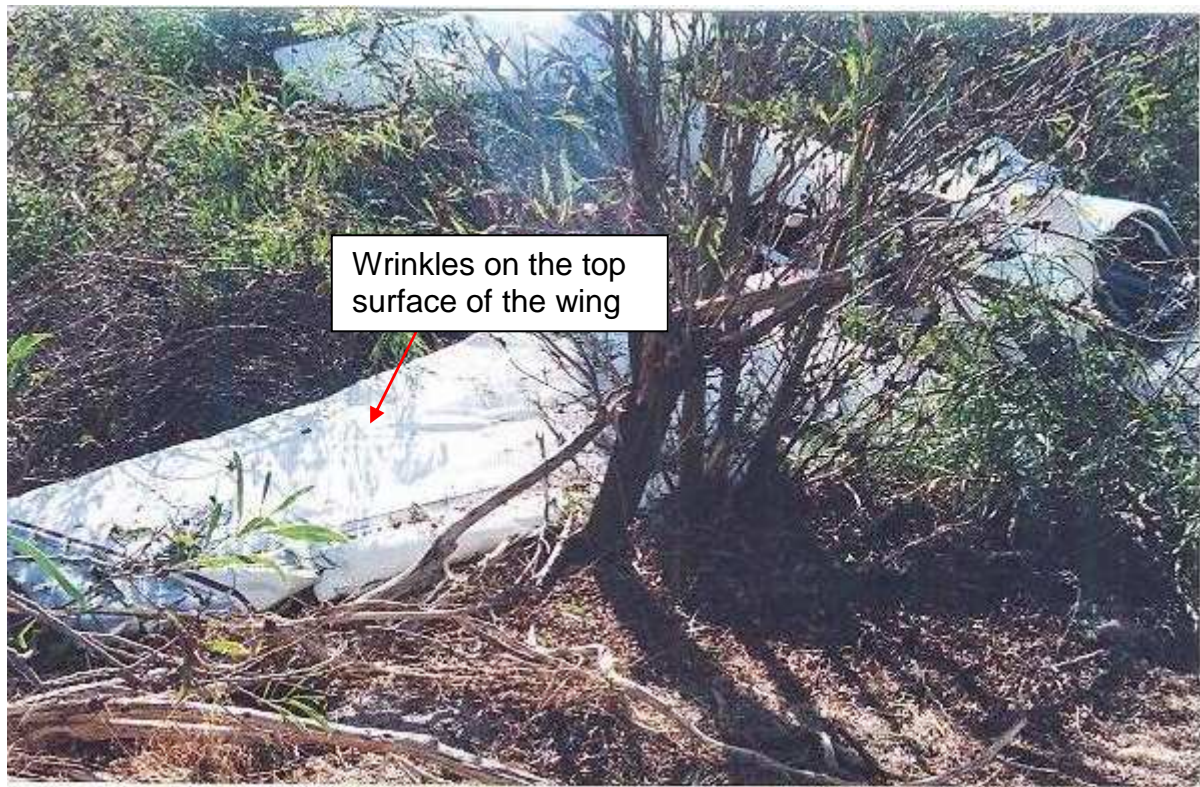
Figure 6: Damage to the right-hand wing
