AIRCRAFT ACCIDENT REPORT AND EXECUTIVE SUMMARY

Reference:	CA18/2/3/8196	
Aircraft Registration	ZS-EXM	Date of Accident	19 October 2006		Time of Accident	0630Z
Type of Aircraft	Piper PA-28-140		Type of Operation	Domestic Charter Flight		
Pilot-in-command Licence Type		Commercial	Age	24	Licence Valid	Yes
Pilot-in-command Flying Experience		Total Flying Hours	865.6		Hours on Type	359.75
Last point of departure		Kimberley Aerodrome (FAKM)				
Next point of intended landing		Kimberley Aerodrome (FAKM)				
Location of the accident site with reference to easily defined geographical points (GPS readings if possible)						
Farm Spitskop, approximately 15 km from Petrusburg on the R48 road towards Kimberley. (GPS: S29°06' E025°16').						
Meteorological Information		Wind speed: 020/15 kts; Temperature: 19°C; Clouds: scattered clouds, with a base of 3 000 ft				
Number of people on board	1 + 1	No. of people injured	0	No. of people killed	2	
Synopsis

AIRCRAFT ACCIDENT REPORT

Name of Owner/Operator : Bevrick Air (PTY) Ltd
Manufacturer : Piper Aircraft Company (PTY) Ltd
Model : PA-28-140
Nationality : South African
Registration Marks : ZS-EXM
Place : Spitskop farm
Date : 19 October 2006
Time

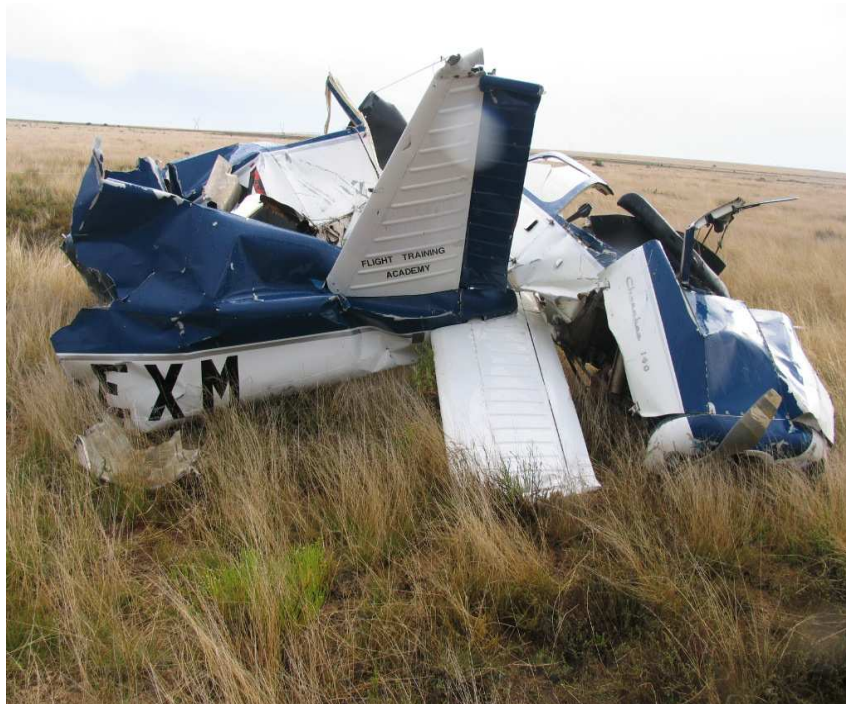
1.3.1 The aircraft was destroyed by post-impact forces.

Figure 1. The wreckage of ZS-EXM.

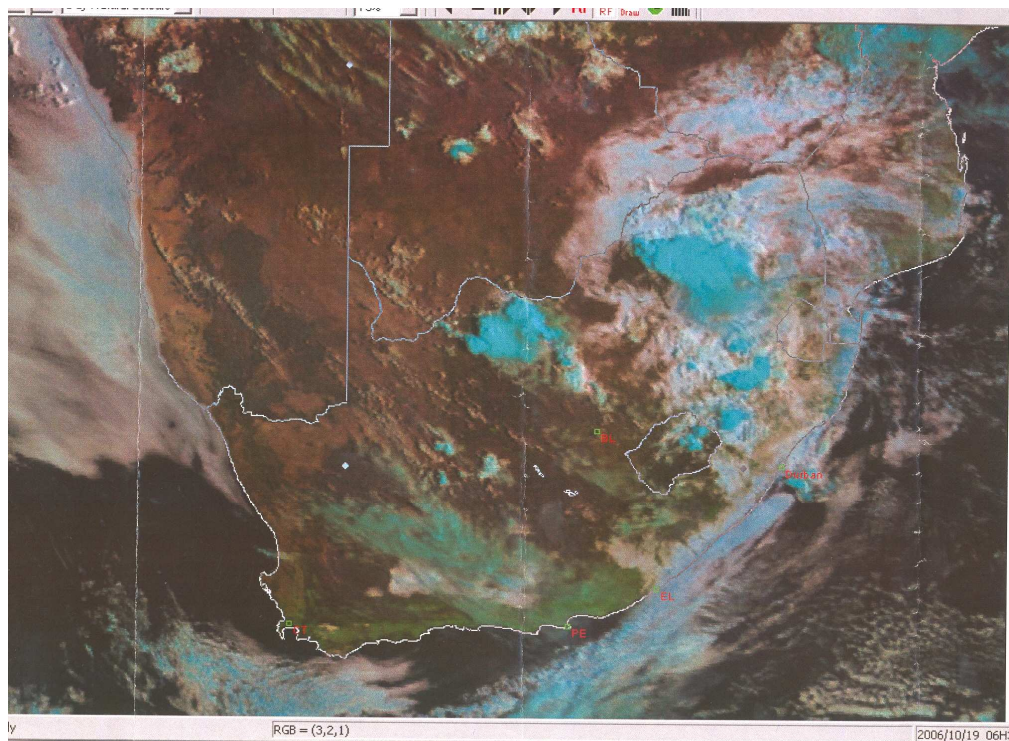
- 1.7.2 Surface analysis – A high pressure system was south-east of the country extending into the eastern part of the country, with a trough of low pressure over the western part of the country. Isolated thunderstorms were present over the north-eastern part of the country.
- 1.7.3 Upper Air Analysis – At 500 hpa a high pressure system was present north of the country.
- 1.7.4 Weather conditions in the vicinity of the accident – On the satellite photograph, thunderstorms can be seen over the NE part of the country and also in the Mafikeng area. There are very few clouds between Bloemfontein and Kimberley.

Figure 2. Satellite image of SA weather.

2.3 The prevailing weather conditions at the time of the incident were considered to be a factor in this accident with the reported surface wind being 020/15 knots. On the satellite photograph, thunderstorms can be seen over the north-eastern part of the country and also in the Mafikeng area. Very few clouds can be seen between Bloemfontein and Kimberley. Windy conditions were also reported at the time of the accident by the farm owner and workers.

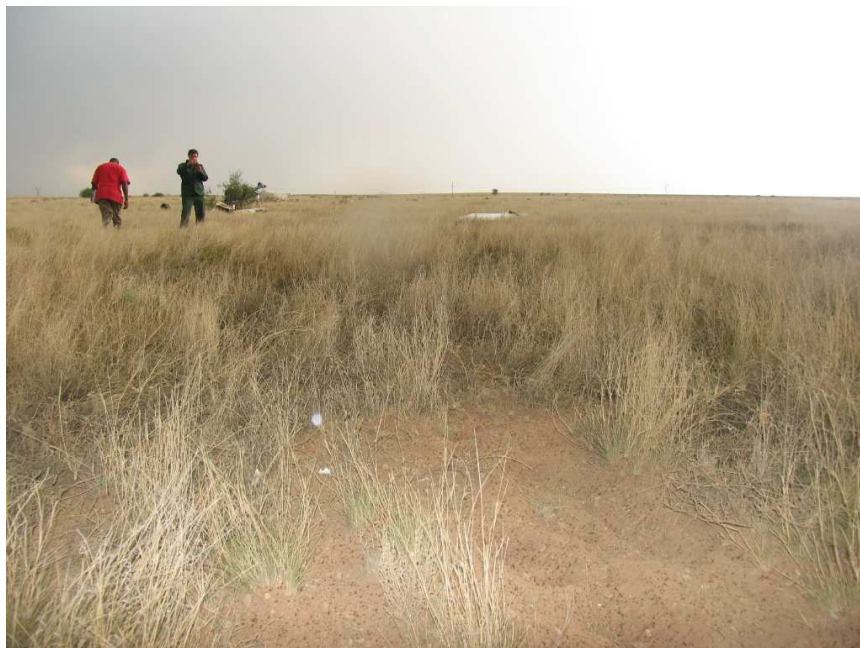
- 1.12.1 The aircraft was reported as flying at low level over the farm. It then made a left-hand turn as if the pilot were looking at something on the ground, and suddenly descended and crashed.
- 1.12.2 The aircraft bounced and skidded for approximately 200 metres from the point of first impact. It then collided with a tree and rolled over. The occupants were thrown out and the aeroplane was destroyed during the accident sequence. It could not be established if the occupants had strapped in.

Figure 3. The first impact mark.

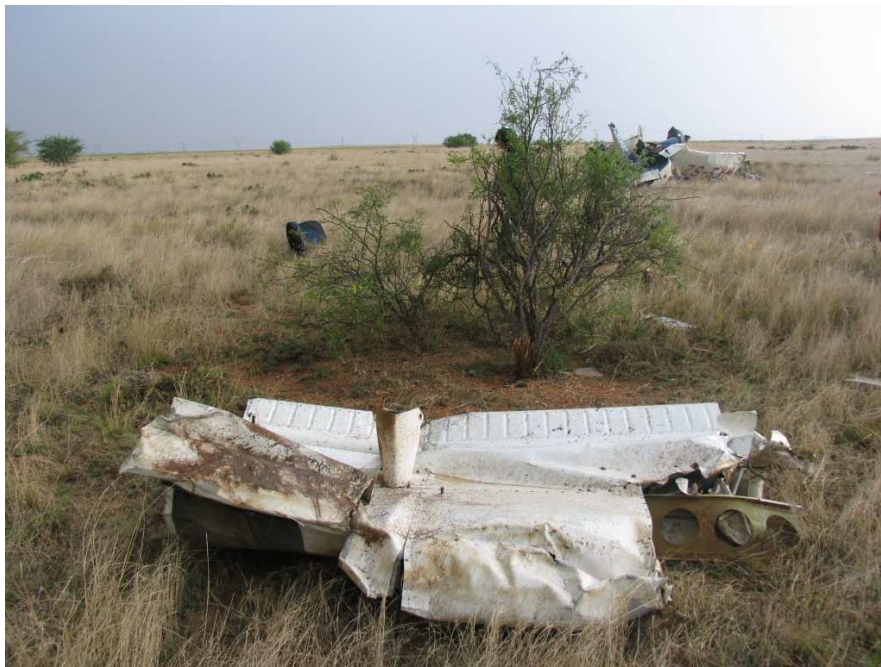
Figure 4. The bush which was struck by the aircraft.
