AIRCRAFT ACCIDENT REPORT AND EXECUTIVE SUMMARY

Reference:	CA18/2/3/8230	
Aircraft Registration	ZS-LVX	Date of Accident	03 January 2007		Time of Accident	1322Z
Type of Aircraft	Piper PA28-181		Type of Operation	Private		
Pilot-in-command Licence Type		Commercial	Age	31	Licence Valid	Yes
Pilot-in-command Flying Experience		Total Flying Hours	811.2		Hours on Type	245.6
Last point of departure		Lady Frere (Private Aerodrome)				
Next point of intended landing		East London (FAEL) Aerodrome				
Location of the accident site with reference to easily defined geographical points (GPS readings if possible)						
During landing on Runway 11 at East London Aerodrome (FAEL)						
Meteorological Information		Surface Wind: 090° @ 6kts. Temperature: 27°C. Visibility: 10km. Cloud base: SCT @ 5000feet.				
Number of people on board	2 + 0	No. of people injured	0	No. of people killed	0	
Synopsis						
<p>The aircraft drifted to the left of the gravel runway on take-off roll and at about rotation, the left main landing gear made contact with an anthill, causing the wheel axle and wheel assembly (lower strut) to separate from the aircraft. The crew continued with the flight to their destination. On lan

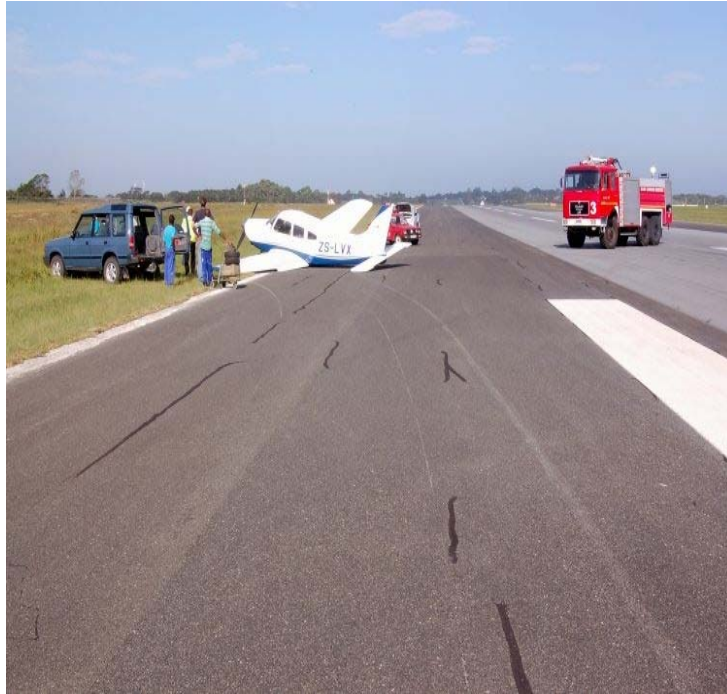
Photo1.

1.4.1 Minor scratch mark on the runway.

Photo 1 indicates the scratch marks on the runway

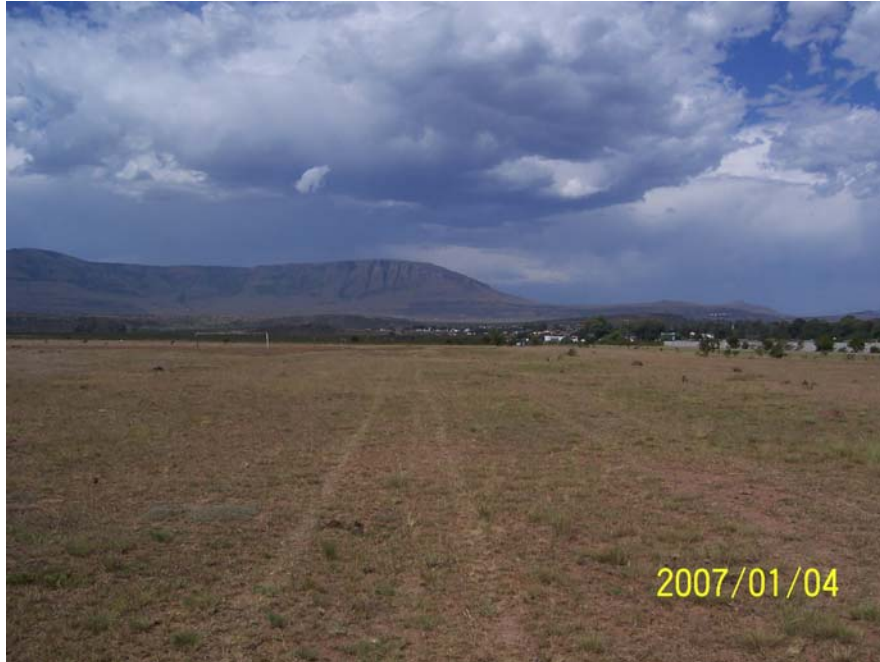
Photo 2.

1.10.1 The pilot took off from an airstrip in an open field at Lady Frere. This was not a licenced airstrip

Photo 2 indicates the airstrip used for the takeoff.

4.1 It is recommended that the Commissioner should urge and encourage owners of unlicensed airstrips to register their strips and to ensure that strips are maintained to an acceptable safe operational standard.

4.2 It is recommended that the SACAA publish an article in the Safety Link to stress the importance to pilots to verify the servicability and adequacy of an airstrip before landing or taking off from such a strip.

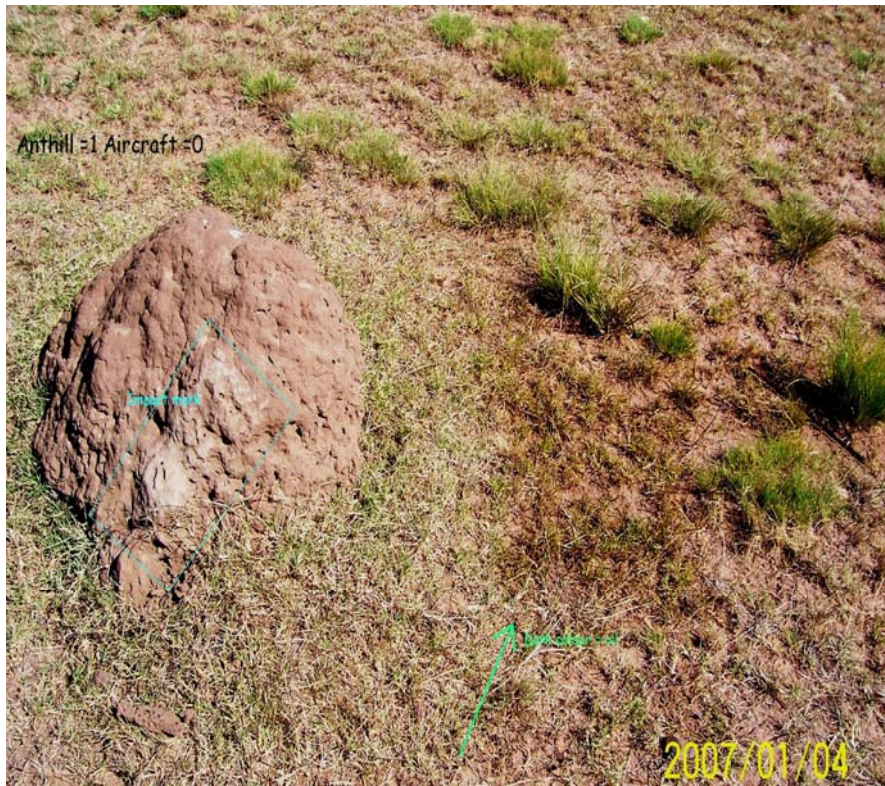
Photo 3.

Photo 3 indicates an anthill which was presumably struck by the left-hand gear.

2.2 During take-off at Lady Frere, the aircraft veered to the left of the airfield at approximately 300m from the threshold. The aircraft impacted with an anthill which was situated to the left of the field. As a result, the left-hand main landing gear separated from the aircraft. The left oleo piston and wheel assembly separated at the torque link lower attachment and piston to cylinder attachment.

2.4 Though the pilots state that they did not feel the impact with an anthill, it is considered that impact with the anthill caused the damage to the left-hand main gear.

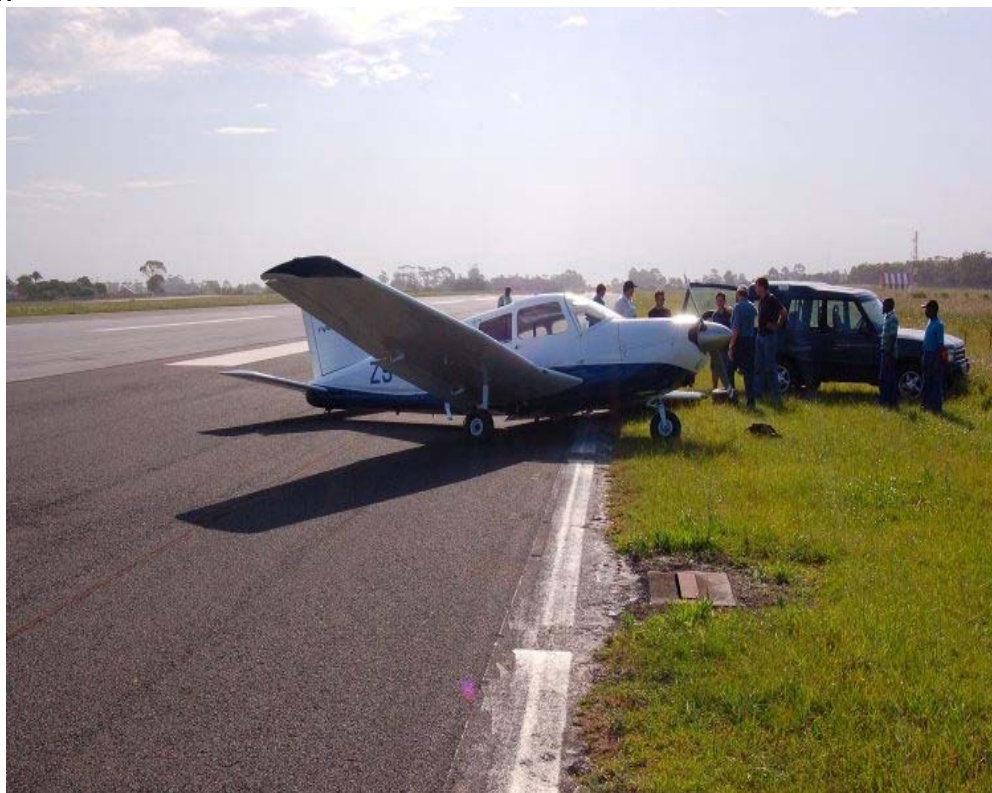
Photo 4.

1.12.1 The approach was normal and on touch-down, the left hand wing settled on the runway. The aircraft skidded for approximately 15m before it came to a halt on the left-hand side of runway 11.

1.12.2 During the landing at the destination aerodrome, the aircraft touched down and the left-hand wing, left-hand main landing gear, oleo cylinder and torque link made contact with the runway surface before the aircraft came to a halt. As a result, the left-hand wing and the elevator contacted the runway surface.

Photo 4 indicates the aircraft as it came to halt on the left-hand side of runway11.

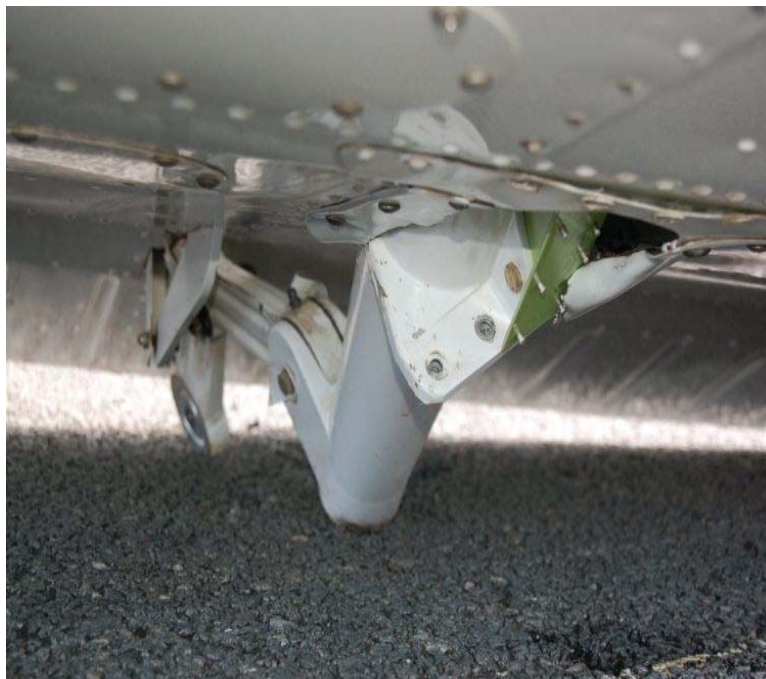
Photo 5.

1.16.1 The site inspection by the pilot revealed a failed landing torque link attachment. The piston had separated from the landing gear cylinder at the securing point and at the lower torque link attachment.

1.16.2 The left-hand landing gear piston and torque link attachment failed on impact with an anthill.

1.16.3 The left-hand landing gear piston and wheel axle assembly were recovered from the locals at the departure point. No tests were carried out on the recovered components.

Photo 5 indicates the left-hand landing gear.

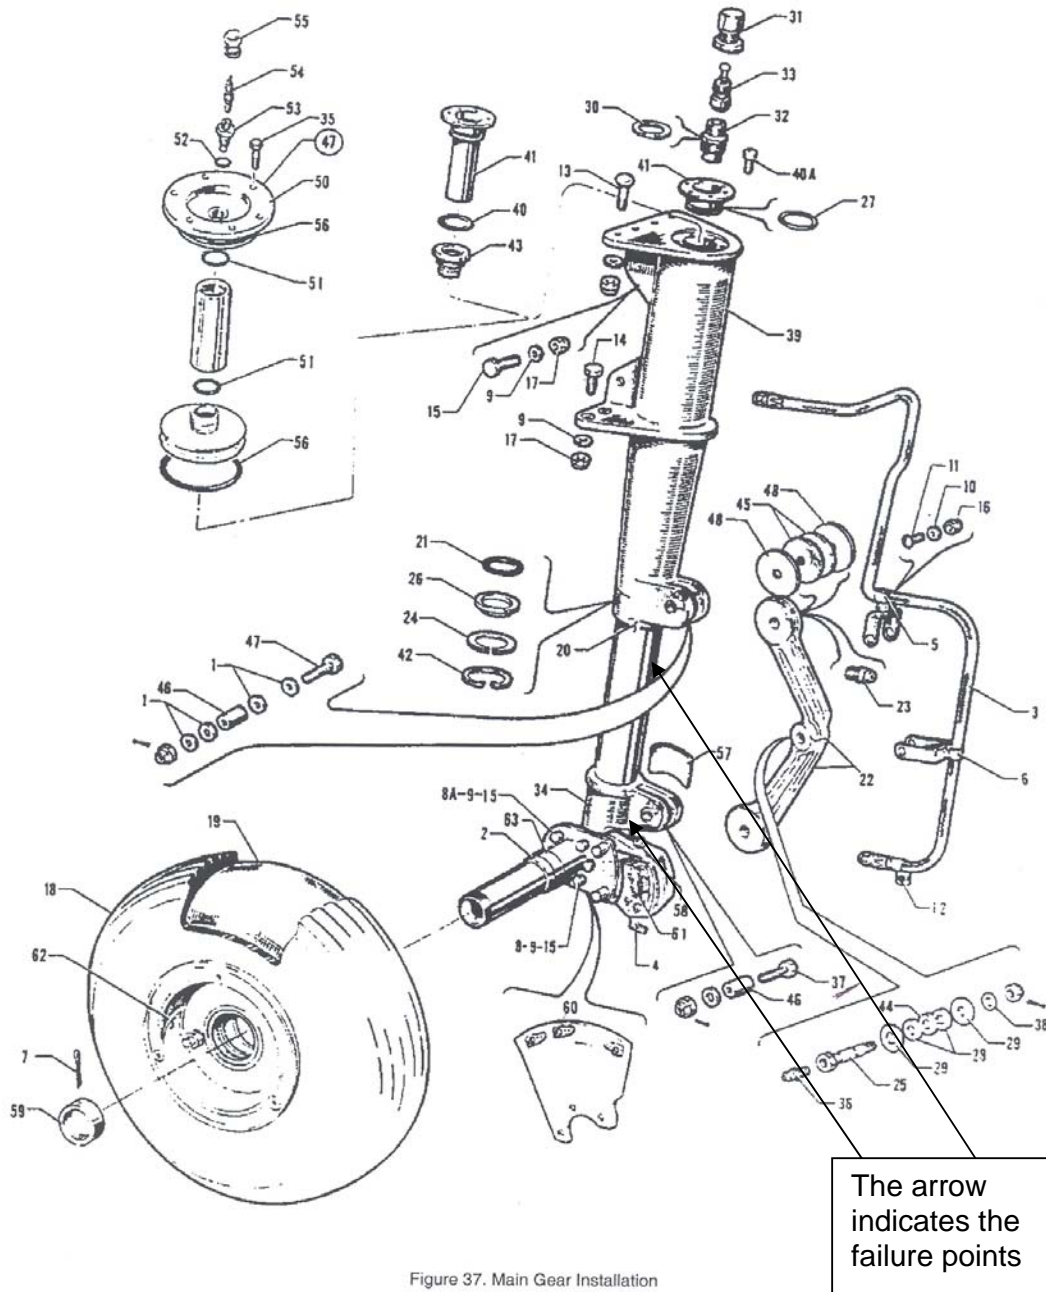
Figure 37. Main Gear Installation

Photo 6 indicates the schematic drawing of the main landing gear.
