## AIRCRAFT ACCIDENT REPORT AND EXECUTIVE SUMMARY

Reference:	CA18/2/3/8247	
<b>Aircraft Registration</b>	ZS-BXT	<b>Date of Accident</b>	27 January 2007		<b>Time of Accident</b>	0600Z
<b>Type of Aircraft</b>	Tiger Moth (DH-82A)		<b>Type of Operation</b>	Private		
<b>Pilot-in-command Licence Type</b>		Private	<b>Age</b>	47	<b>Licence Valid</b>	Yes
<b>Pilot-in-command Flying Experience</b>		Total Flying Hours	612.0		Hours on Type	263.0
<b>Last point of departure</b>		Oak Valley District near Grabouw (Western Cape)				
<b>Next point of intended landing</b>		Oak Valley District near Grabouw (Western Cape)				
<b>Location of the accident site with reference to easily defined geographical points (GPS readings if possible)</b>						
Private farm in Oak Valley District, Grabouw. GPS position: S34° 10" 404' E019° 03" 512'						
<b>Meteorological Information</b>		<b>Wind:</b> South-easterly, light & variable; <b>Visibility:</b> CAVOK				
<b>Number of people on board</b>	1 + 1	<b>No. of people injured</b>	1 + 1	<b>No. of people killed</b>	0

## AIRCRAFT ACCIDENT REPORT

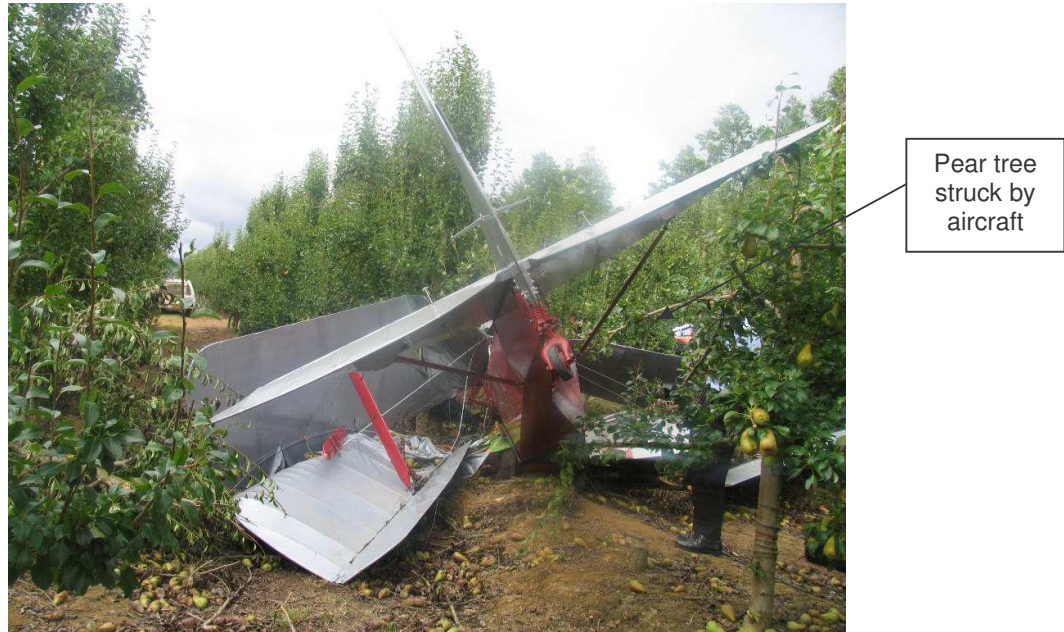
1.3.1 The aircraft's left and right, upper and lower wings, nose section and fuselage were substantially damaged on impact with the pear trees and the ground. The propeller separated from the engine.

Figure 1. The wreckage of ZS-BXT.

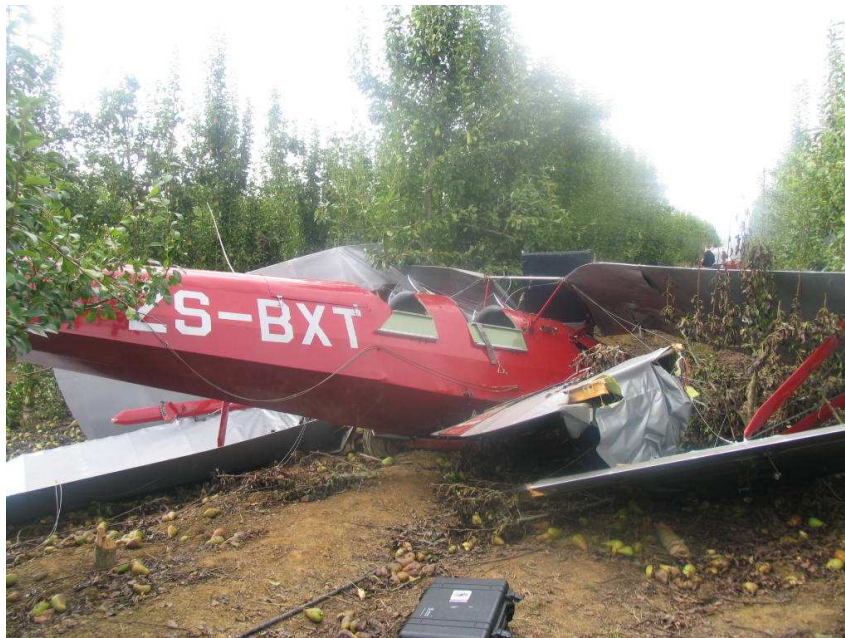
1.12.1 The aircraft struck a pear tree in an orchard slightly left of the extended centreline of runway 15. The aircraft skidded for approximately 10 m before coming to rest.

**Figure 2.** The wreckage of the aircraft – side view.

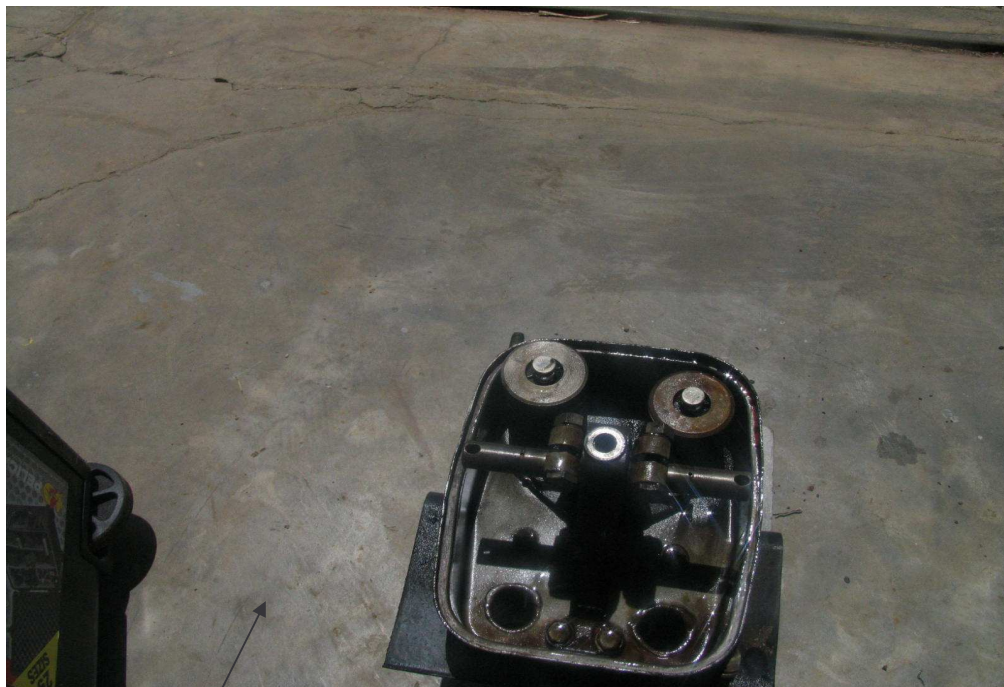
1.16.1 The engine was examined by an Approved Person, who established that the number 2 and 3 cylinders exhaust valves were stuck in the open position due to excessive carbon build-up in the valve guides – an indication that the engine had been running at too high a temperature. As a result, both cylinders had a complete loss of compression and a subsequent loss of power.

**Figure 3.** The cylinder removed from the engine.

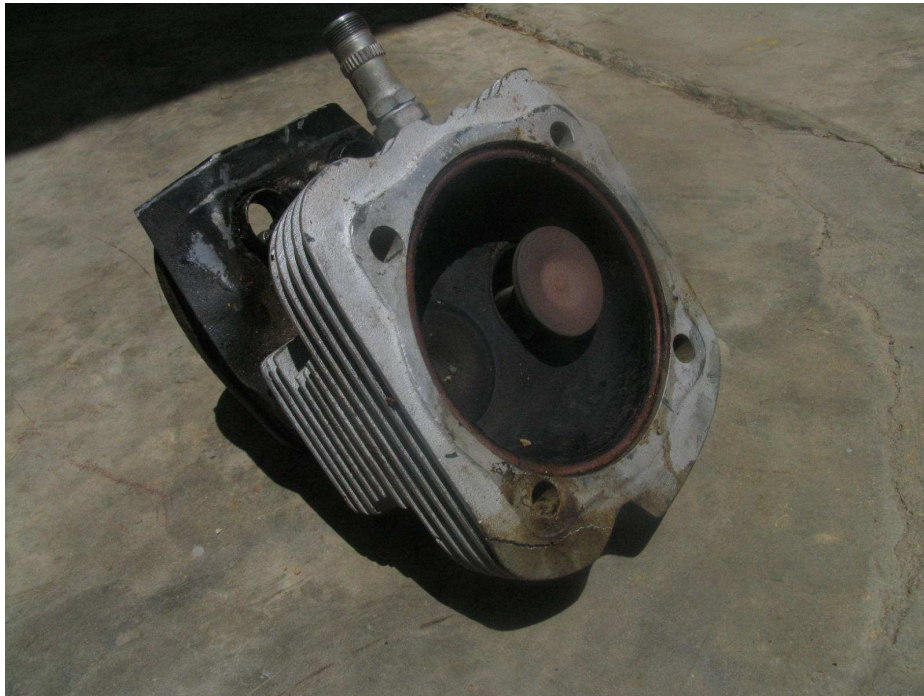
**Figure 4.** The exhaust valve stuck in an open position.

- 3.1.1 The pilot had a valid licence at the time of the accident.
- 3.1.2 Weather was not a contributing factor to the accident.
- 3.1.3 The No. 2 and 3 cylinder exhaust valves stuck in the open position due to excessive carbon build-up in the exhaust valve guides.
- 3.1.4 The pilot followed the correct emergency procedure.

- 3.2.1 Cylinder temperatures were too high, causing excessive carbon build-up in the exhaust valve guides. This resulted in the No. 2 & 3 exhaust valves becoming stuck in the open position.
