AIRCRAFT ACCIDENT REPORT AND EXECUTIVE SUMMARY

Reference: CA18/2/3/8270

Aircraft Registration	ZS-XPS	Date of Accident	16 March 2007		Time of Accident	0600Z
Type of Aircraft	Cirrus SR 22 Aeroplane		Type of Operation		Private	
Pilot-in-command Licence Type		Private Pilot	Age	56	Licence Valid	Yes
Pilot-in-command Flying Experience		Total Flying Hours as on 13 January 2007	2 400		Hours on Type	Unknown
Last point of departure		New Tempe Aerodrome near Bloemfontein (FATP)				
Next point of intended landing		Queenstown Aerodrome (FAQT)				
Location of the accident site with reference to easily defined geographical points (GPS readings if possible)						
Next to a dirt road near Queenstown at the geographical position determined as S 32°2.943' E 026°48 .165'						
Meteorological Information		Wind: Calm; Temperature: 12.5°C				
Number of people on board	1 + 0	No. of people injured	0	No. of people killed	1	
Synopsis		<p>On 16 March 2007, at approximately 0600Z, a Cirrus SR 22 aircraft was destroyed on impact with terrain while manoeuvring 14 nautical miles from Queenstown. A post-impact fire ensued. The pilot was fatally injured.</p> <p>Witnesses on the ground stated that they had heard th

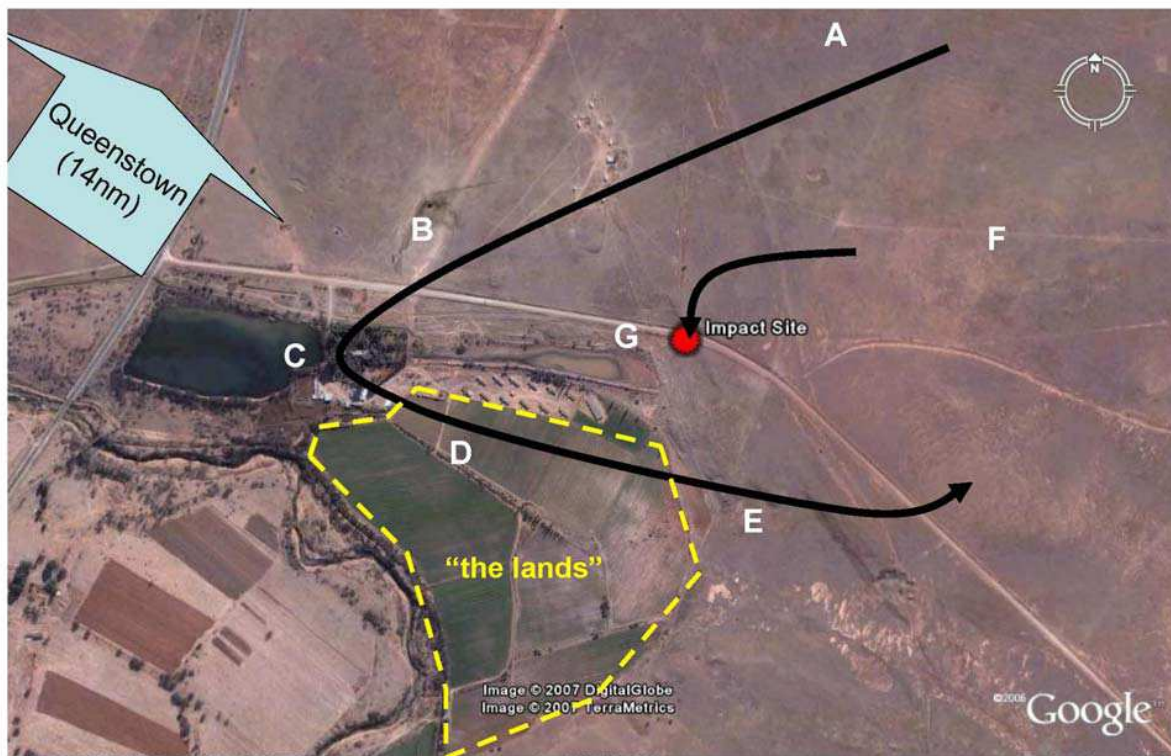
- 1.1.6 At 0600Z, another witness stated that he was listening to the 0600Z news when he heard the aircraft. He went out to look and saw the aircraft approximately 50 metres above the ground over his house (between A and B – see Figure 1 below). He described the mist as starting to lift, but still patchy.

- 1.1.7 Another witness, who was busy working, stated that he had heard the aircraft coming towards him. At location C (see below) he saw it suddenly appear out of the mist just above the trees and house, then bank left and down over a poultry abattoir towards the area referred to as “the lands”.

- 1.1.8 The final witness, who saw the impact, described seeing the aircraft coming out of the mist and dropping suddenly. He initially thought the aircraft was going to land, but then it flattened out and travelled along “the lands” at about 7 metres above the ground. He said that at point E the aircraft climbed, turning to the left, and disappeared into the mist. The witness then heard the aeroplane coming back and saw it in the vicinity of point F approximately 200 metres above the ground. He stated that it then suddenly turned left and seemed to dive straight into the ground at point G.

Figure 1: Flight path as described by witnesses.

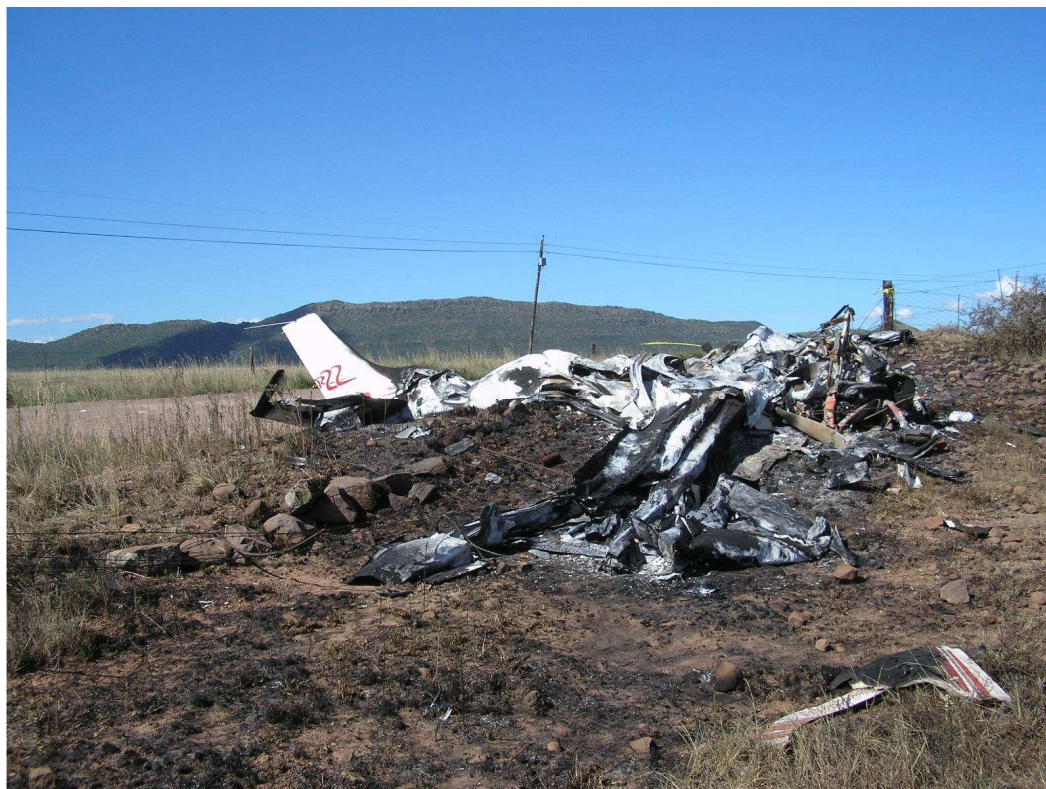
1.3.1 The aircraft was destroyed by impact forces and a post-impact fire.

Figure 2: The wreckage of ZS-XPS.

- 1.12.1 The aircraft came to rest facing in a north-westerly direction at an altitude of 3 392 feet.
- 1.12.2 Ground scarring at the accident site indicated that the aircraft had first struck a road and then a sand mound on the side of the road before it came to rest. Ground scarring also showed that the aircraft had hit the road in a wings-level attitude. It seems that the aircraft's flight path was between the telephone wires and the ground, based on the location of the initial ground scar, the orientation of the wreckage, the undisturbed telephone wires and the fence on the side of the road opposite the accident site.
- 1.12.3 Although the wreckage was consumed by fire, all major components were accounted for and included the fuselage, stabilisers, flight control surfaces, engine and propeller.

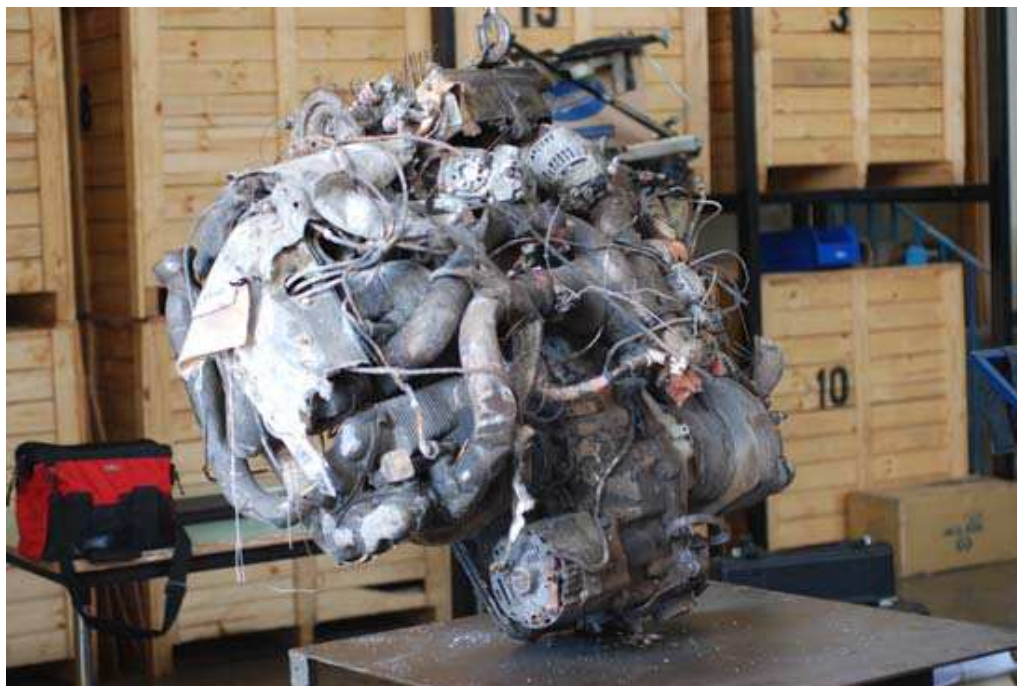
1.16.1 The engine was examined by a field inspector of Teledyne Continental Motors Inc.

The inspector stated that “No pre-mishap abnormalities were visually observed with the engine/propeller inspection that would have prevented normal engine operation”.

Figure 4: The damaged engine.

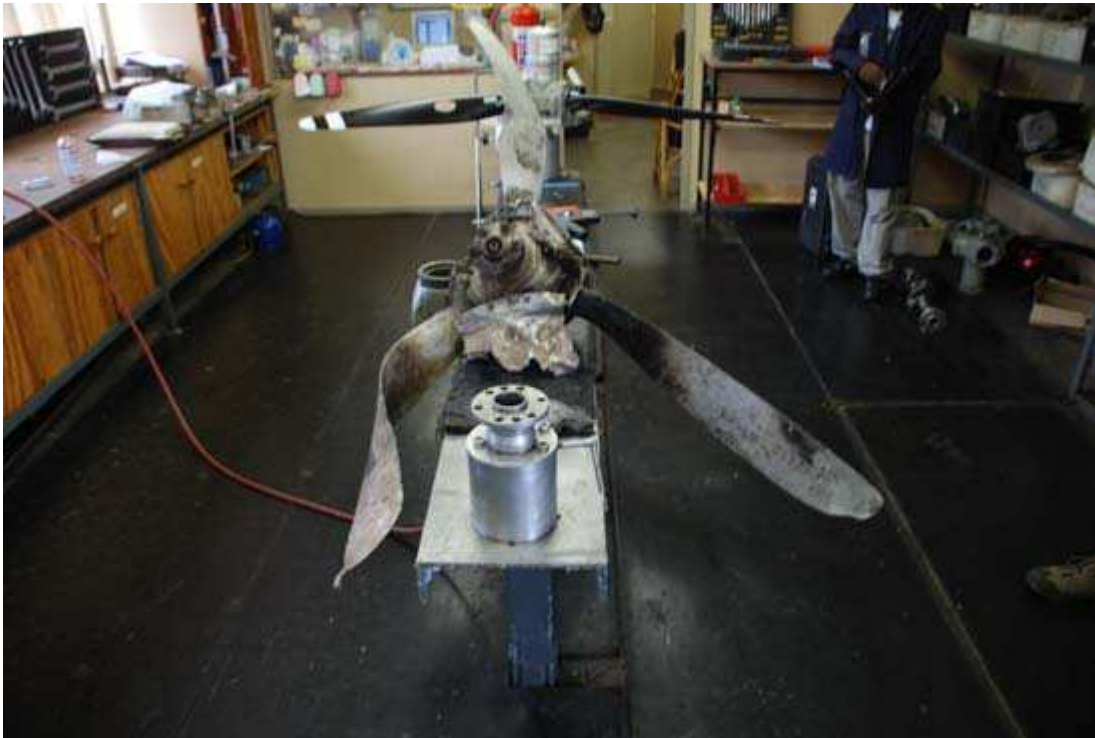
- i. The propeller was separated from the engine crankshaft just aft of the propeller flange.
- ii. Blades were arbitrarily numbered 1-3. Blade 1 was distinguishable by the s-bending of the blade and the fact that it was the most damaged of the three. Blades 2 and 3 were numbered consecutively in a counter-clockwise fashion as viewed from the pilot's seat looking forward.
- iii. Blade 1 exhibited twisting and s-bending. Chord-wise scratches were present on the camber side of the blade. There were gouges along the outer two-thirds of the blade's leading edge. The blade tip was gouged on three sides.

The trailing edge of the blade also had small gouges.

- iv. Blade 2 exhibited aft bending at its mid-span and forward bending near the blade tip. A portion of the blade tip was broken off. Gouges were present on the leading and trailing edges from the tip inboard to approximately one-third of the blade's length. Chord-wise scratches were present on the cambered side of the blade.
- v. Blade 3 exhibited chord-wise scratches on the cambered side of the blade. Approximately 2 inches of the tip were bent aft and approximately ½ inch of the blade tip was missing.

Figure 5: The damaged propeller.

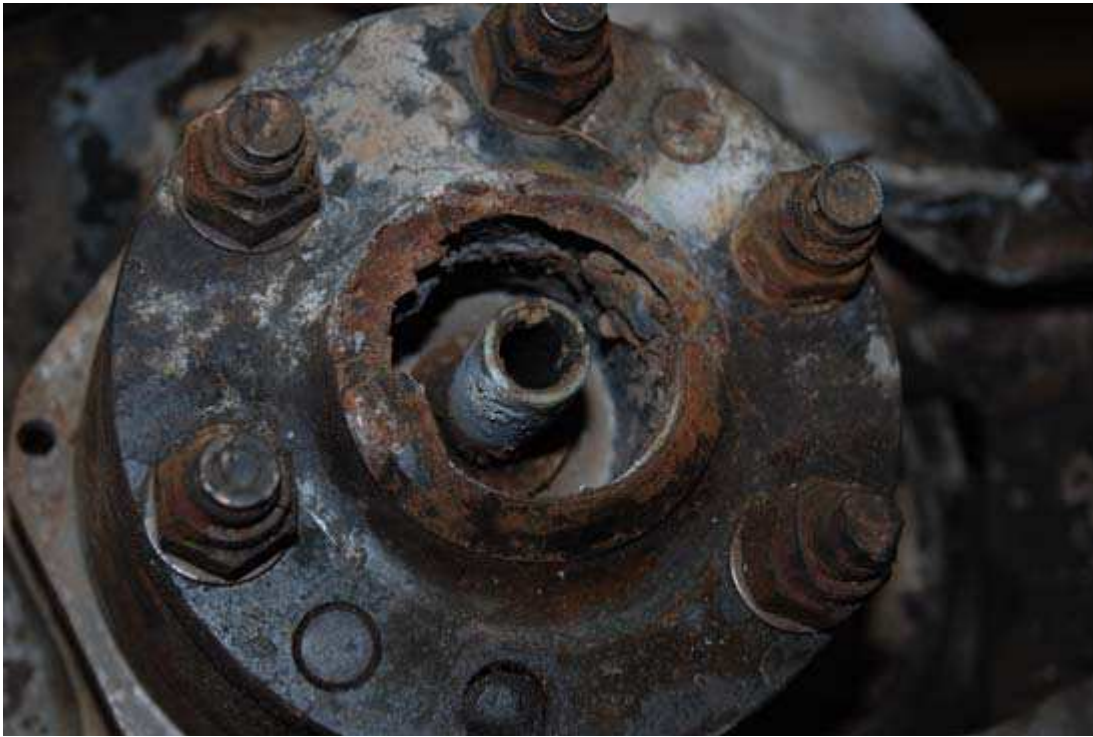
Figure 6: Damage to the propeller hub.
