AIRCRAFT ACCIDENT REPORT AND EXECUTIVE SUMMARY

Reference:	CA18/2/3/8281	
Aircraft Registration	ZU-DLV	Date of Accident	7 April 2007		Time of Accident	0630Z
Type of Aircraft	Bushbaby 450 (aeroplane)		Type of Operation	Private		
Pilot-in-command Licence Type		Microlight	Age	44	Licence Valid	Yes
Pilot-in-command Flying Experience		Total Flying Hours	178.4		Hours on Type	178.4
Last point of departure		Bapsfontein aerodrome (Gauteng province)				
Next point of intended landing		Rhino Park aerodrome (Gauteng province)				
Location of the accident site with reference to easily defined geographical points (GPS readings if possible)						
700 m short of threshold of runway 09, Rhino Park aerodrome (GPS position: South 25°50'57 East 028°32'30)						
Meteorological Information		Surface wind: 090°/5 kts; Temperature: 17°C; Visibility: +10 km				
Number of people on board	1 + 1	No. of people injured	0	No. of people killed	0	
Synopsis						
<p>The pilot, accompanied by a passenger, departed from Bapsfontein aerodrome on a private flight to Rhino Park aerodrome, with the intention of returning to Bapsfontein. He stated that he approached Rhino Park from the east and joined on a right downwind fo

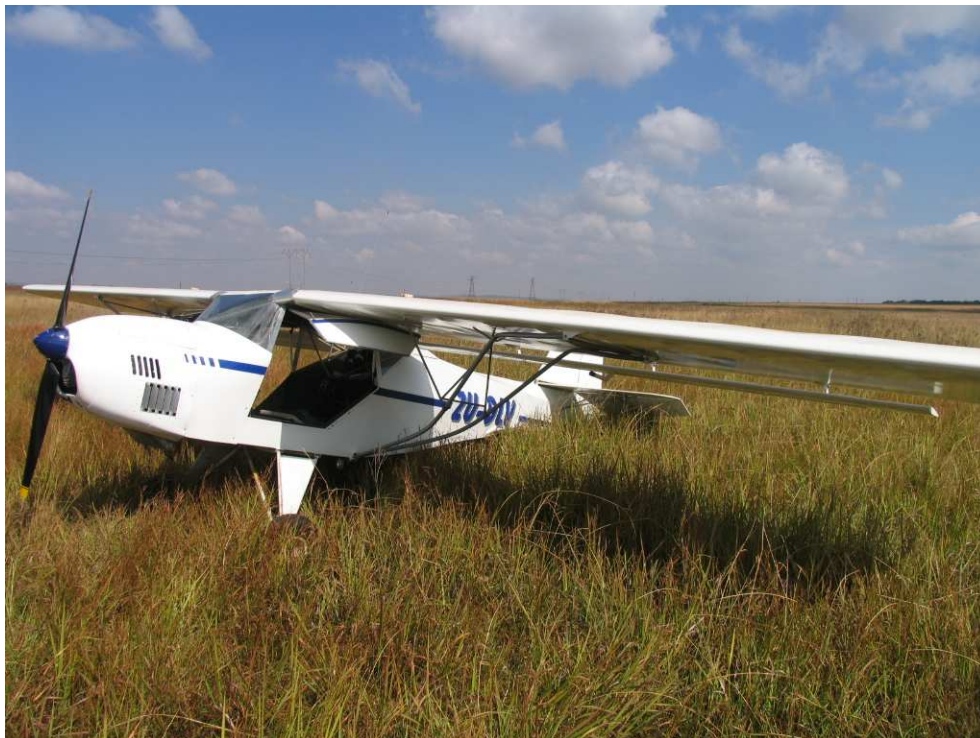
1.3.1 The aircraft sustained substantial structural damage as a result of nosing over.

Figure 1. The aircraft after being righted.

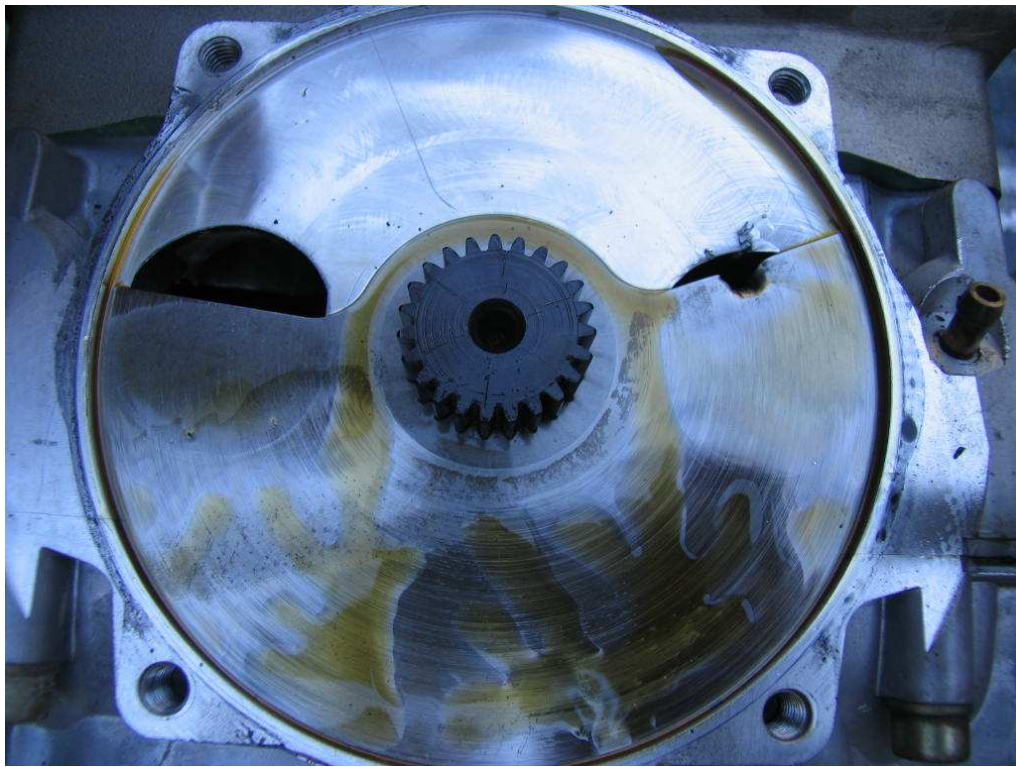
- (vii) A substantial amount of engine oil was present in the engine.
- (viii) The injection rotary valve displayed evidence of object damage in line with the No. 2 cylinder.

- (xii) All the bearings within the engine assembly were in good condition.
- (xiii) The injection intake rotary valve (151° rotation) showed evidence of object damage on the flange in line with the No. 2 cylinder port.

Figure 2. Damage to rotary valve inlet of the No. 2 cylinder.

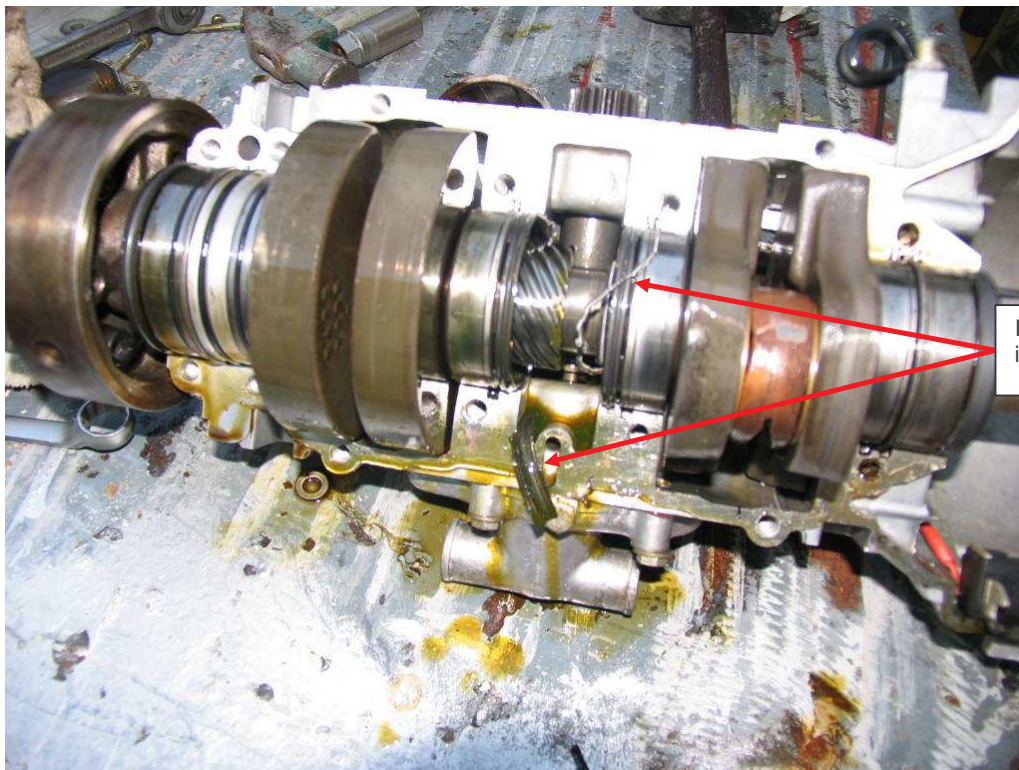
- (ix) A substantial amount of debris, in the form of broken oil rings, was retrieved from within the engine casing. These originated from the No. 2 piston, which had failed during engine operation.

Internal engine debris
in the crankcase.

Figure 3. Debris on crankshaft and in casing area.

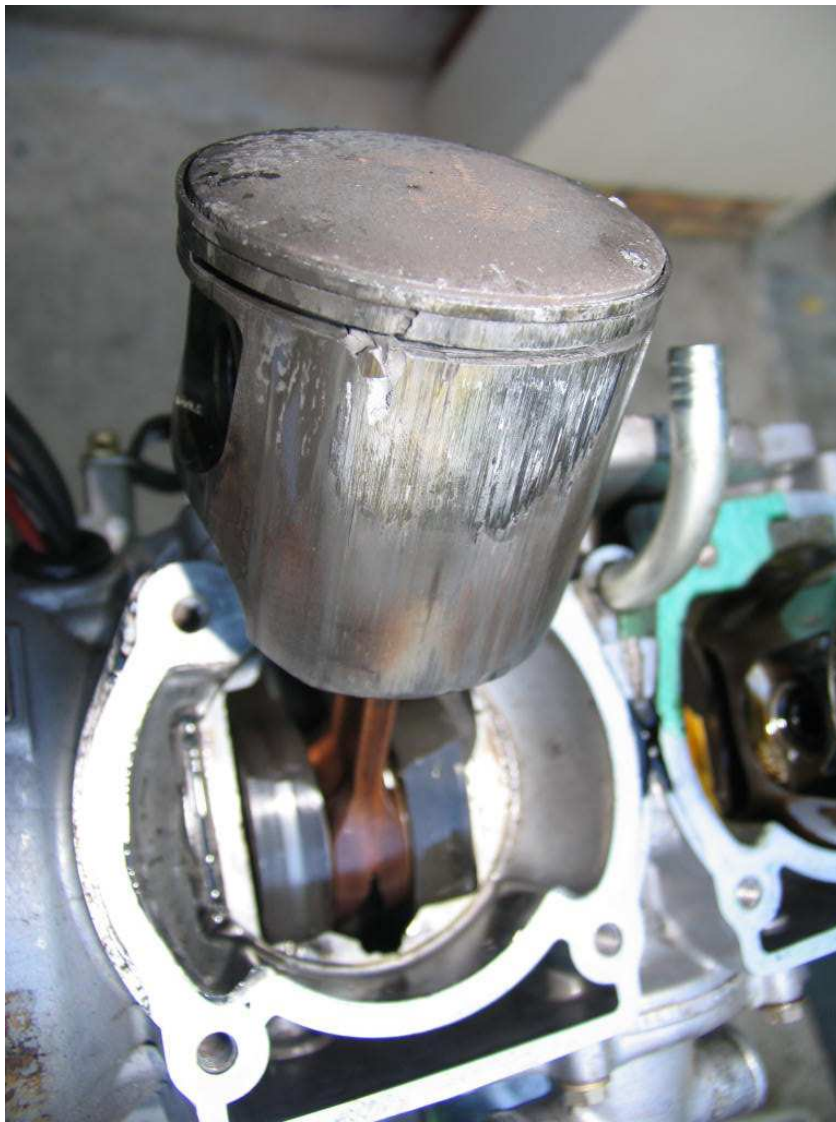
- (x) The No. 1 cylinder and piston assembly was found to be in good condition, with both oil rings undamaged.
- (xi) The No. 2 cylinder displayed evidence of severe scuffing which resulted from the failure of the lower oil ring in the piston. The piston was also severely scuffed, due to a lack of lubrication and resultant engine seizure.

Figure 4. No. 2 piston displaying evidence of severe scuffing.

2.1 During the recovery of the aircraft it was noted that the engine could not be turned by hand. The teardown inspection and follow-up metallurgical examination revealed that the lower oil ring guide pin on the No. 2 piston (it was a two-cylinder engine) had been forced in too far and had not held the ring itself in place. The ring had then rotated within the ring slot during operation, resulting in damage to the cylinder sleeve and subsequent engine failure. On the inner side of the guide pin position, the piston showed evidence of surface cracking. The guide pin hole had originally been drilled to the correct depth, but it is believed that an external force, most probably produced during fitment of the pin or subsequent engine operation, had forced the pin in too deep. Following the failure of the ring, the associated debris caused extensive internal engine damage, resulting in engine stoppage.

- 4.1 It is recommended that the manufacturer of Rotax engines should include a note in the maintenance manual emphasising the proper inspection of the ring guide pin for extension and security.

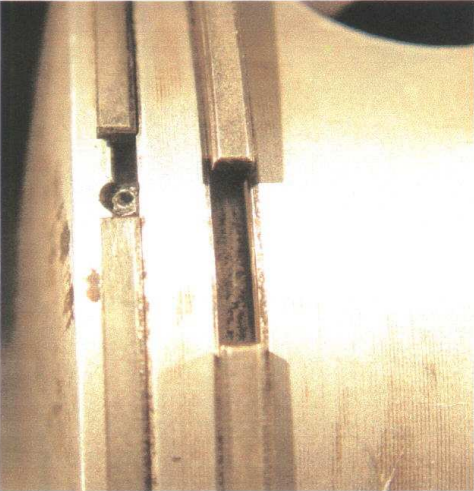
Photo 1: Piston showing no guide pin in position (digital)			
1.2. This report is divided into the following sections:			
(a)	INTRODUCTION	Par. 1	
(b)	APPLICABLE DOCUMENTS	Par. 2	
(c)	DEFINITIONS	Par. 3	
(d)	INVESTIGATOR	Par. 4	
(e)	APPARATUS AND METHODOLOGY	Par. 5	
(f)	INVESTIGATION	Par. 6	
(g)	DISCUSSION AND CONCLUSIONS	Par. 7	
(h)	RECOMMENDATIONS	Par. 8	
(i)	DECLARATION	Par. 9	
2. APPLICABLE DOCUMENTS			
(a)	None.

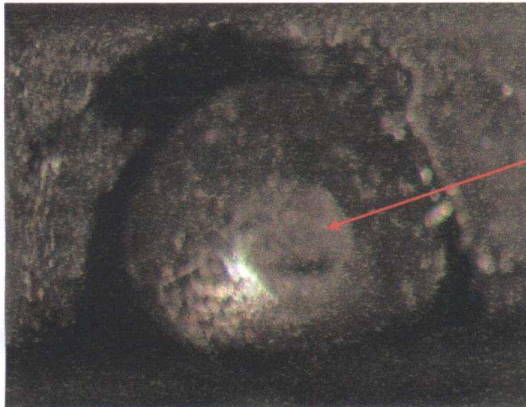
6.1. **Visual and Stereo-microscope Investigation.** The visual investigation on the as found piston revealed that the bottom ring guide pin to be flush with the ring slot root (Photo 2) when compared to the remaining piston ring guide pin position (Photo 4). This caused the ring to rotate within the ring slot during operation resulting in the damaging of the sleeve and subsequent engine failure. On the inner side of the guide pin position the piston showed surface cracking (Photo 3). This is an indication that the guide pin has been forced from position during fitment and/or operation. After dissecting of the piston it became clear that although both pins are of the same length, the failed piston guide pin was forced to a position deeper than the remaining piston pin (Photo's 5 and 6). On comparing the bottom ends of both guide pins the failed pin showed clear indentations relative to the remaining pin (Photo 7). This can be attributed to some force applied on the pin during fitment and/or operation. The outer end from the failed pin showed slight scuffing marks (Photo 8) relative to the remaining pin and can be attributed to contact with the rotating ring during operation. The guide pin hole from the failed piston (Photo 9) showed some polishing marks generated by the movement on the pin during operation. A clear line to the bottom of the hole is an indication that the hole was most probably drilled to the correct depth but the exposed to some force leading to deformation in the bottom area as well as resulting in the crack formation on the inner side (Photo 3). The effect of this deformation is that the relevant guide pin had only limited protrusion into the ring slot.

Photo 2: Failed piston guide pin position (stereo)

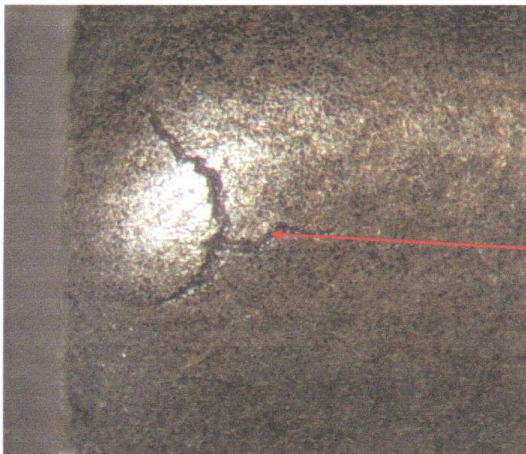
Photo 3: Crack formation on inner area of failed piston (stereo)

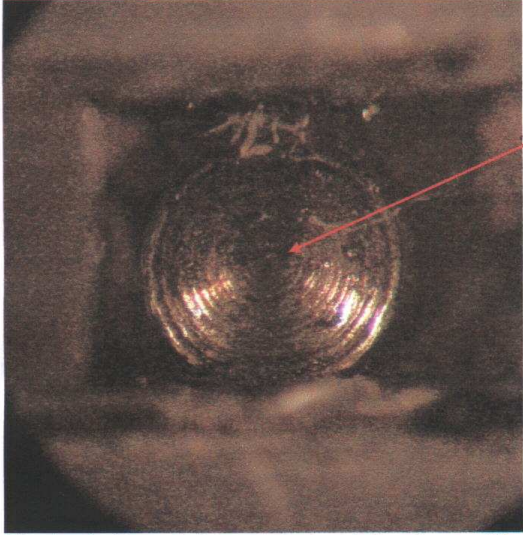
Photo 4: Remaining piston guide pin position (stereo)

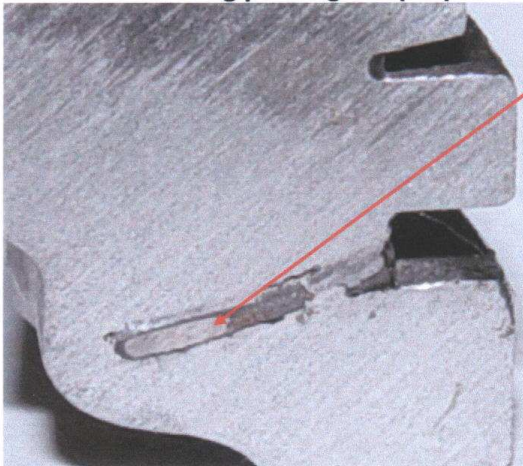
Photo 5: Failed piston guide pin position (digital)

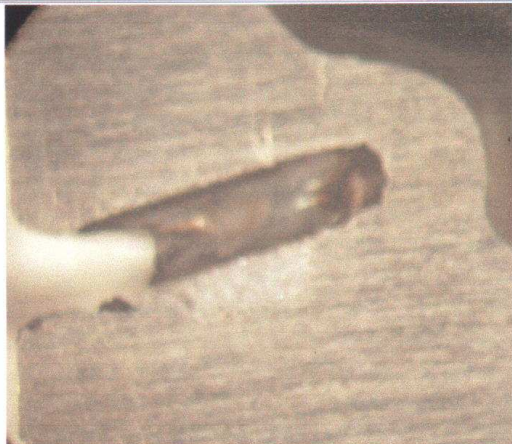
<p>Photo 10: Guide pin hole, remaining piston (stereo)</p>			
<p>7. DISCUSSION AND CONCLUSIONS</p> <p>7.1. The investigation results revealed that the ring guide pin was ineffective by being flush with the ring slot root area. This resulted in the rotational movement of the ring during operation. The guide pin hole was drilled to the appropriate depth but an external force, most probably during fitment thereof, led to the deformation of the hole. The guide pin was probably still protruding to some extent during the fitment of the ring but forced to a greater depth during operation rendering it ineffective.</p>			
<p>8. RECOMMENDATIONS</p> <p>8.1. None.</p>			
<p>9. DECLARATION</p> <p>9.1. All digital images has been acquired by the author and displayed in an un-tampered manner.</p>
