AIRCRAFT ACCIDENT REPORT AND EXECUTIVE SUMMARY

Reference:	CA 18/2/3/8305	
Aircraft Registration	ZU-CIP	Date of Accident	01 June 2007		Time of Accident	1500Z
Type of Aircraft	Jabiru SP - Aeroplane		Type of Operation		Private	
Pilot-in-command Licence Type		Private	Age	38	Licence Valid	Yes
Pilot-in-command Flying Experience		Total Flying Hours	511.5		Hours on Type	229
Last point of departure		Klerksdorp Aerodrome (FAKD)				
Next point of intended landing		Rustenburg Aerodrome (FARG)				
Location of the accident site with reference to easily defined geographical points (GPS readings if possible)						
Klerksdorp Aerodrome: S26° 52.00', E026° 43.00', (North West Province)						
Meteorological Information		Wind: North 36, Temperature: 22°C. CAVOK				
Number of people on board	1+1	No. of people injured	0	No. of people killed	0	
Synopsis						
<p>The pilot experienced vibration in the front end of the aircraft after take off. He then decided to turn the aircraft back towards the runway to land and as soon as he turned, the vibration increased. After he turned, the propeller then separated from the engine. He switched off the engine and started descending to land, and subsequently landed

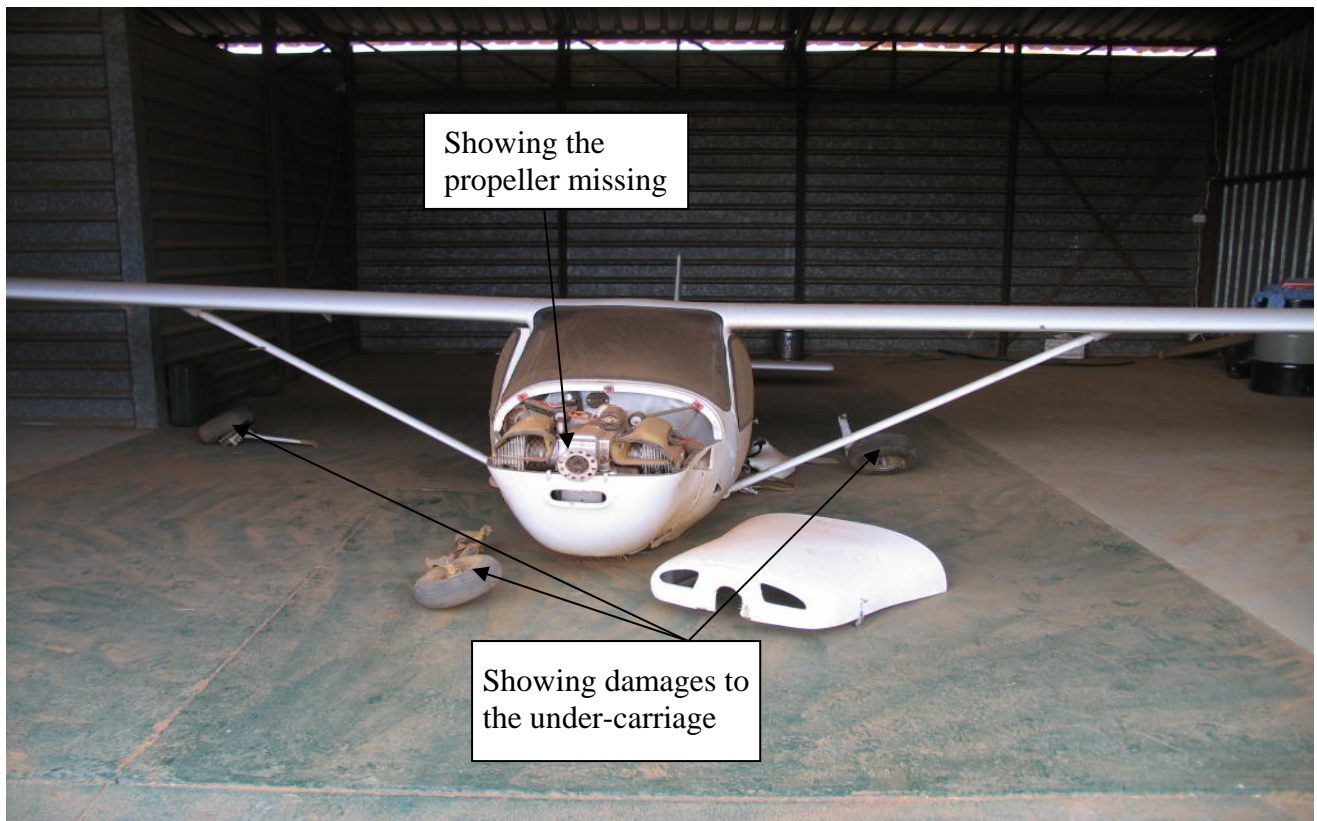
1.3.1. The aircraft was substantially damaged in the accident, with damages to the passenger side window, undercarriage and under-fuselage.

Photo 1: Damage caused to the aircraft
