AIRCRAFT ACCIDENT REPORT AND EXECUTIVE SUMMARY

Reference:	CA18/2/3/8362	
Aircraft Registration	ZS-RWW	Date of Accident	9 September 2007		Time of Accident	1000Z
Type of Aircraft	Robinson R44 Raven II		Type of Operation	Training Flight		
Pilot-in-command Licence Type		Commercial	Age	25	Licence Valid	Yes
Pilot-in-command Flying Experience		Total Flying Hours	668.8		Hours on Type	Unknown
Last point of departure		Port Alfred Aerodrome (FAPA)				
Next point of intended landing		Port Alfred Aerodrome (FAPA)				
Location of the accident site with reference to easily defined geographical points (GPS readings if possible)						
Farms Welgevind and Hopedale, Cove Ridge area near East London (GPS: South 33°04.210' East 027°47.212')						
Meteorological Information		Surface wind; 070°/9kt, Temperature; 18°C, Cloud cover; BKN 1000ft, BKN at 2100ft and OVC at 3000ft. Top of cloud between 6000 and 7000ft AGL.				
Number of people on board	2 + 0	No. of people injured	0	No. of people killed	2 + 0

Name of Owner : Activest 23 (Pty) Ltd
Name of the Operator : 43 Air School
Manufacturer : Robinson Helicopter Company
Model : R44 Raven II
Nationality : South African
Registration Marks : ZS-RWW
Place : C

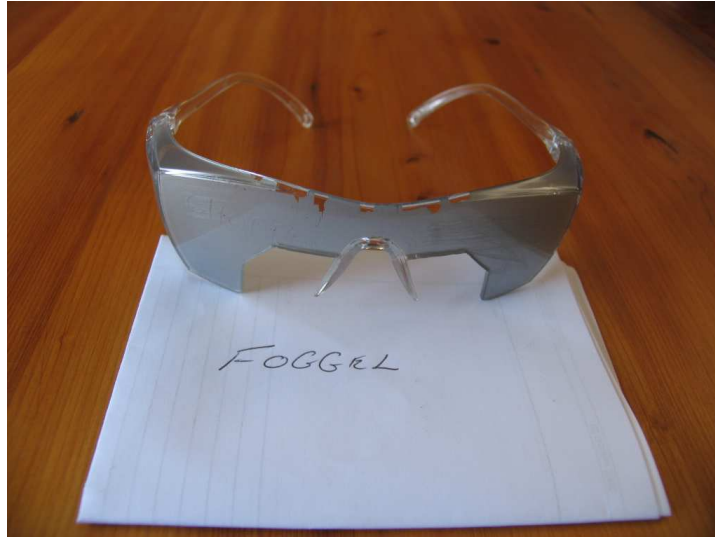
Photo 1. A view of the foggel-type glasses, referred to in the paragraph 1.1.2.

- 2.4 The pilot-flying at the time was wearing foggels (special glasses for IF flying), which limited his outside view/visibility and basically allowed him only to focus on the instrument panel in order to fly the helicopter. Not knowing what the actual weather conditions were like on the outside, he continued to fly the helicopter to the best of his ability.

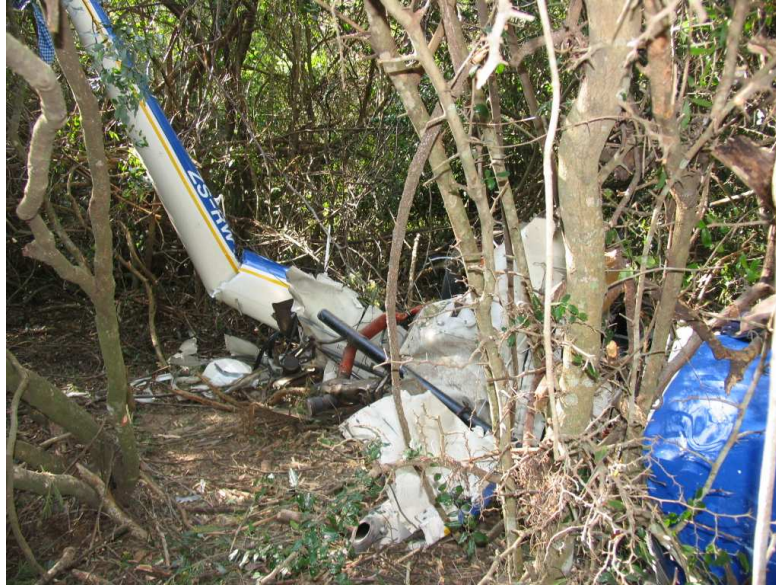
- 1.3.1 The helicopter was destroyed when the main rotor blades contacted and penetrated the cockpit/cabin area in-flight and it crashed to the ground in a nose-down attitude.

Photo 3. A view of the main wreckage, which crashed in dense bush-type terrain.

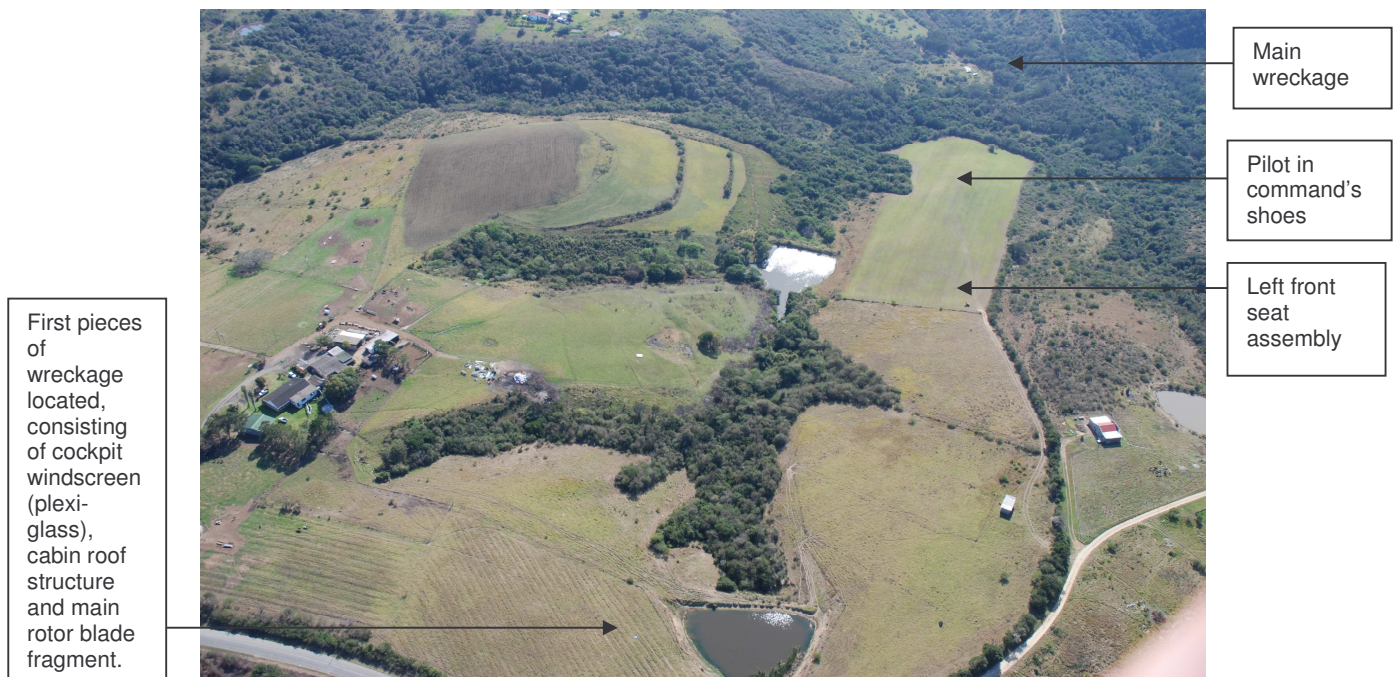
1.12.2 The main rotor gearbox, main rotor drive shaft, and one of the main rotor blades, which was still attached to the main rotor head were found approximately 500 m from the main wreckage as it had separated from the fuselage in the air. The second main rotor blade was found to have separated in overload mode from the main rotor head, most probably during blade contact with the cockpit/cabin area in flight. The blade was found some 400 m past the main wreckage along the wreckage trail. Some inner body material of one of the main rotor blades was located in the area where the first pieces of debris were located, which was approximately 1 km from the main wreckage and 6 km (3.2 nm) from the East London Aerodrome on a heading of 068 °M.

Photo 6. An aerial view of the wreckage trail, which was taken at a height of about 800 feet above ground level.

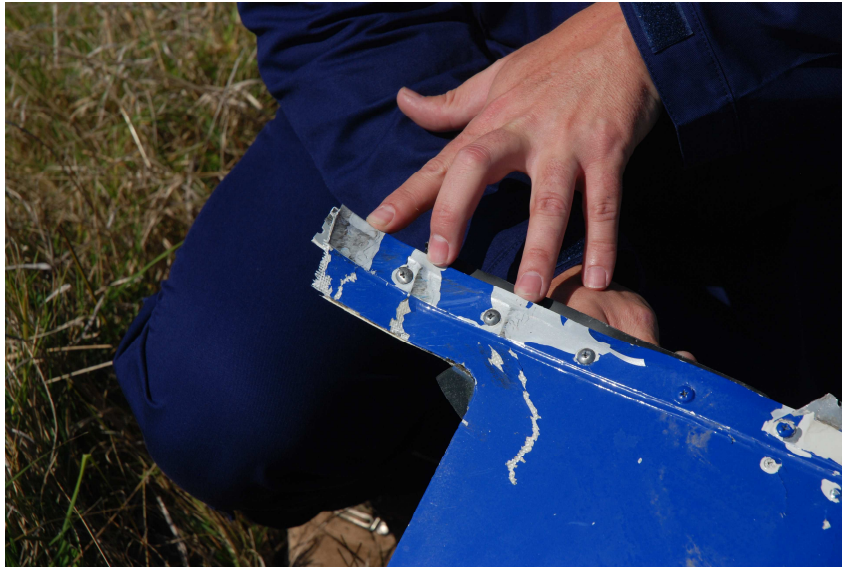
1.12.3 The pieces of debris that first indicates a relationship with a accident namely a shattered windscreen (plexi-glass), a section of inner main rotor blade material as well as the roof structure of the cabin/cockpit. The roof structure displayed evidence consistent with main rotor blade contact (blade upset in-flight), which led to the destruction of the cabin/cockpit area and a loss of control.

Photo 7. Main rotor blade impact marks evident on the left-hand side of the roof structure.

The cockpit/cabin roof area displayed evidence of a main rotor blade strike. These markings were located more to the left-hand side of the roof structure. There was evidence that the main rotor blades had struck a section of the instrument panel as well as the floor structure on the left-hand side. The left shoe of the pilot-in-command (flight instructor) that was seated on the left-hand side, also displayed evidence of main rotor blade damage with the left rudder/yaw pedal being pushed inwards (towards the pilot's seat).

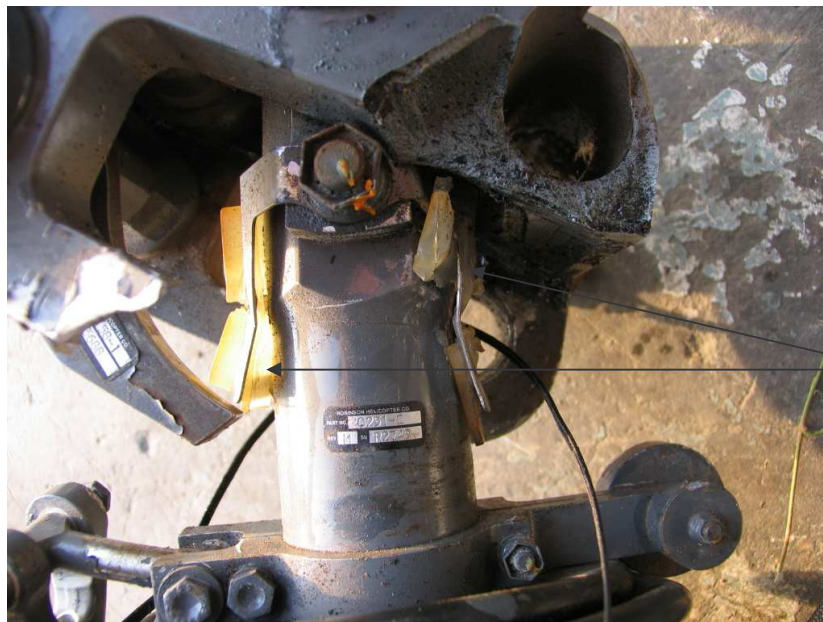
The main rotor shaft was bent just below the main rotor head attachment and both droop stop damper rubbers located on the main rotor shaft displayed evidence of excessive deformation associated with a low-G, mast bumping event. It can be seen from the photo below that the droop stop damper rubber on the right-hand side is substantially more disrupted than the one on the left, even though both rubbers reflect extensive deformation evidence associated with main rotor hub contact with the mast (main rotor drive shaft).

Damage visible to the rubber stops on both sides of the main rotor shaft.

Photo 8. A view of the upper main rotor shaft displaying deformation evidence to the rubber stops.

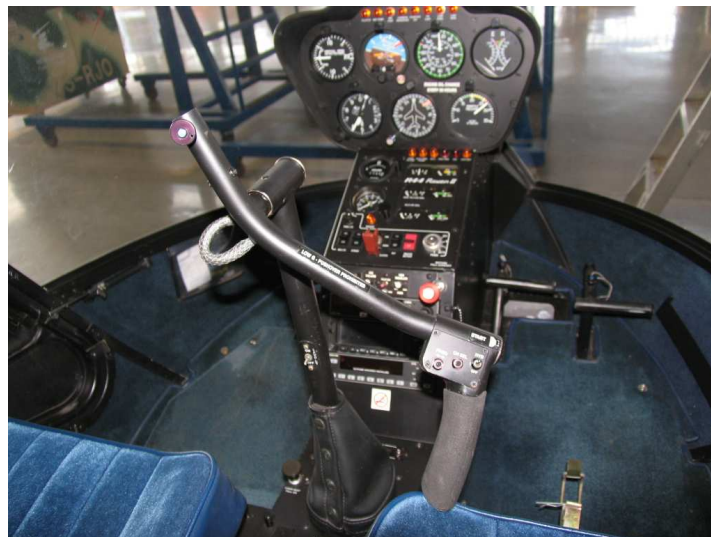
- 2.6 It is believed that the pilot-flying at the time reacted to the right roll as he would have in an aeroplane, by immediately correcting the attitude (to wings level) of the aircraft/helicopter by applying left cyclic input. With no positive load on the main rotors, excessive blade flapping occurred and the main rotor blades made contact with the fuselage, resulting in the destruction of the left cockpit/cabin area and subsequent loss in control of the helicopter. It is believed that the sequence of events was sudden, which did not allow the flight instructor any time to take over control of the helicopter and recover from the condition they suddenly found themselves in. It should be noted that the cyclic design of the Robinson R44 is such that the position of the cyclic control handles for either side (pilot and co-pilot) is located on a T-bar with one pilot flying holding the cyclic handle and should control be transferred or the other pilot should take over control the T-bar (see picture below) needs to be tilted to the respective side for that pilot to take control of the helicopter. This design is totally unconventional when compared with most other helicopter types available on the market, where both crewmen will have his/her own cyclic stick to manipulate the controls, a design that allows for immediate control transfer or take-over from one pilot to the other.

Photo 9. The picture illustrates the T-bar design that functions like a see-saw.
