AIRCRAFT ACCIDENT REPORT AND EXECUTIVE SUMMARY

Reference:	CA18/2/3/8387	
Aircraft Registration	ZS-GVR	Date of Accident	10 November 2007		Time of Accident	08:35Z
Type of Aircraft	UFM-10 Samba		Type of Operation		Private	
Pilot-in-command Licence Type	PPL Foreign Validation	Age	56	Licence Valid	Yes	
Pilot-in-command Flying Experience	Total Flying Hours	Unknown		Hours on Type	Unknown	
Last point of departure	Brits Aerodrome North-West Province					
Next point of intended landing	Brits Aerodrome North-West Province					
Location of the accident site with reference to easily defined geographical points (GPS readings if possible)						
Private farm, approximately 6 nm north of Brits Aerodrome. GPS Position: 25°27' 28.79" E027° 46' 05.28"						
Meteorological Information	The weather conditions were fine; Temp: 27° C, Wind 190°/7 kt; with no clouds.					
Number of people on board	1 + 0	No. of people injured	0	No. of people killed	1	
Synopsis						
<p>According to available information submitted by the aircraft owner, the pilot, a German citizen, arrived at Brits Aerodrome on 10 November 2007 at approximately 0730Z in order to carry out a local private flight. He carried out a pre-flight i

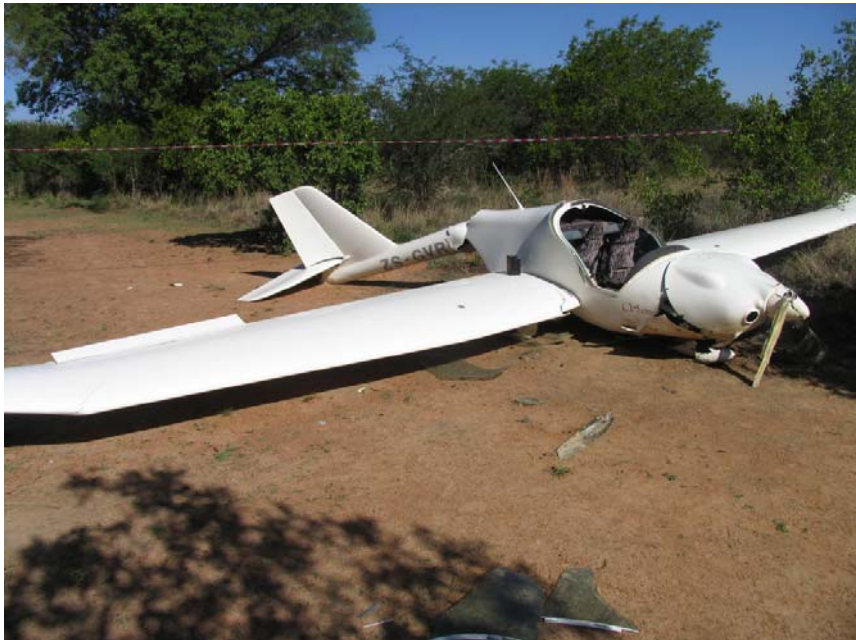
1.12.1 The aircraft went into a spin and impacted the ground in a flat attitude with virtually no forward speed, between tall trees and bushes. The aircraft wreckage remained virtually intact on impact with the ground.

FIGURE 2: SHOWING AIRCRAFT INTACT WITH PROPELLER DAMAGED.

1.12.2 The aircraft was destroyed during the impact sequence.
