# AIRCRAFT ACCIDENT REPORT AND EXECUTIVE SUMMARY

Reference:	CA18/2/3/8416	
<b>Aircraft Registration</b>	ZS-ELT	<b>Date of Accident</b>	1 January 2008		<b>Time of Accident</b>	0940Z
<b>Type of Aircraft</b>	Piper PA28-180 Aeroplane		<b>Type of Operation</b>		Private	
<b>Pilot-in-command Licence Type</b>		Private Pilot	<b>Age</b>	51	<b>Licence Valid</b>	Yes
<b>Pilot-in-command Flying Experience</b>		Total Flying Hours as on 7 October 2006	268		Total Hours on Type as on 16 August 2005	40.1
<b>Last point of departure</b>		Mosselbay Aerodrome (FAMO)				
<b>Next point of intended landing</b>		Beaufort West Aerodrome (FABW)				
<b>Location of the accident site with reference to easily defined geographical points (GPS readings if possible)</b>						
On the Swartberg mountains next to the Swartberg pass at the geographical position determined as S 33° 21 31 E 022° 3 07.						
<b>Meteorological Information</b>		Wind: 100°TN at 10 Knots; Temperature: 18°C; Visibility: 50 metres or less in cloud.

**Name of Owner/Operator** : Medocar CC  
**Manufacturer** : Piper Aircraft Corporation  
**Model** : PA 28- 180  
**Nationality** : South African  
**Registration Marks** : ZS-ELT  
**Place** : Swar

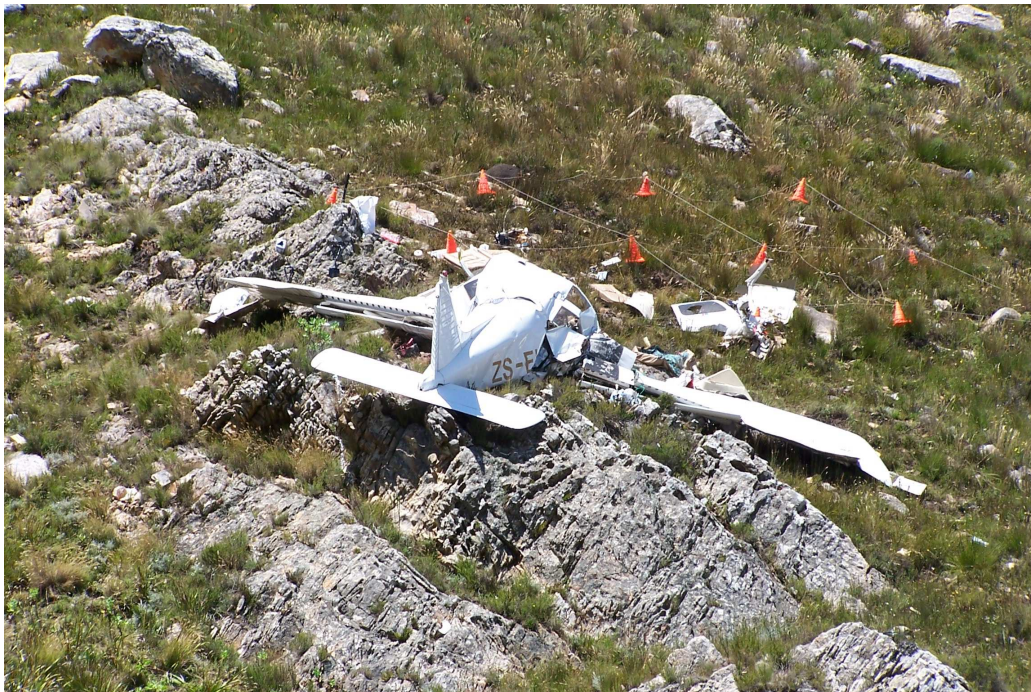
1.3.1 The aircraft was destroyed on impact with the terrain.

**Image 1:** Indicating the damage that the aircraft sustained.

- 1.18.4 On-site investigation
- Inspection of the wreckage after the accident revealed that both wings had sustained damage and the fuel tanks had ruptured on impact.

- The cabin of the aircraft was found disintegrated as a result of the impact and the contents of the aircraft as well as the occupants were found lying over an area of approximately 23 metres in front of the wreckage.

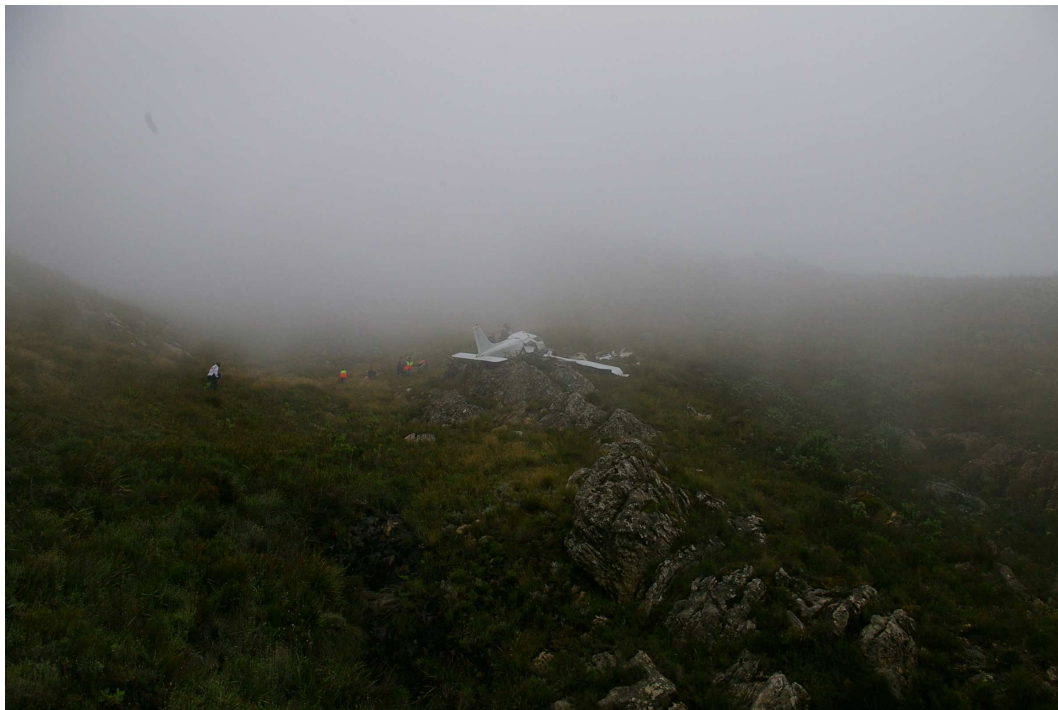
**Image 2:** Indicating the weather conditions a few hours after impact.

- 2.2 The weather information obtained shows that cloudy and misty conditions with a visibility of approximately 50 metres or less were present at the time when the accident occurred. The weather was therefore considered to have contributed to the accident.

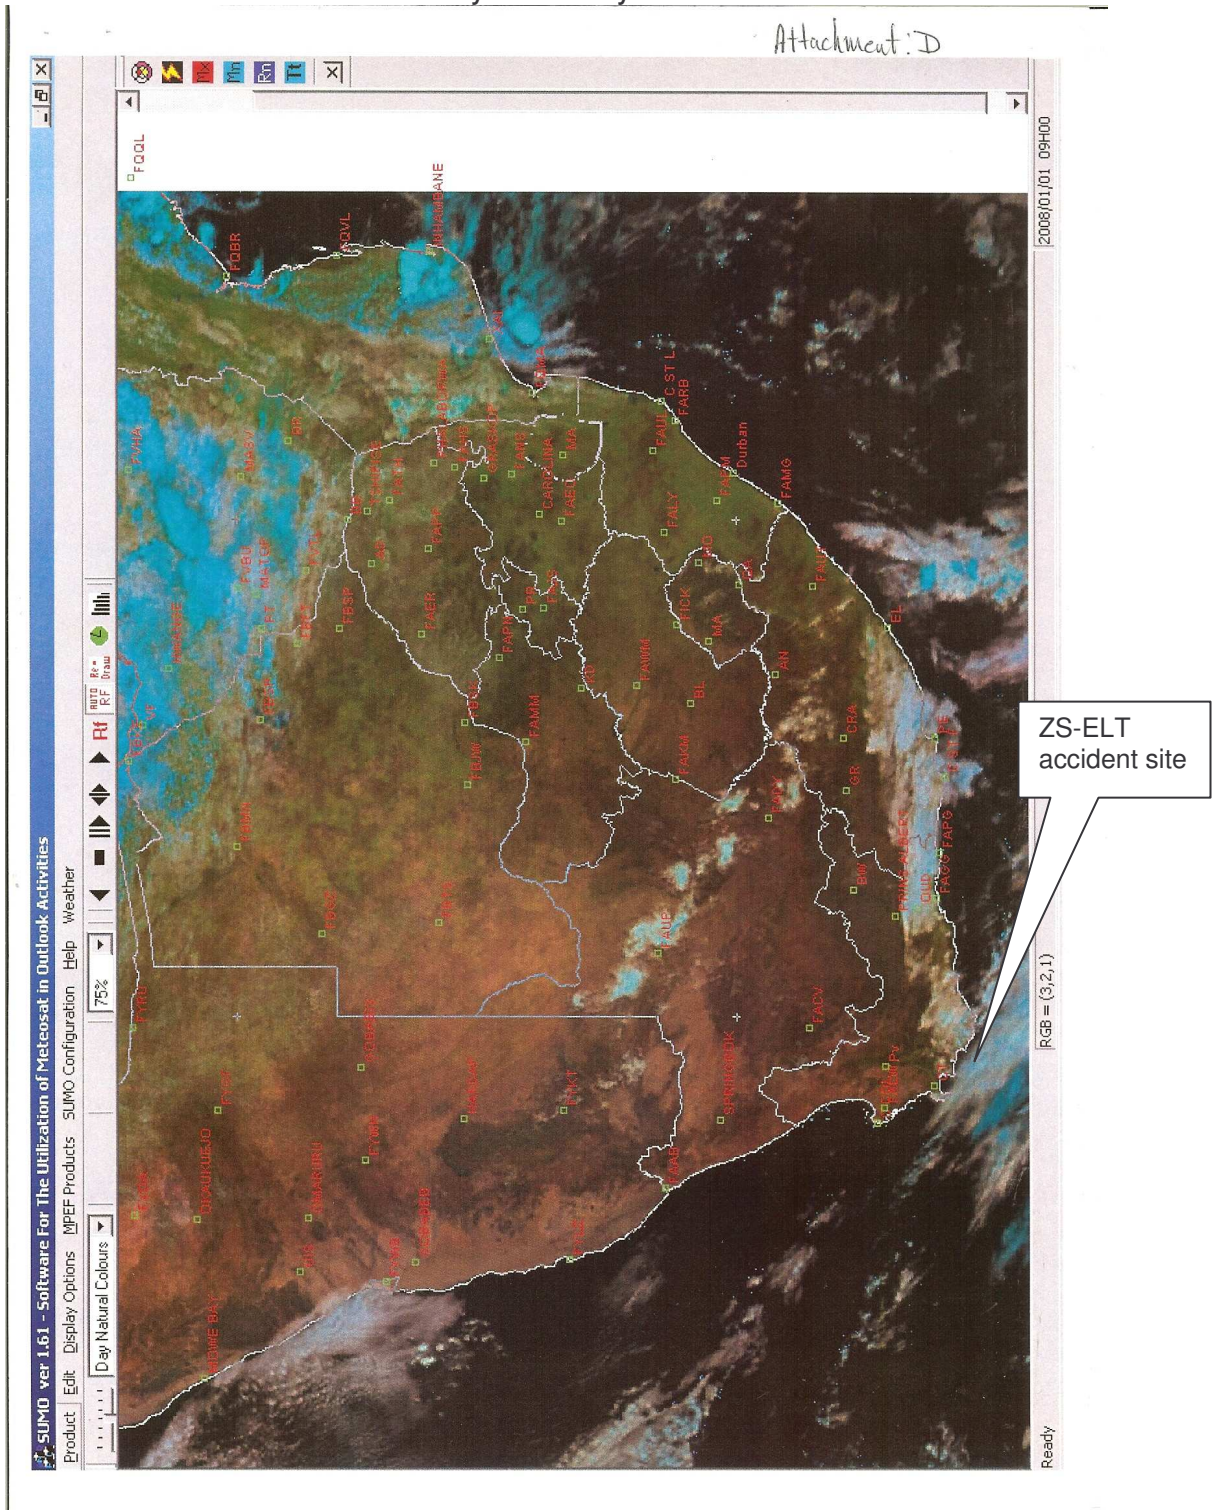
The satellite image for 09h00Z shows cloudy conditions over the Swartberg.

of moist air onto the southern Cape and this caused cloudy conditions (Orographic cloud) over the mountains of the southern Cape. The most likely weather at the place of the accident is as follows:

Image 3: Satellite image of the weather.

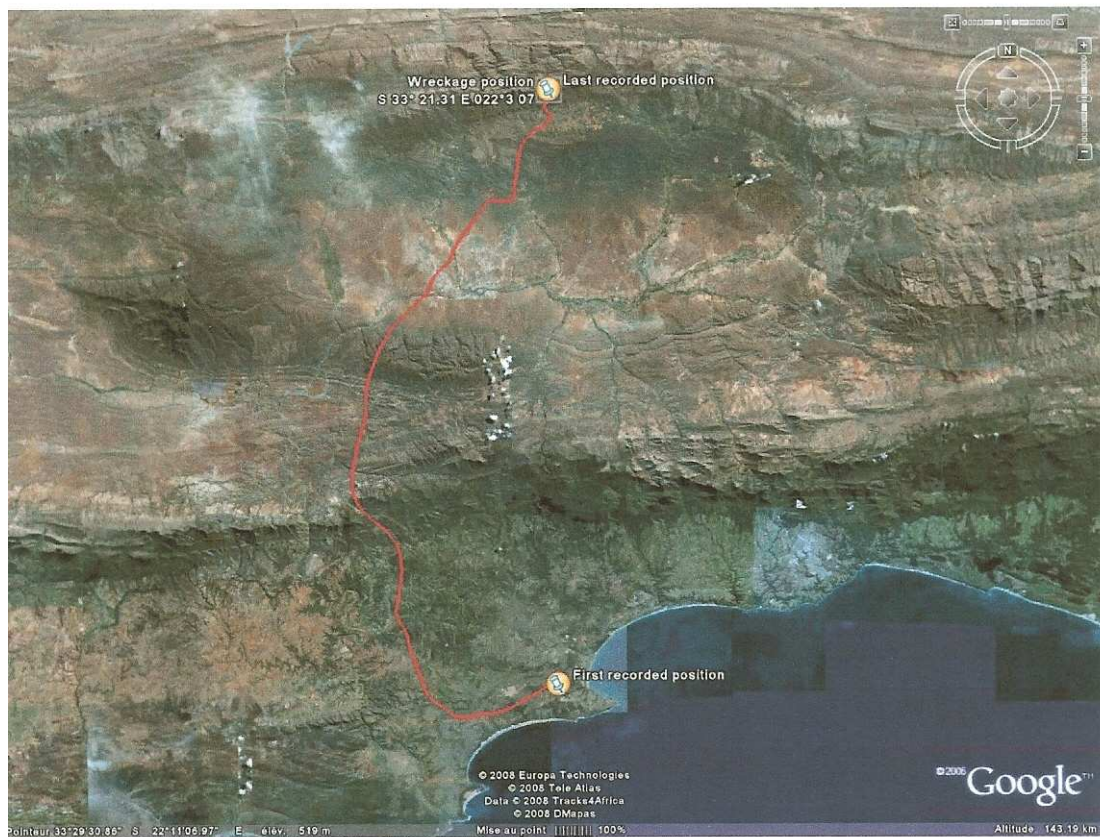
**Image 4:** Indicating the flight path of the aircraft.

- 2.4 The pilot probably, tried to maintain a visual flight and stayed below the clouds because he was not instrument rated. Evidence obtained from the GPS found in the wreckage as well as the position of the wreckage, shows that the pilot tried to turn the aircraft back into the direction from which they were coming and in the process impacted with the side of the mountain. The pilot probably saw an opening in the clouds above the Swartberg Mountain and might have lost visual reference with the mountain at the last minute. As a result he took the decision to turn the aircraft away from the mountain, but in the process entered some mist and impacted with the side of the mountain whilst in a turn.

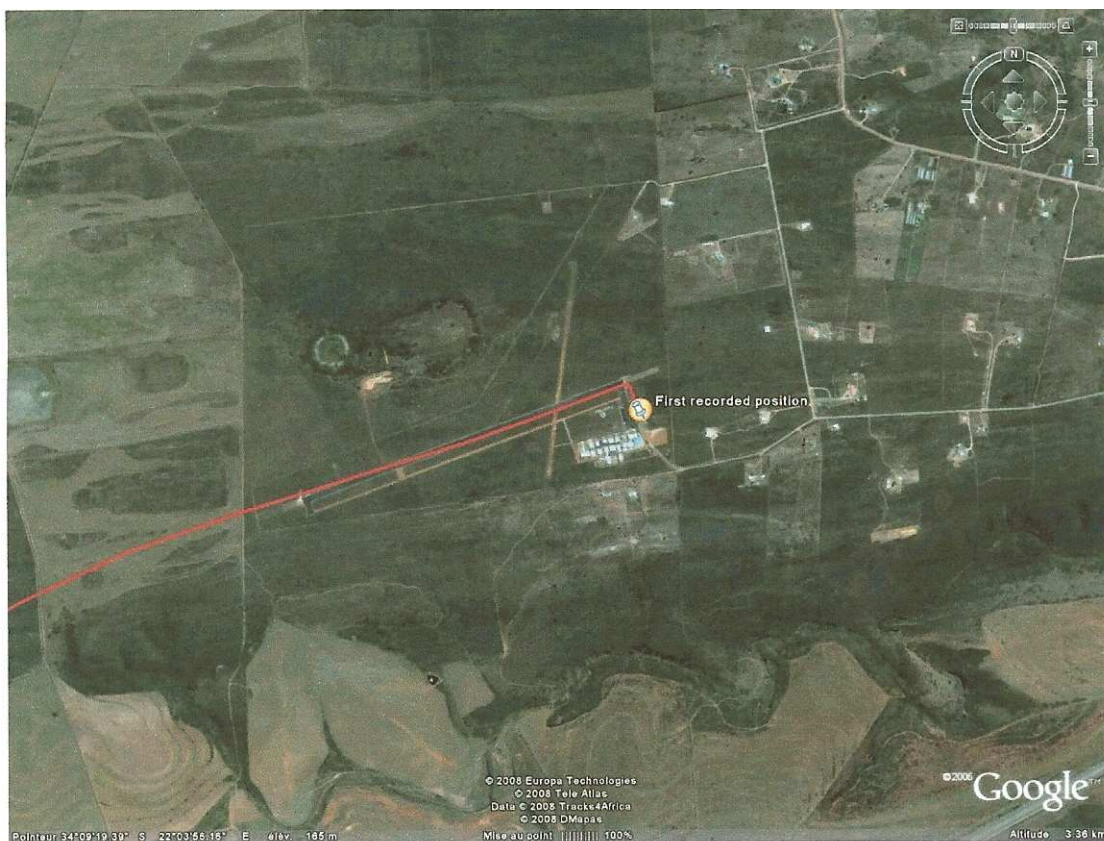
**Image 5:** Indicating the first recorded position at Mosselbay Aerodrome.

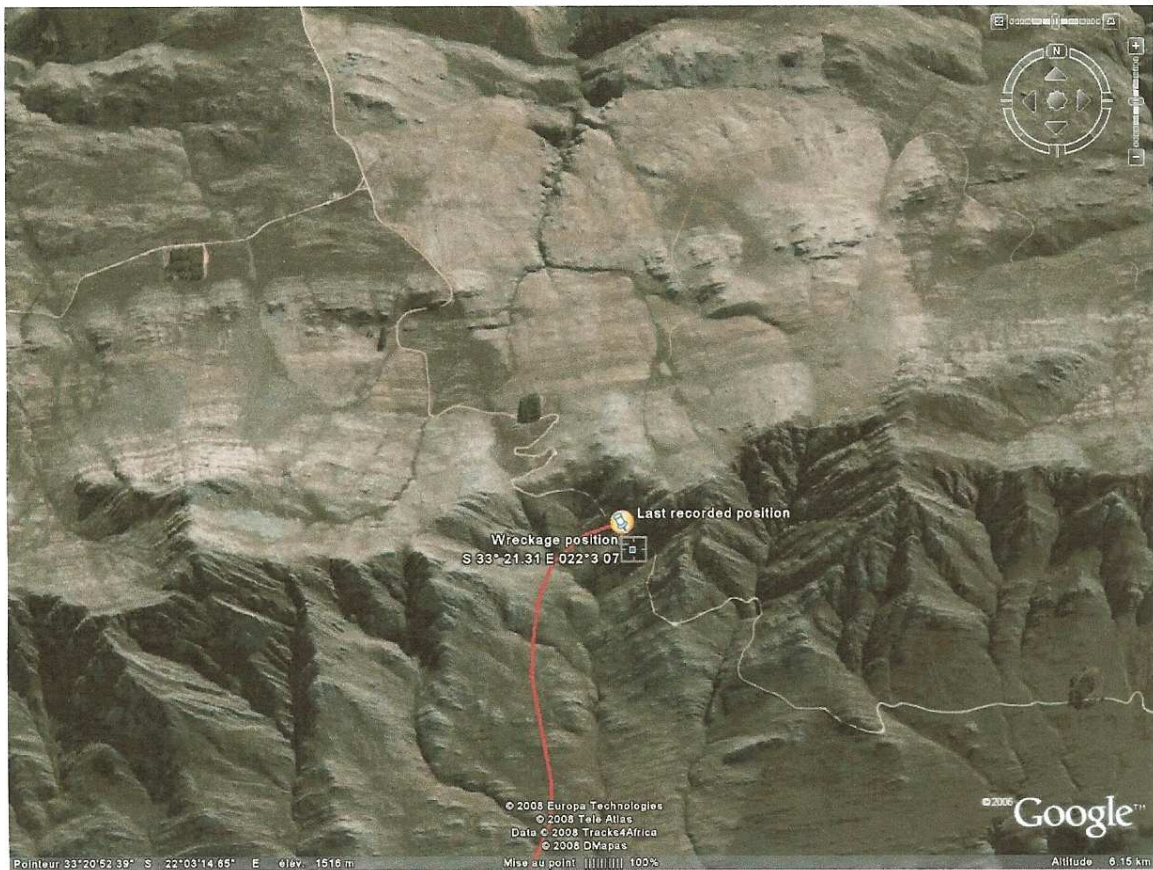
**Image 6:** Indicating the last recorded position on impact with the mountain.

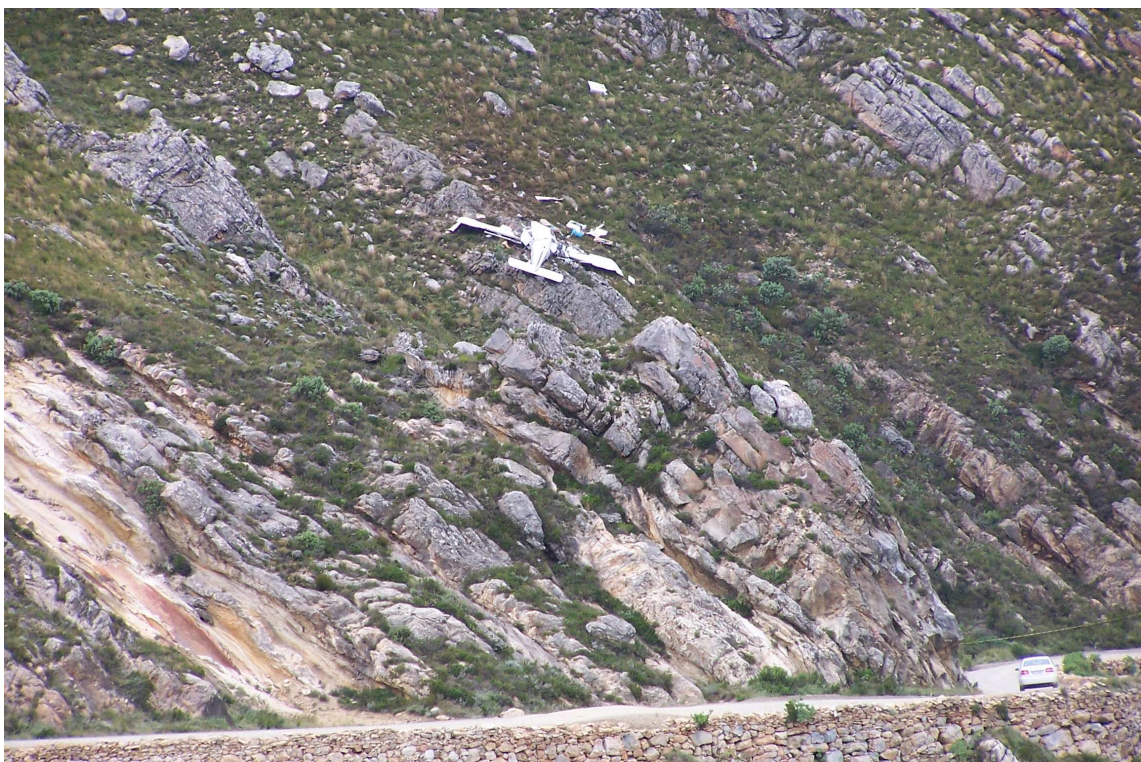
- 1.12.1 The relative impact angle of the aircraft with terrain was at approximately 5° nose-up attitude with the right-hand wing low, because the aircraft was in a turn when it impacted with the Swartberg Mountain.
- 1.12.2 The direction of impact was determined as 049° magnetic. The aircraft impacted with the mountain at the geographical position determined as S 33° 21.31 E 022° 3.07 and at an elevation of 4985 feet.
- 1.12.3 The aircraft impacted with the side of the mountain approximately 36 metres above the road in the Swartberg pass.

**Image 7:** Indicating the impact angle of the wreckage.
