AIRCRAFT ACCIDENT REPORT AND EXECUTIVE SUMMARY

Reference:	CA18/2/3/8431	
Aircraft Registration	ZU-ERW	Date of Accident	7 February 2008	Time of Accident	1230Z	
Type of Aircraft	Apollo Fox		Type of Operation	Private		
Pilot-in-command Licence Type		Microlight	Age	38	Licence Valid	Yes
Pilot-in-command Flying Experience		Total Flying Hours	37.9		Hours on Type	Unknown
Last point of departure		Tempe Aerodrome (FATP)				
Next point of intended landing		Nelspruit Aerodrome (FANS)				
Location of the accident site with reference to easily defined geographical points (GPS readings if possible)						
Senekal, Free State Province. GPS co-ordinates: S28°10.567' E027°29.225'						
Meteorological Information		Wind:040°/03kts, Temperature: 28°C, Clouds: SCT at 8500ft AMSL, Dew point: 10°C				
Number of people on board	1 + 1	No. of people injured	0	No. of people killed	2	
Synopsis						
<p>The pilot, accompanied by a passenger, departed from Tempe Aerodrome to Nelspruit Aerodrome on a VFR flight. Witnesses in the Senekal area reported that the aircraft was flying at low level. Both occupants were fatally injured</p> <p>The investigation concluded that the aircraft collided with trees, the pilot lo

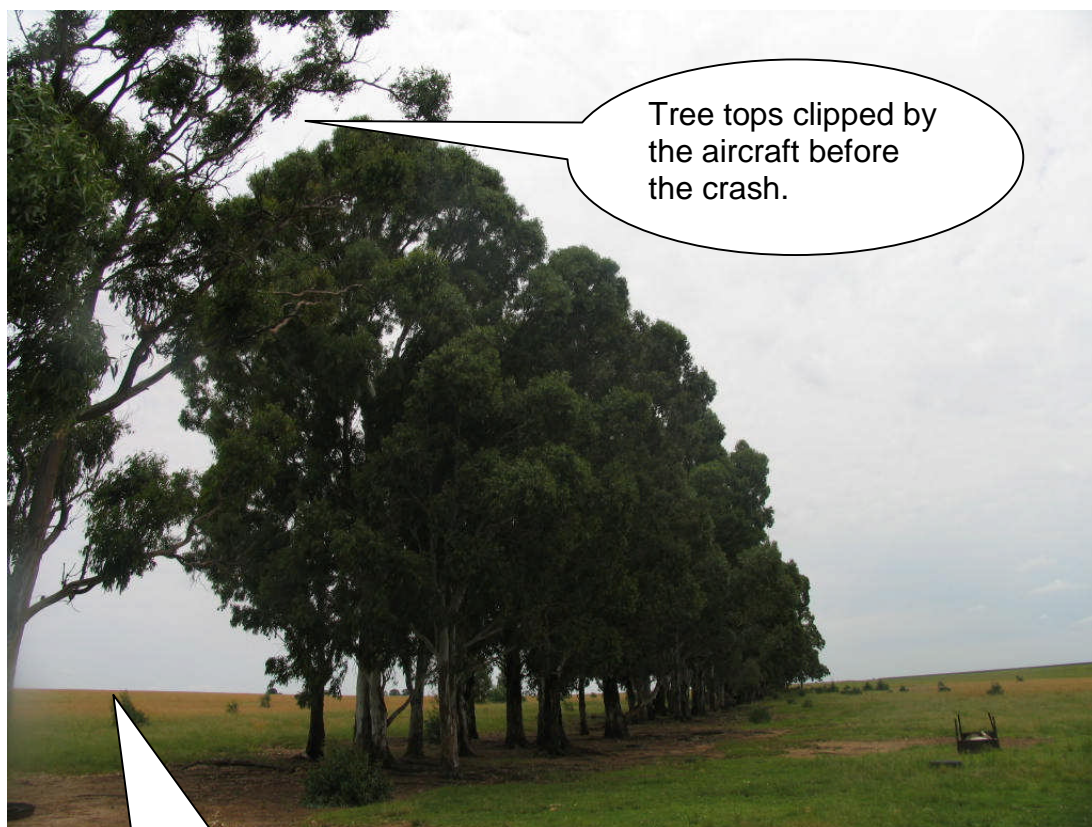
- 1.1.3 The investigation revealed that the aircraft flew over a maize field and then over rising terrain. At the edge of this, on the track of the microlight, was a copse/row of tall trees, and there was evidence that the aircraft clipped the tops of the trees.

Figure 1. The trees struck by the aircraft.

Edge of rising terrain from the direction of the aircraft's approach.

1.12.1 The aircraft approached the trees, which were approximately 5 m high and in the flight path, and collided with the tree tops. It crashed approximately 1 km from the trees on the same flight path. On-site observation showed that the aircraft had struck the ground in a steep nose-down attitude. The wreckage was contained in a small area and the fire that erupted burnt the surrounding grass. There was rising terrain a few kilometres from the trees (see Figure 3).

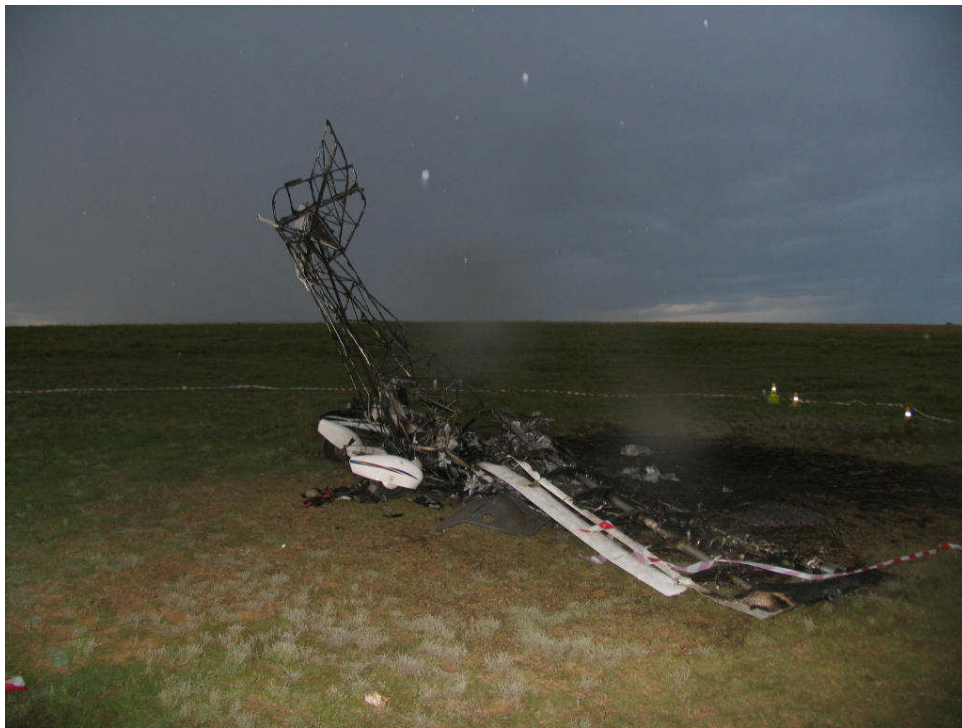
1.3.1 The aircraft was destroyed by the impact as well as by post-impact fire.

Figure 2. The wreck of the microlight.

1.12.2 A post-impact fire erupted and much of the aircraft was reduced to debris and ash. Only the structure of the airframe was left – in the same position as the aircraft had impacted the ground. The tail section stood almost vertically, showing that the microlight has impacted the ground at a very steep angle.

1.12.3 The wings were largely destroyed. The leading edges, in particular, suffered the worst damage due to the nose-down impact. All flight controls on both primary and secondary surfaces were still intact, however, and no indications were found of flight controls malfunctioning.

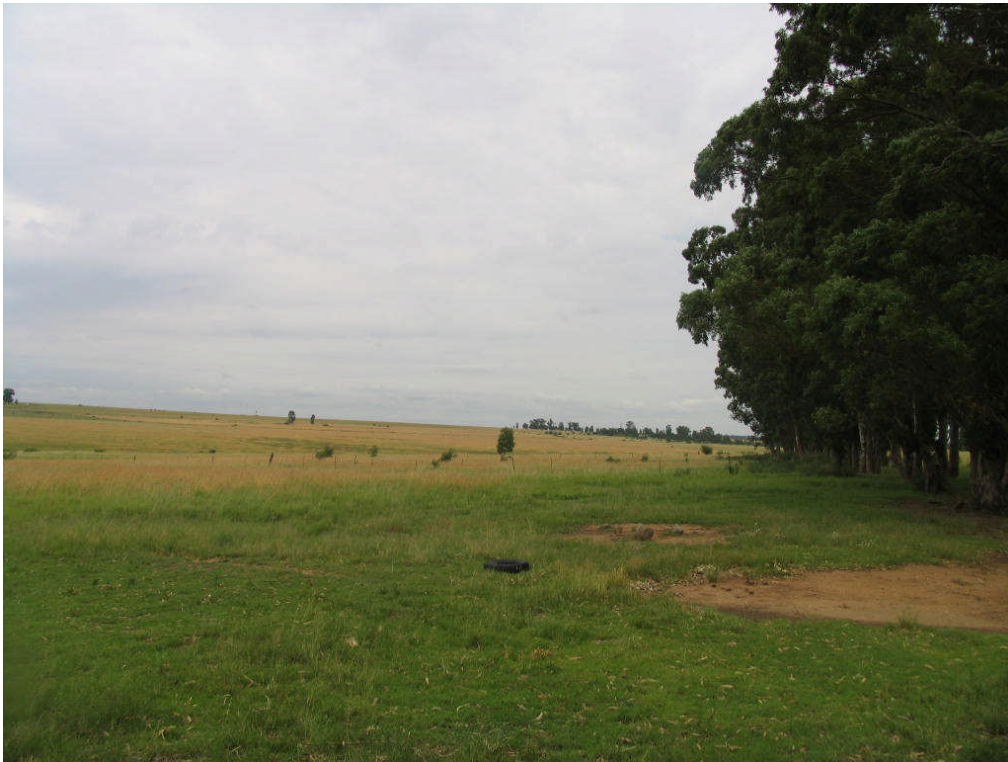
Figure 3. The rising terrain, on the left, from which the aircraft approached the trees.

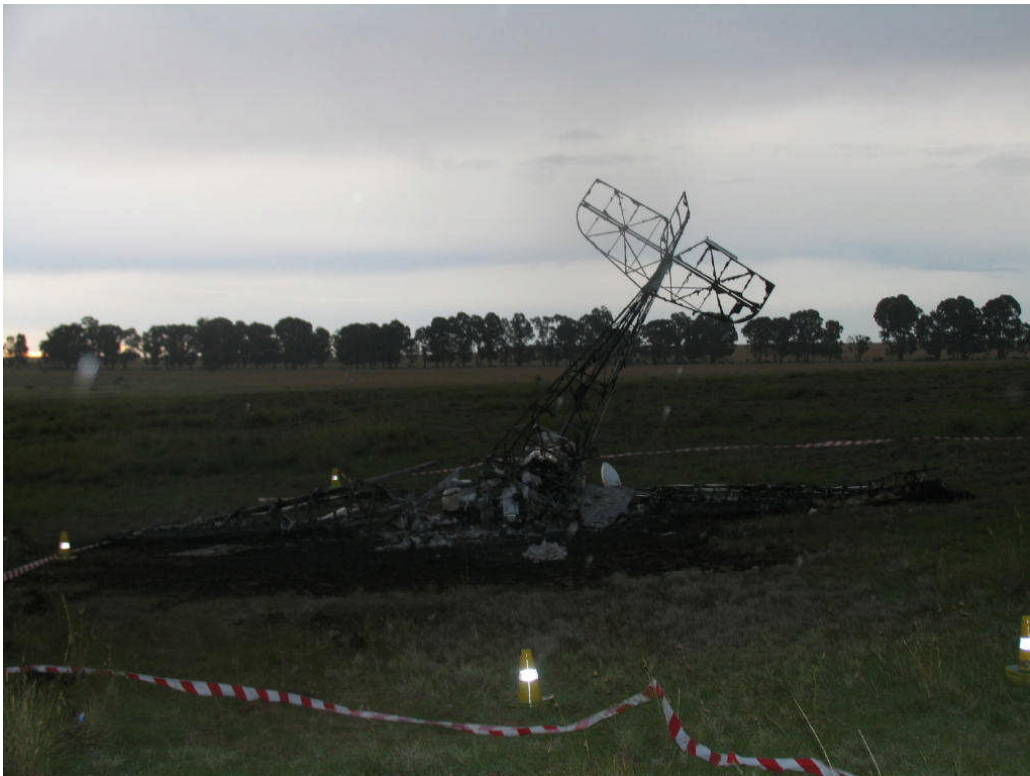
Figure 4. The wreckage cordoned off after the accident.
