AIRCRAFT ACCIDENT REPORT AND EXECUTIVE SUMMARY

Reference:	CA18/2/3/8461	
Aircraft Registration	ZS-FAC	Date of Accident	20 March 2008		Time of Accident	1250Z
Type of Aircraft	Piper PA-28-140 (Aeroplane)		Type of Operation		Training	
Pilot-in-command Licence Type		Commercial	Age	31	Licence Valid	Yes
Pilot-in-command Flying Experience		Total Flying Hours	950		Hours on Type	59
Last point of departure		Brakpan Benoni Aerodrome (FABB)				
Next point of intended landing		Brakpan Benoni Aerodrome (FABB)				
Location of the accident site with reference to easily defined geographical points (GPS readings if possible)						
During landing on Runway 18 at Brakpan Aerodrome S 26°13'986" E 028°17' 966"						
Meteorological Information		Fine weather. Temperature 27°C.				
Number of people on board	2 + 0	No. of people injured	0	No. of people killed	0	
Synopsis						
<p>On the 20th of March 2008, the instructor and the student pilot were on a circuit training flight at Brakpan Benoni Aerodrome.</p> <p>During the second approach, the student pilot abruptly applied the full left rudder which caused the aircraft to yaw and roll to the left. The instructor applied some corrective right rudder to get t

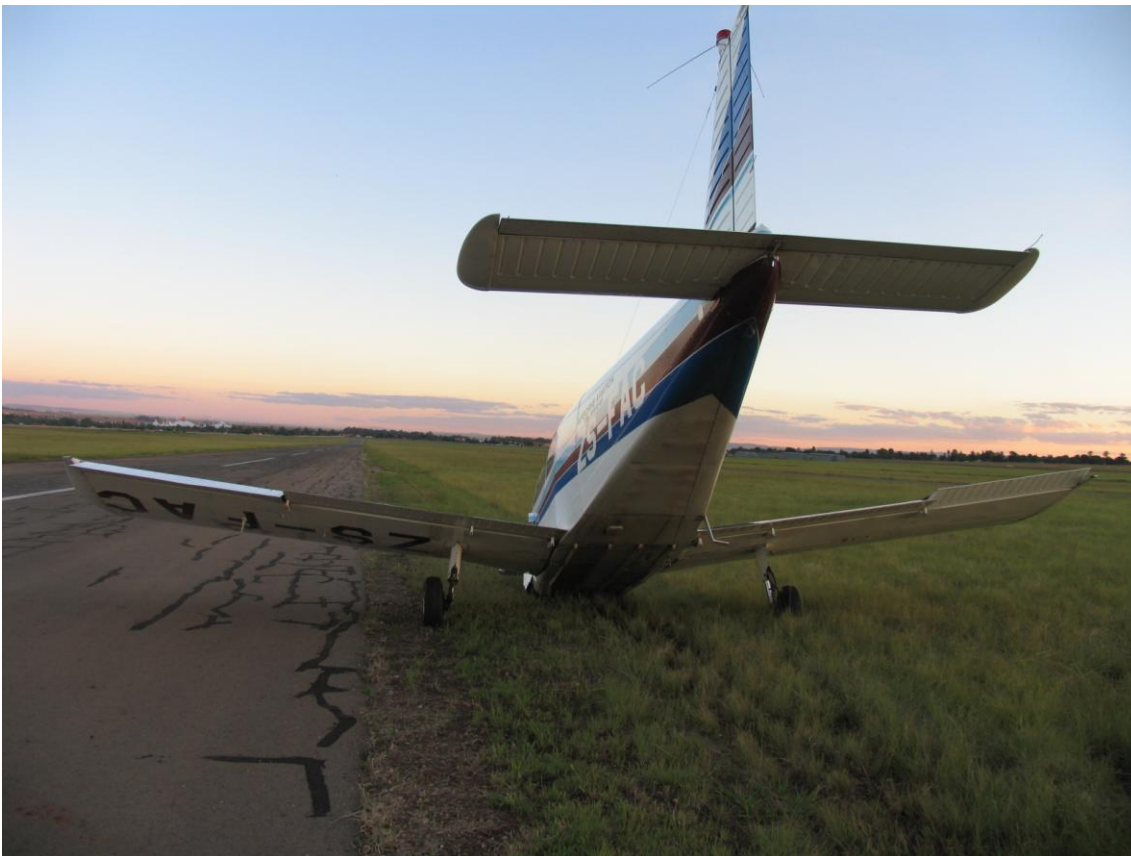
- 1.3.1 The aircraft sustained damages to the nose landing gear, the bottom nose section and the propeller.

- 1.12.1 During the landing and on round out, the student applied full left rudder, resulting in a left yaw. The instructor then applied right rudder and the student also applied full right rudder, resulting in an abrupt right yaw. By applying full right rudder the aircraft made a right yaw followed by a hard landing on the nose gear, which resulted in the nose gear collapsing and the propeller striking the ground.

Photo 1: shows the aircraft after the nose wheel had separated from the aircraft.

3.1.6 The aircraft landed hard on the nose gear, and as a result the nose gear separated.
