AIRCRAFT ACCIDENT REPORT AND EXECUTIVE SUMMARY

Reference:	CA18/2/3/8470	
Aircraft Registration	ZS-RTK	Date of Accident	7 April 2008		Time of Accident	0610Z
Type of Aircraft	Robinson R44 Raven II (Helicopter)		Type of Operation		Private	
Pilot-in-command Licence Type		Private	Age	33	Licence Valid	Yes
Pilot-in-command Flying Experience		Total Flying Hours	1 224.0		Hours on Type	147.0
Last point of departure		Oryx Safari Game Farm (near Kuruman, Northern Cape)				
Next point of intended landing		Oryx Safari Game Farm (near Kuruman, Northern Cape)				
Location of the accident site with reference to easily defined geographical points (GPS readings if possible)						
Oryx Safari Game Farm (GPS position: South 27°32,392', East 023°21,728') Elevation 4 698 feet						
Meteorological Information		There was no wind reported; Temperature: 12 °C; Visibility: 10 km				
Number of people on board	1 + 2	No. of people injured	0	No. of people killed	0	
Synopsis

Name of Owner/Operator : G.R. Eccles
Manufacturer : Robinson Helicopter Company
Model : R44, Raven II
Nationality : South African
Registration Marks : ZS-RTK
Place : Oryx Safari Game Farm, Kuruman
Date : 7 April 2008
Time : 0610Z

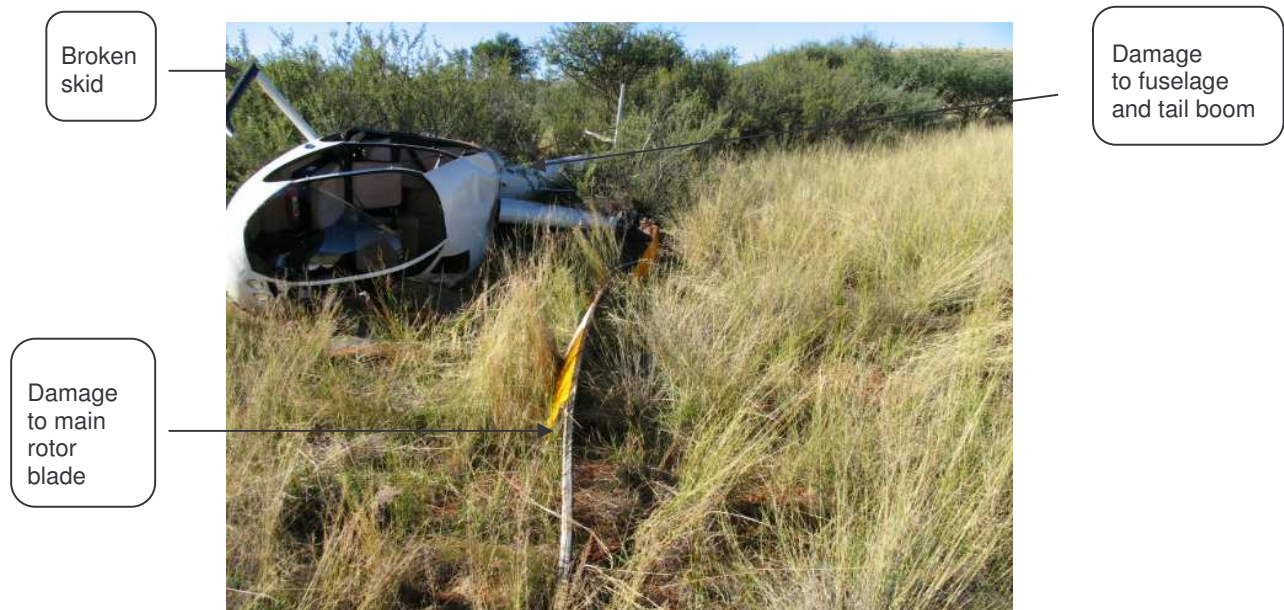
1.3.1 The aircraft was substantially damaged.

Figure 1: The extent of the damage to the aircraft.

1.12.3 The tail boom and tail rotor sustained damage as a result of the impact. The right-hand skid was partially broken and the left-hand skid broke off completely. The main cabin was also deformed, and there was damage to the firewall.

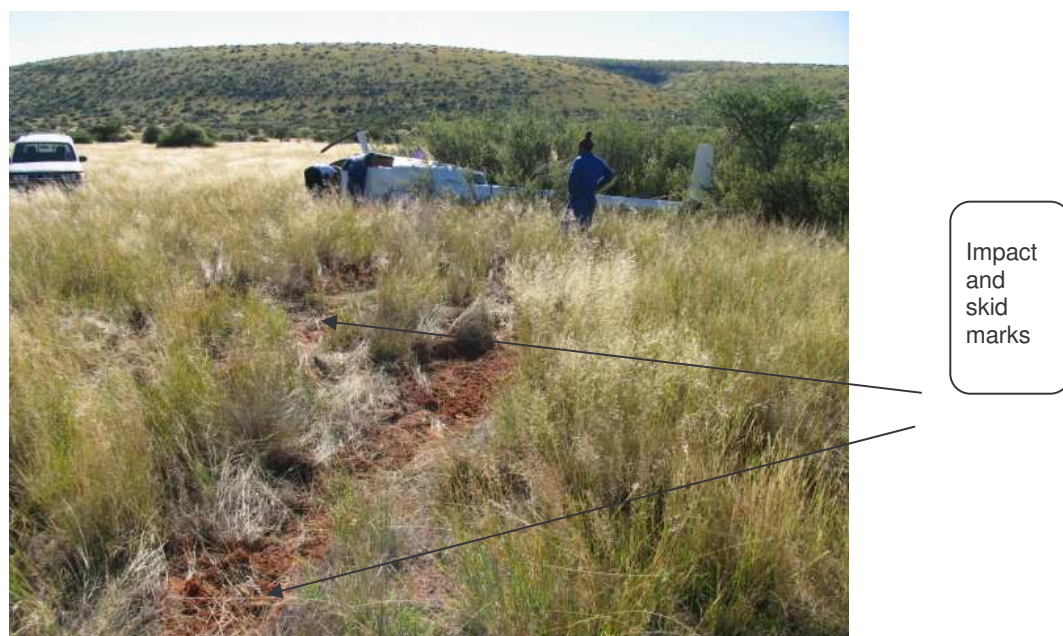
1.12.1 As the pilot attempted to land, the helicopter rolled to the right and the right skid touched the ground. The aircraft levelled out briefly, then rolled to the left hand side, and the left skid struck the ground.

1.12.2 The helicopter skidded for about 5 metres, breaking the left skid. The aircraft eventually came to a halt, lying port-side down, after impacting with the bushes.

1.12.4. The picture shows the impact and skid marks left on the grass by the helicopter.

Figure 2: The ground impact markings.
