## AIRCRAFT ACCIDENT REPORT AND EXECUTIVE SUMMARY

Ref No.	CA18/2/3/8480	
<b>Aircraft Registration</b>	<b>ZS-RYR</b>	<b>Date of Accident</b>	19 April 2008		<b>Time of Accident</b>	0900Z
<b>Type of Aircraft</b>	Robinson R44 Raven II		<b>Type of Operation</b>		Commercial charter flight	
<b>Pilot-in-command Licence Type</b>		Commercial (helicopter)	<b>Age</b>	28	<b>Licence Valid</b>	Yes
<b>Pilot-in-command Flying Experience</b>		Total Flying Hours	895.0		Hours on Type	490.8
<b>Last point of departure</b>		Dragon Peaks Park, KwaZulu-Natal				
<b>Next point of intended landing</b>		Dragon Peaks Park, KwaZulu-Natal				
<b>Location of the accident site with reference to easily defined geographical points (GPS readings if possible)</b>						
Crystal Beds, Drakensberg (GPS position: South 28°58.373" East 029°15.871")						
<b>Meteorological Information</b>		Surface wind: northerly 5-8 kts; Temperature: 17°C; CAVOK				
<b>Number of people on board</b>	1 + 3	<b>No. of people injured</b>	0	<b>No. of people killed</b>	0

**Name of Owner/Operator** : Dragon Peaks Park Pty (Ltd)  
**Manufacturer** : Robinson Helicopter Company  
**Model** : R44 Raven II  
**Nationality** : South African  
**Regis

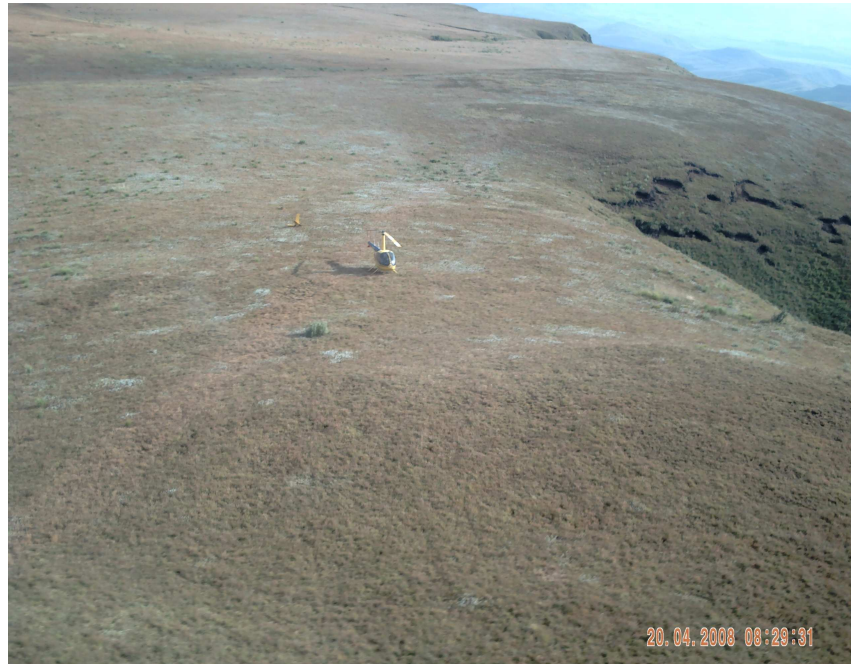
**Figure 1.** Aerial view of helicopter near Crystal Beds after the accident.

- 1.12.1 The helicopter struck the sloping ground, causing it to swing through 180°. During the impact sequence, the tail boom was severed from the fuselage and the helicopter slid backwards for some metres before coming to rest.
- 1.12.2 The tail boom and rotor assembly were found approximately 17 metres from the main wreckage.

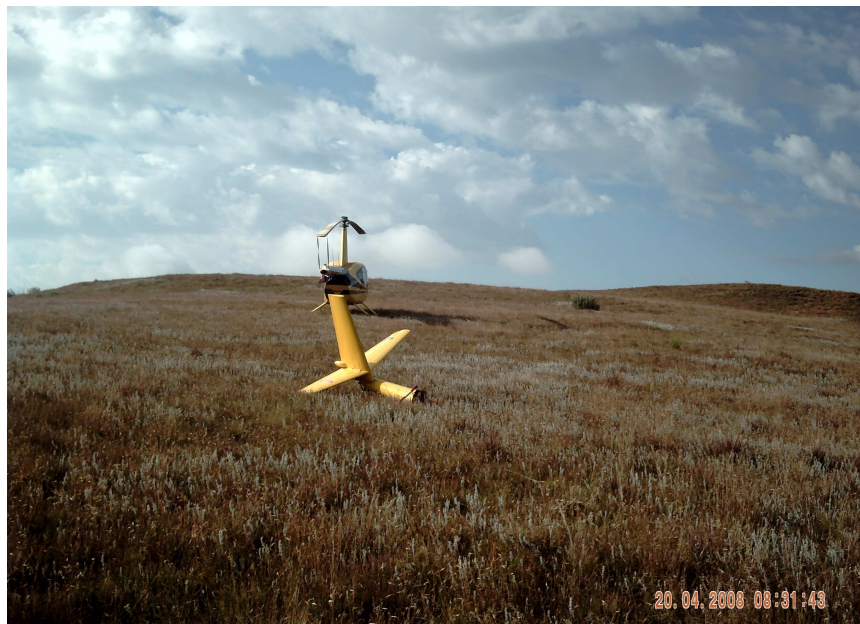
**Figure 2.** The tail boom that separated from the helicopter on impact.

1.3.1 The tail boom was severed from the helicopter during the accident sequence.

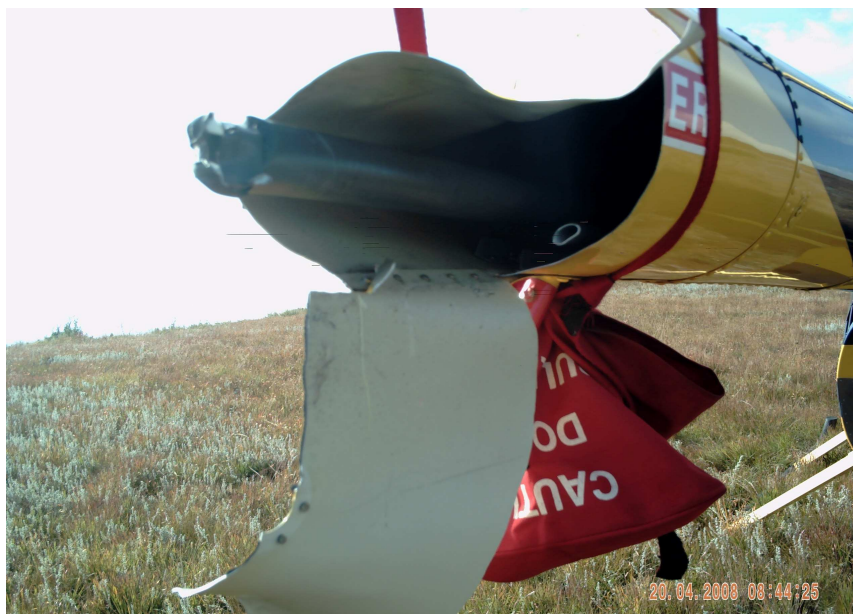
**Figure 3.** Aft fuselage of helicopter showing where tail boom separated.

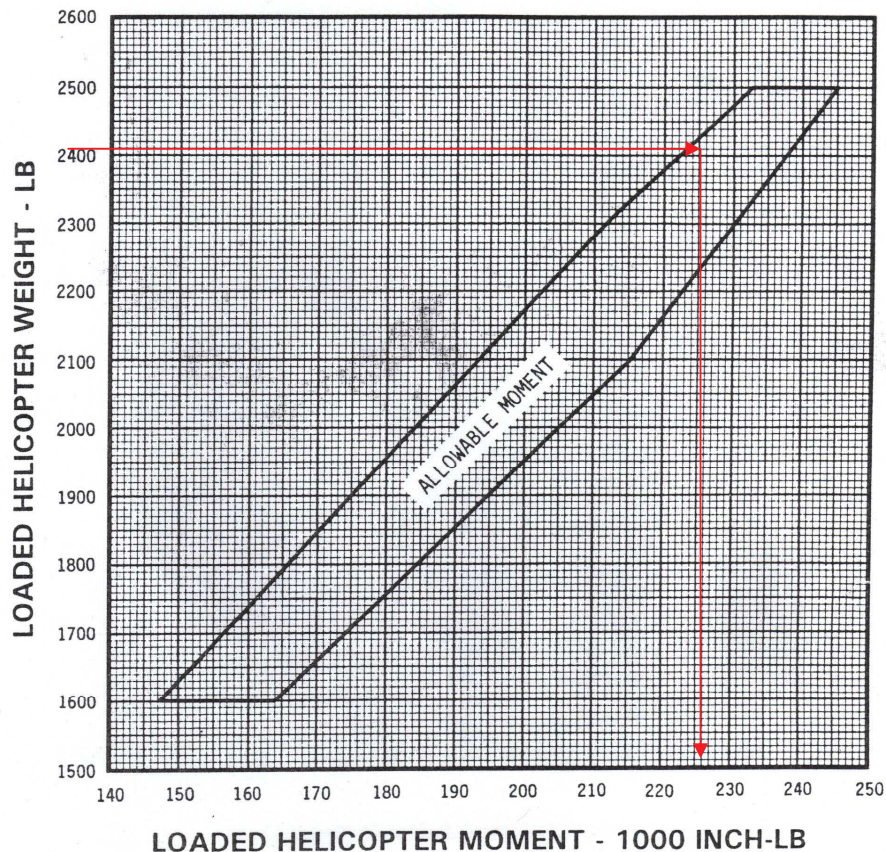
ALLOWABLE LOADED MOMENT VS. GROSS WEIGHT  
ENVELOPE

- (i) The fuel conversion factor that was used to calculate the fuel was:  
1 US gallon = 6 pounds.
- (ii) The helicopter was being operated within its allowable centre of gravity envelope (CG) as indicated by the graph on the next page.

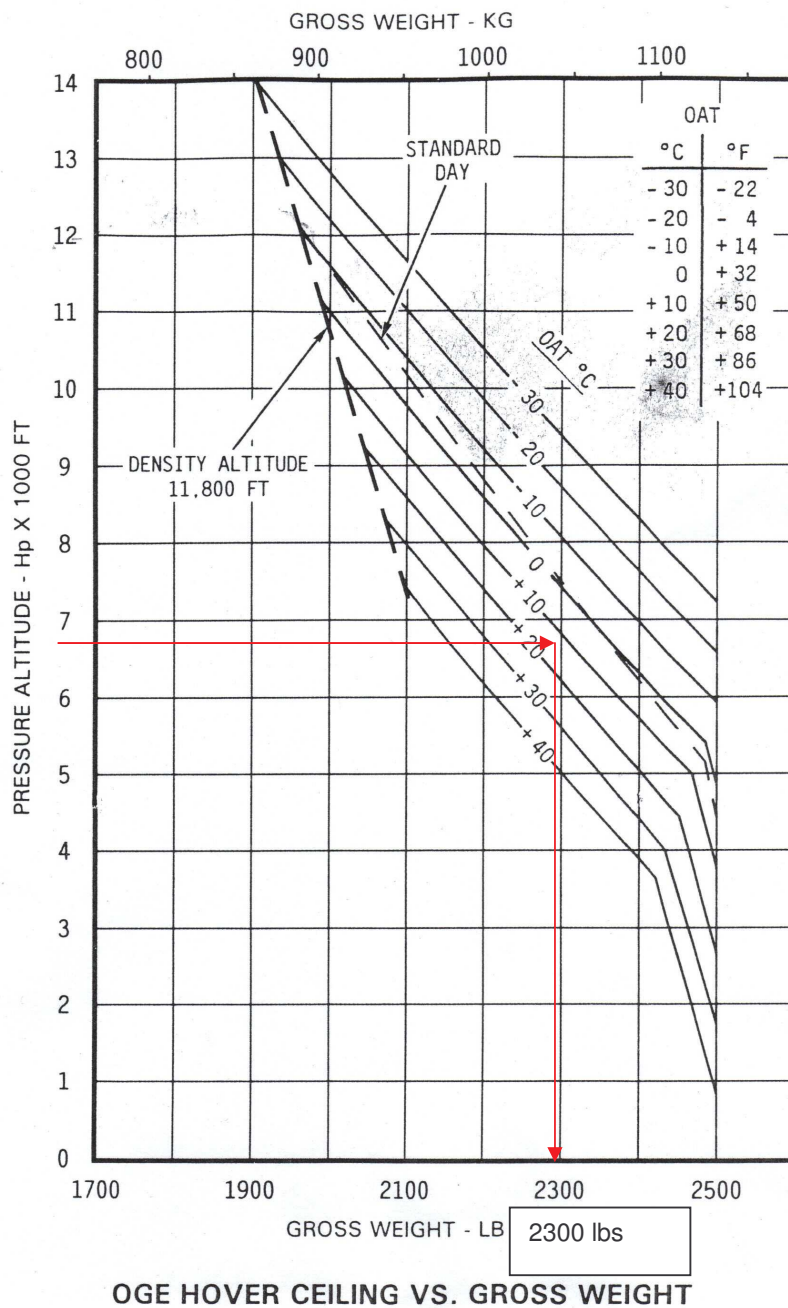
OUT OF GROUND EFFECT  
TAKEOFF POWER OR FULL THROTTLE  
ZERO WIND

- (iii) The in-ground effect (IGE) hover graph, as described in the POH, Section 5, pages 5-4, was used. This indicated that an IGE hover at 6 620 feet with pressure altitude at 17°C and a gross weight of 2 426 lbs would have been possible. The pilot was able to attain an in-ground effect hover over the terrain.
- (iv) However, the performance figures on the out-of-ground effect (OGE) hover graph indicate that the maximum out-of-ground hover gross weight at 6 620 feet pressure altitude and 17°C should not exceed 2 300 lbs. The gross weight of the helicopter on takeoff was 2 426 lbs, which exceeded the OGE calculated limit by 126 lbs, as shown in the OGE graph below.

- 3.1.7 The helicopter was capable of performing an in-ground effect (IGE) hover, according to the IGE performance graph.
- 3.1.8 The out-of-ground effect (OGE) performance graph indicated that the aircraft weight should not have exceeded 2 300 lbs. The aircraft weight exceeded the OGE calculated limit by 126 lbs.

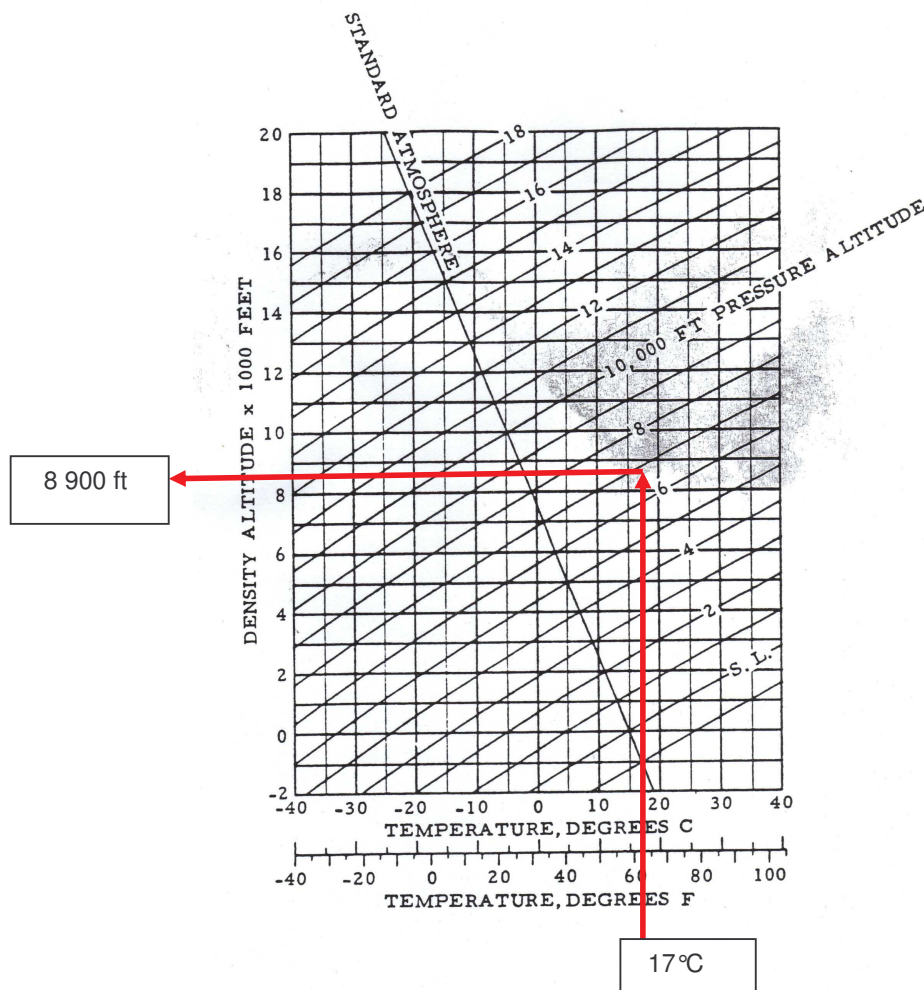
DENSITY ALTITUDE CHART

- 1.7.2 According to the density altitude chart tabled in Section 5 of the POH, at 6 620 feet pressure altitude and a temperature of 17°C, the density altitude would be about 8 900 feet.
