AIRCRAFT ACCIDENT REPORT AND EXECUTIVE SUMMARY

Reference:	CA18/3/2/8482	
Aircraft Registration	ZS-MZS	Date of Accident	22 April 2008		Time of Accident	1020Z
Type of Aircraft	Robinson R44 Raven II – Helicopter		Type of Operation	Private		
Pilot-in-command Licence Type		Private	Age	43	Licence Valid	Yes
Pilot-in-command Flying Experience		Total Flying Hours	68.8		Hours on Type	16.3
Last point of departure		Farm Driehoek, Hoedspruit – Limpopo Province				
Next point of intended landing		Nelspruit – Mpumalanga Province				
Location of the accident site with reference to easily defined geographical points (GPS readings if possible)						
Approximately S24°29' 50" E030°53' 32" Elevation 2375ft and 10 nm from the departure point.						
Meteorological Information		Wind: 5-10 knots / South; Temperature: 24°C; Visibility: Good				
Number of people on board	1+2	No. of people injured	1	No. of people killed	0	
Synopsis						
<p>The pilot and two passengers took off from a farm in Hoedspruit on a flight to Nelspruit. After about 4 to 5 minutes into the flight, the cylinder head temperature increased, although still in the green band, and the low rotor RPM alarm sounded. The pilot executed a prec

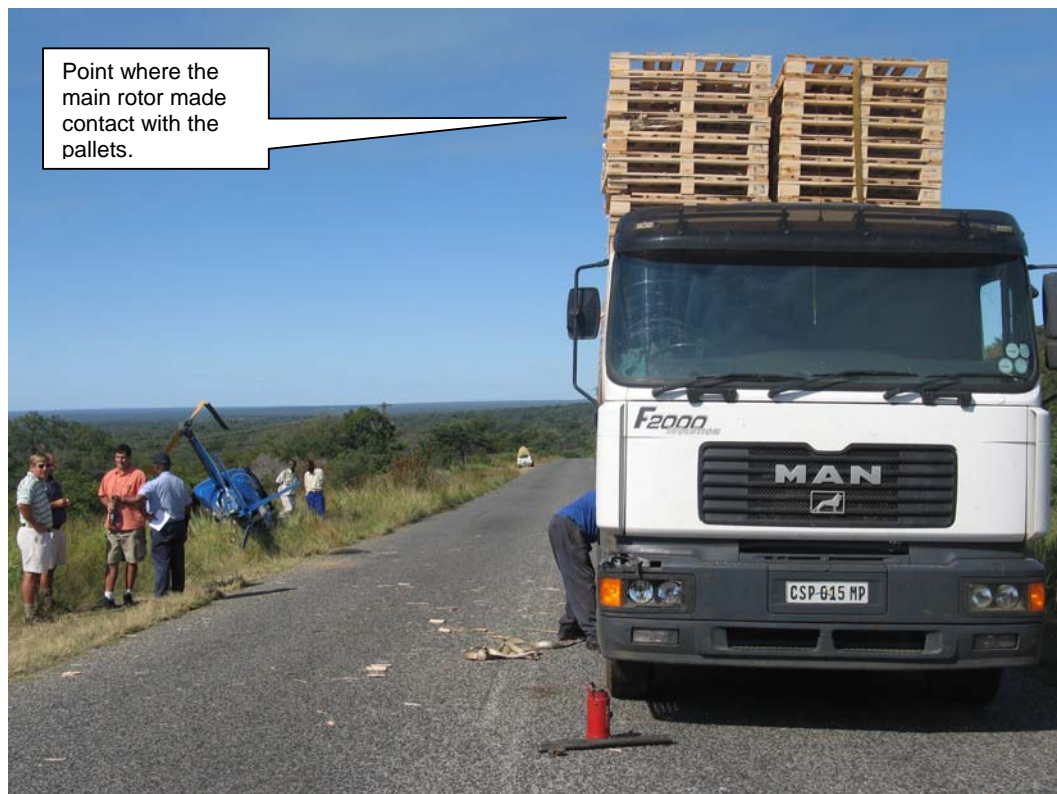
Photo 1. A view of the accident site.

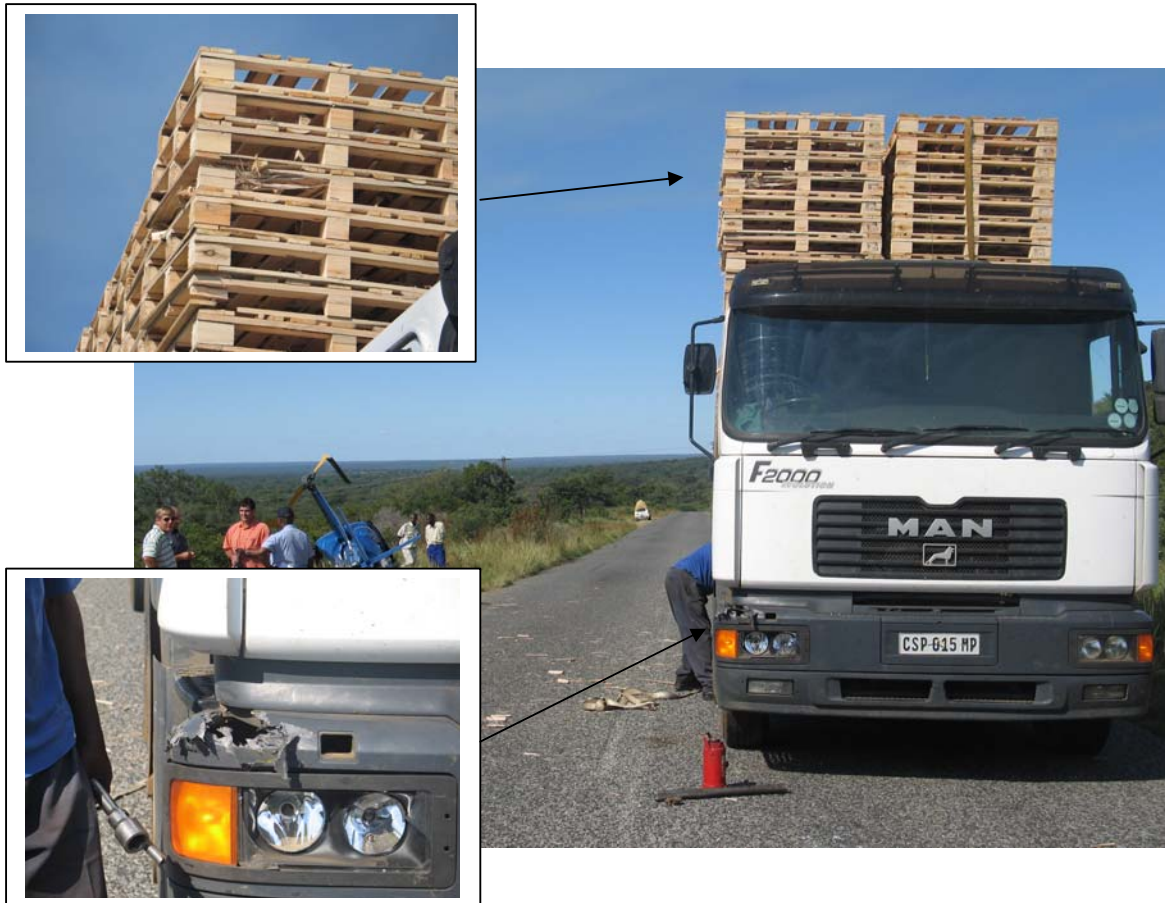
- 1.4.1 The truck sustained minor damage and its cargo load (empty pallets) was damaged.

Photo 2. A view of the damage of the truck and pallets after the accident.

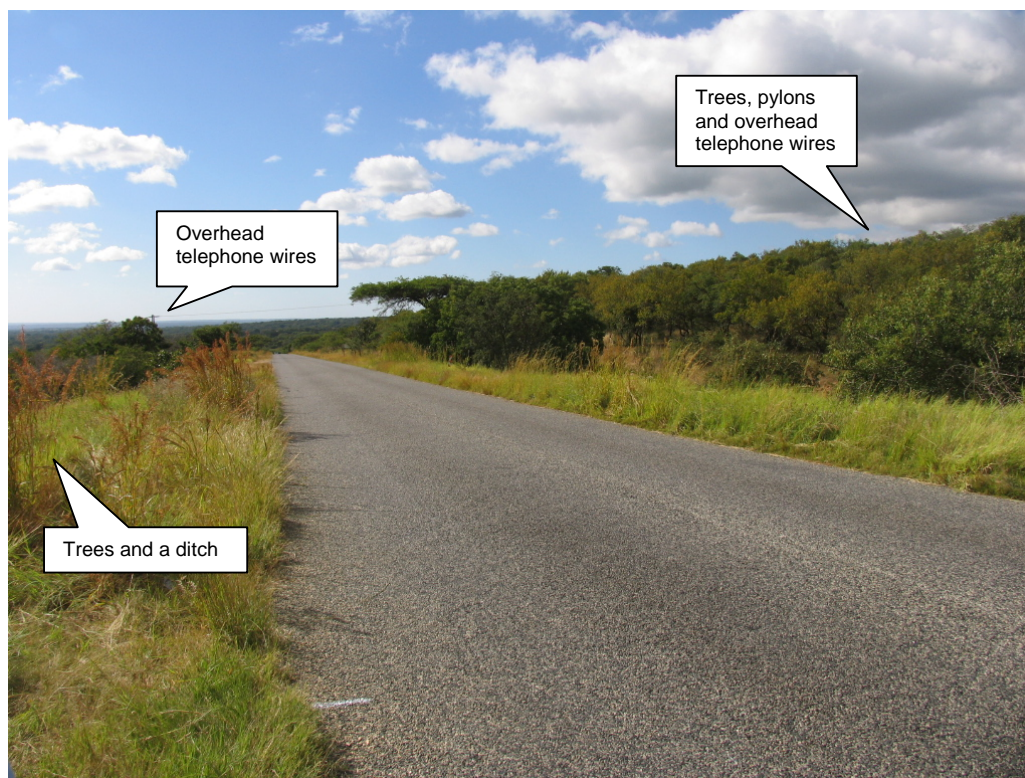
1.10.2 As indicated on the photograph, on the left-hand side of the wreckage and road is a ditch and trees. On the right-hand side of the road is a rise in ground elevation, trees, pylons and telephone overhead wires.

Photo 3. The area where the accident occurred.

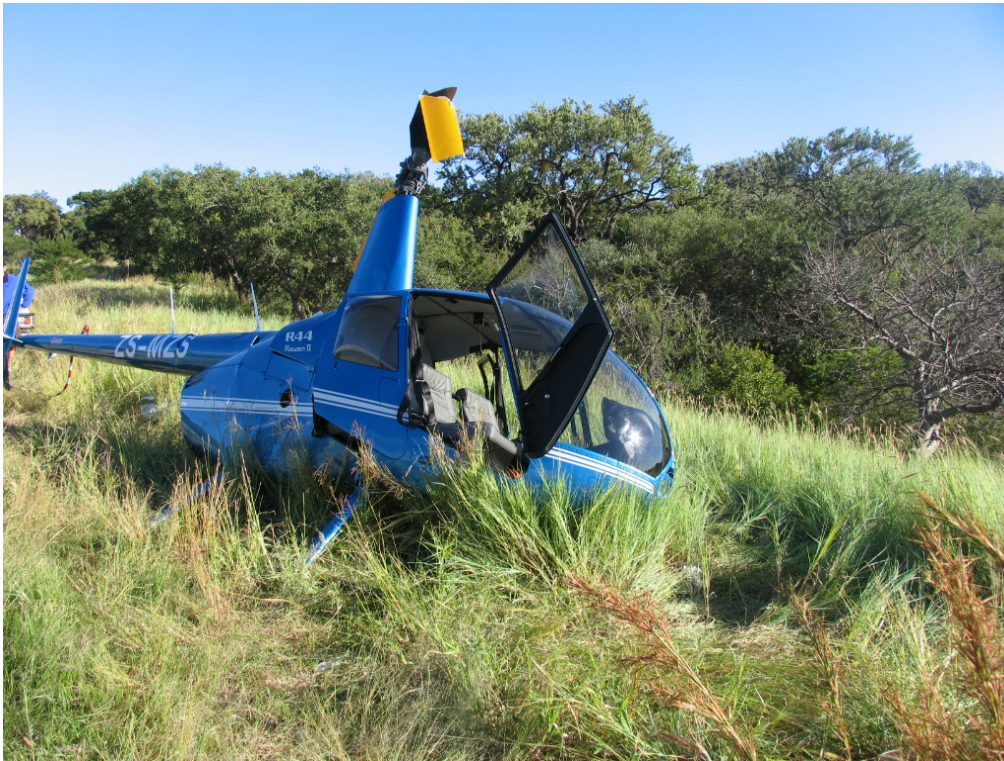
- 1.12.2 The helicopter sustained damage to the skids, main rotor, tail rotor, tail boom and fuselage.
- 1.12.3 The wreckage was moved approximately 2 metres to the side of the road by the South African Police Services, to give access to vehicles to pass.

Photo 4. A view of the helicopter after it was moved out of the road.

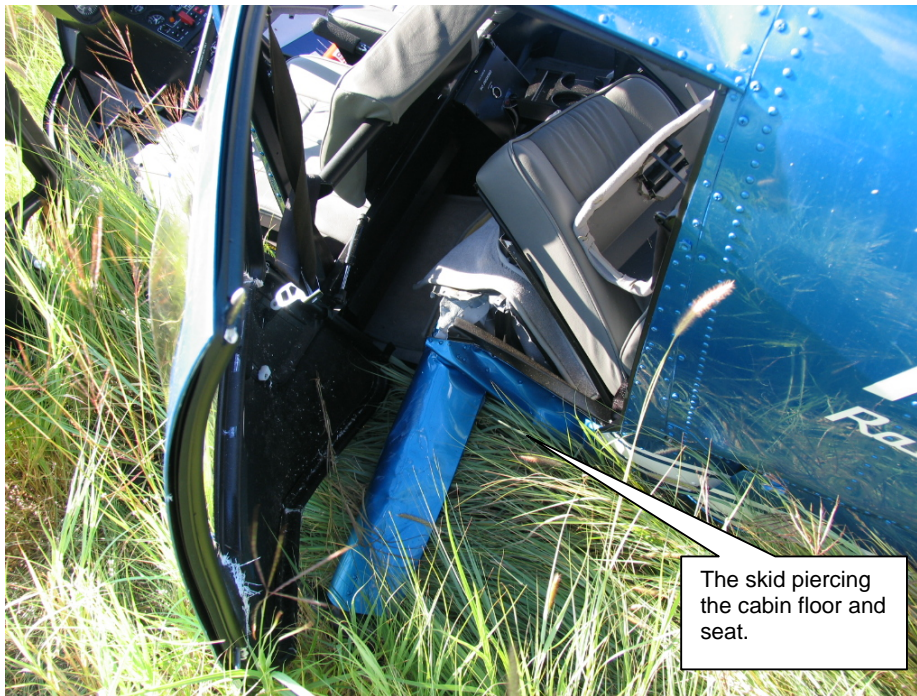
1.15.2 During the impact sequence, the left skid pierced the helicopter cabin floor and went into the aft left seat.

Photo 5. The skid that pierced the cabin floor and seat.

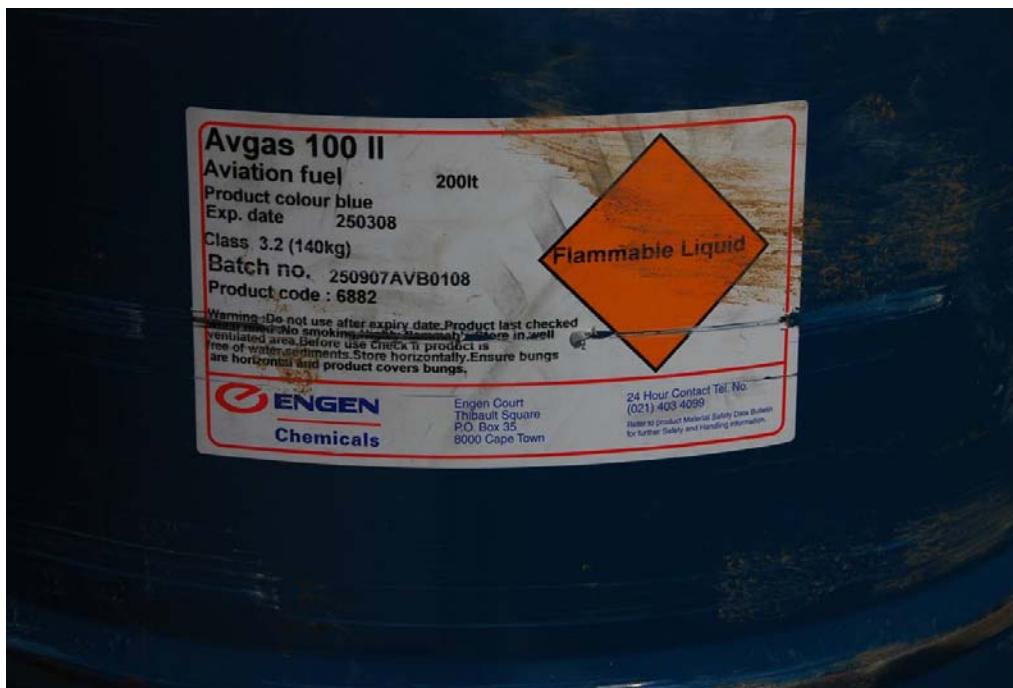
- The helicopter had been refuelled with Grade GP5 Aviation Turbine fuel instead of Avgas 100LL.
- The fuel that was sampled from the drum was found to be yellow in colour.
- The label on the fuel drum indicated that the contents were Avgas 100LL and blue in colour. Also see Photo 6 below.

Photo 6. The Avgas 100LL labelled fuel drum that contained the Grade GP5 Aviation Turbine fuel with which the aircraft was refuelled. Note expiry date displayed.

- 2.6 During the investigation it was found that the Avgas 100LL labelled drum contained fuel that was different in colour from the Avgas 100LL that the helicopter was certified to use. The expiry date displayed on the label indicated that this date was exceeded by the time the helicopter was last refuelled from this particular drum. It is the opinion of the investigator that the pilot accepted the fuel from the Avgas 100LL labelled drum as correct, as it was sealed and came from a reputable supplier. He thus did not properly inspect and identify the colour of the fuel in the drum or gave any attention to the expiry date. Analyses later also revealed that the fuel from the drum was Grade GP5 Aviation Turbine fuel and yellow in colour.
