# AIRCRAFT ACCIDENT REPORT AND EXECUTIVE SUMMARY

Reference:	CA18/2/3/8486	
<b>Aircraft Registration</b>	<b>ZS-MSR</b>	<b>Date of Accident</b>	26 April 2008		<b>Time of Accident</b>	1100Z
<b>Type of Aircraft</b>	CESSNA T210L (Aeroplane)		<b>Type of Operation</b>		Private	
<b>Pilot-in-command Licence Type</b>		Private	<b>Age</b>	40	<b>Licence Valid</b>	Yes
<b>Pilot-in-command Flying Experience</b>		Total Flying Hours	109.2		Hours on Type	Unknown
<b>Last point of departure</b>		Krokodilspuit Farm, Private Aerodrome (near Cullinan) in Gauteng Province				
<b>Next point of intended landing</b>		Volksrust Aerodrome				
<b>Location of the accident site with reference to easily defined geographical points (GPS readings if possible)</b>						
Krokodilspuit near Cullinan GPS: Position: S25° 33' 799" E028° 26' 395"						
<b>Meteorological Information</b>		Surface Wind: 270° / 5kts; Temperature: 22°C; Visibility: >10km				
<b>Number of people on board</b>	1 + 2	<b>No. of people injured</b>	1	<b>No. of people killed</b>	2

## AIRCRAFT ACCIDENT REPORT

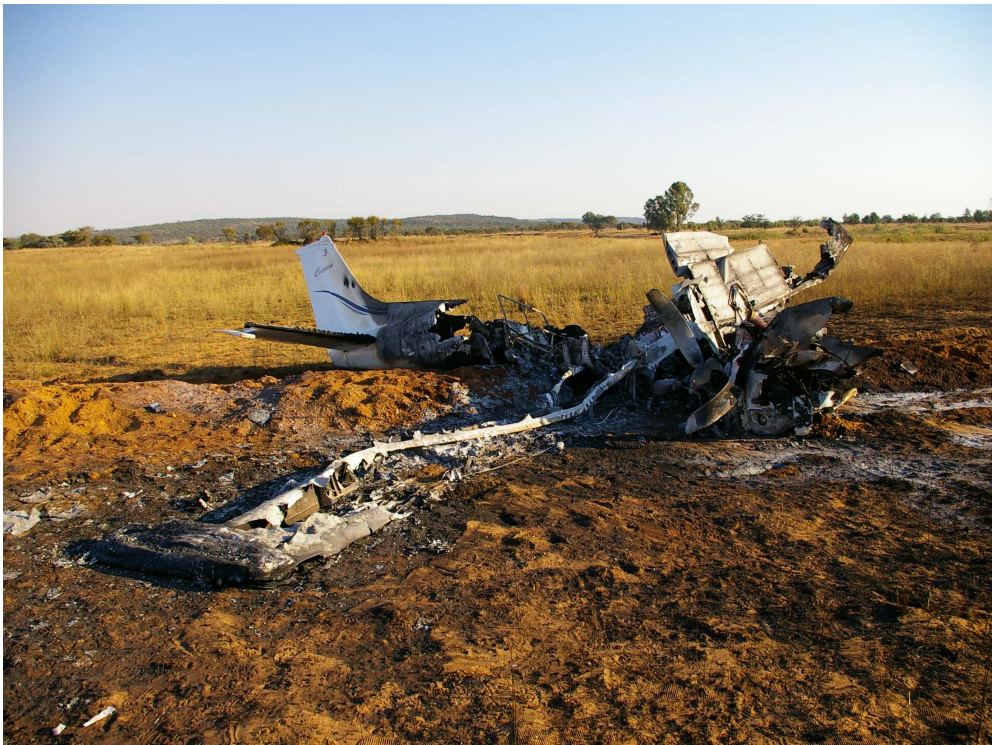
1.3.1 The aircraft was destroyed during the impact sequence and by post-impact fire.

Figure 1 shows damage to the aircraft.

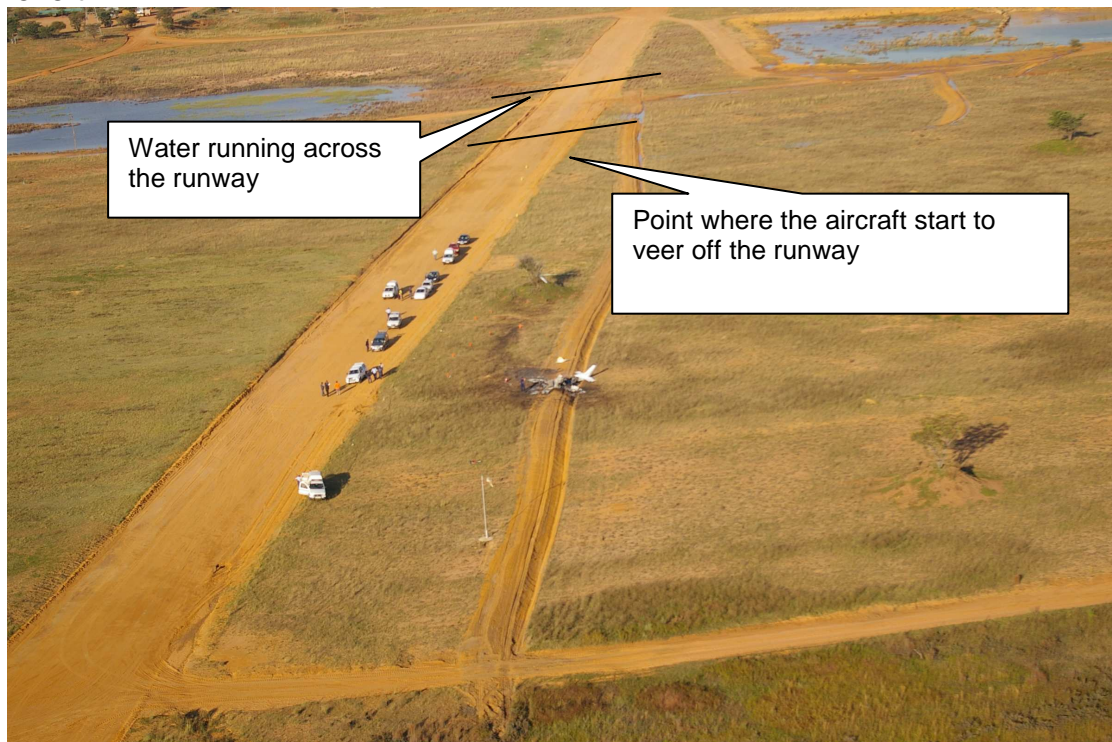
- 1.10.1 There is a dam situated to the left-hand side of the runway. When the dam is full, the excess water runs across the runway, approximately 450 m from the beginning of the runway. The surface of the runway where the water runs across the runway is hard with a little loose sand. Just after the water path, there was a fair amount of loose sand on the runway. This is also the point where the aircraft start to veer to the left.

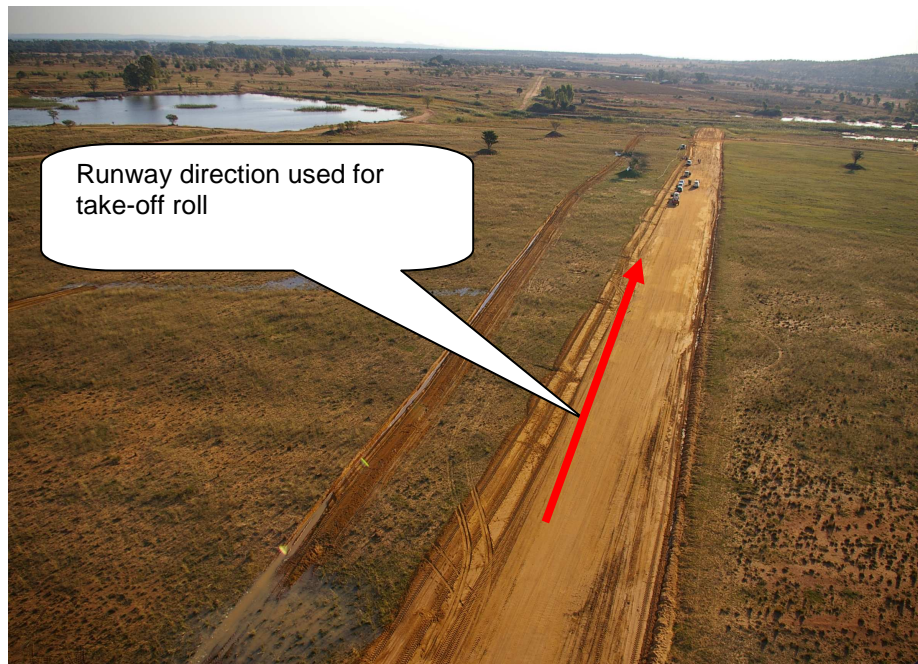
Figure 2 above indicates the runway used for take-off.

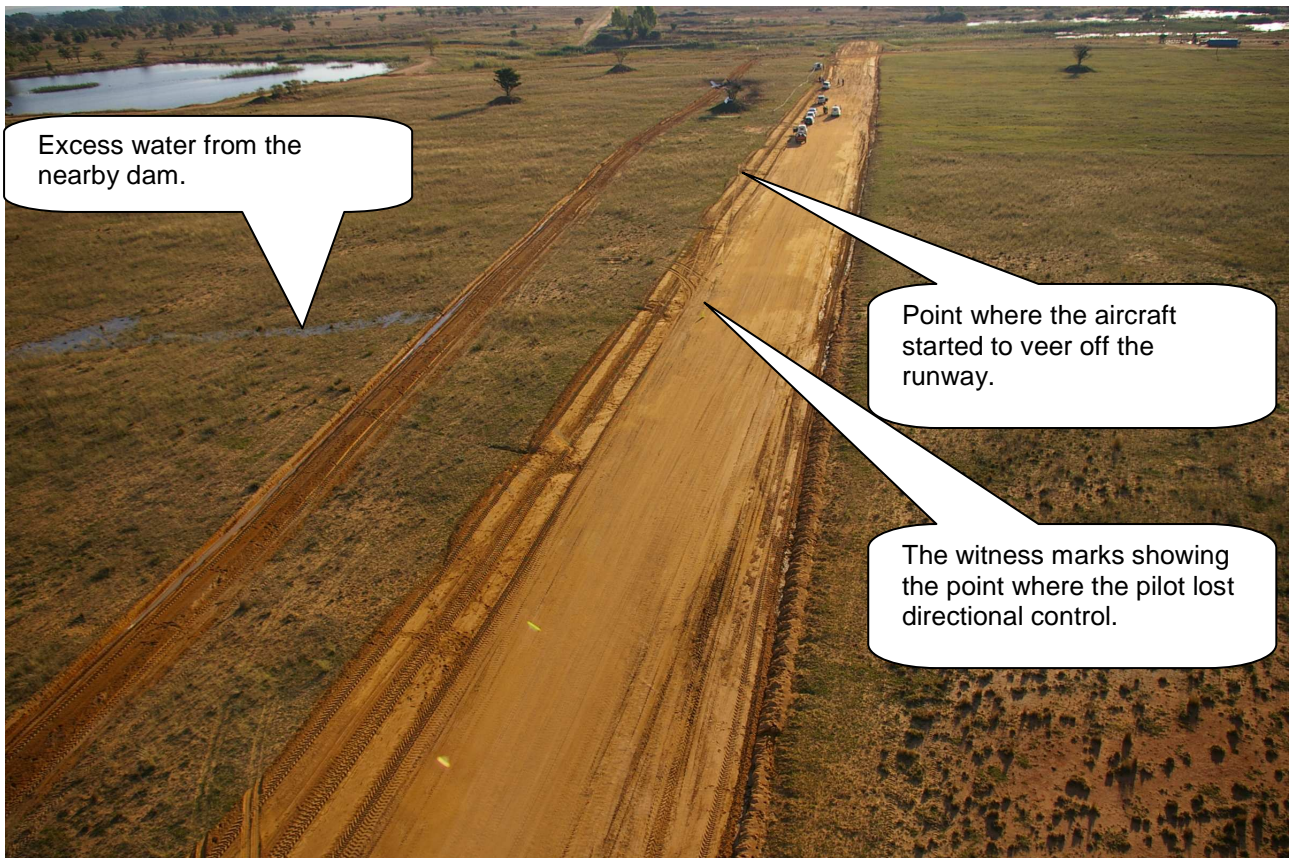
Figure 2 shows the point where the aircraft began to lose directional control.

The runway condition was such that it had wet areas as a result of excess water from the nearby dam. It also had hard surfaces. This may have resulted in the aircraft losing traction on the left-hand gear and the aircraft veering to the left.

- 4.1 It is recommended that the CCA should develop minimum standards to be adhered to by all owners of non-registered/licensed aerodromes.

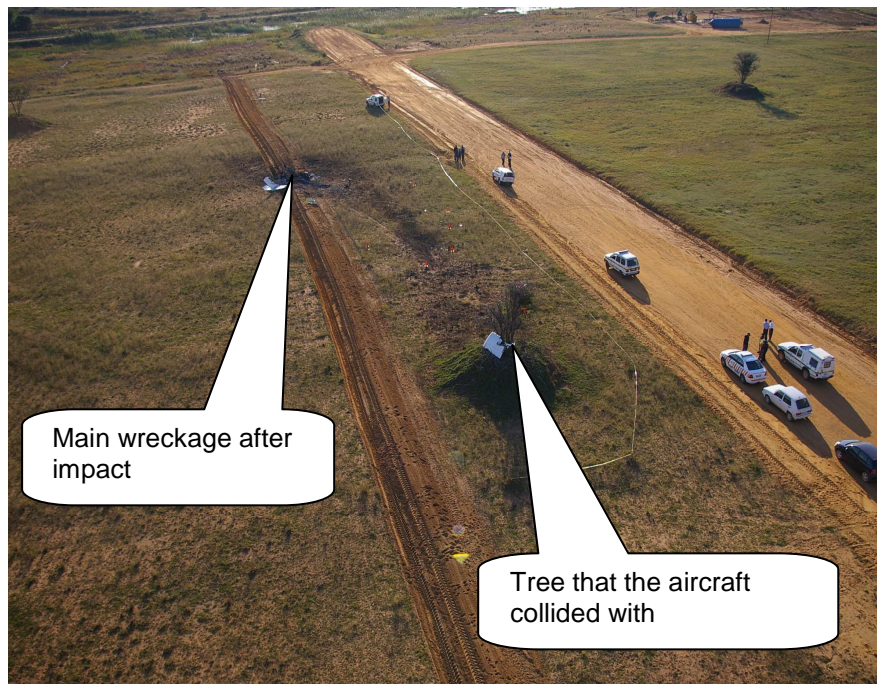
Figure 3 indicates the gravel road which was parallel to the runway and the tree with which the aircraft collided.

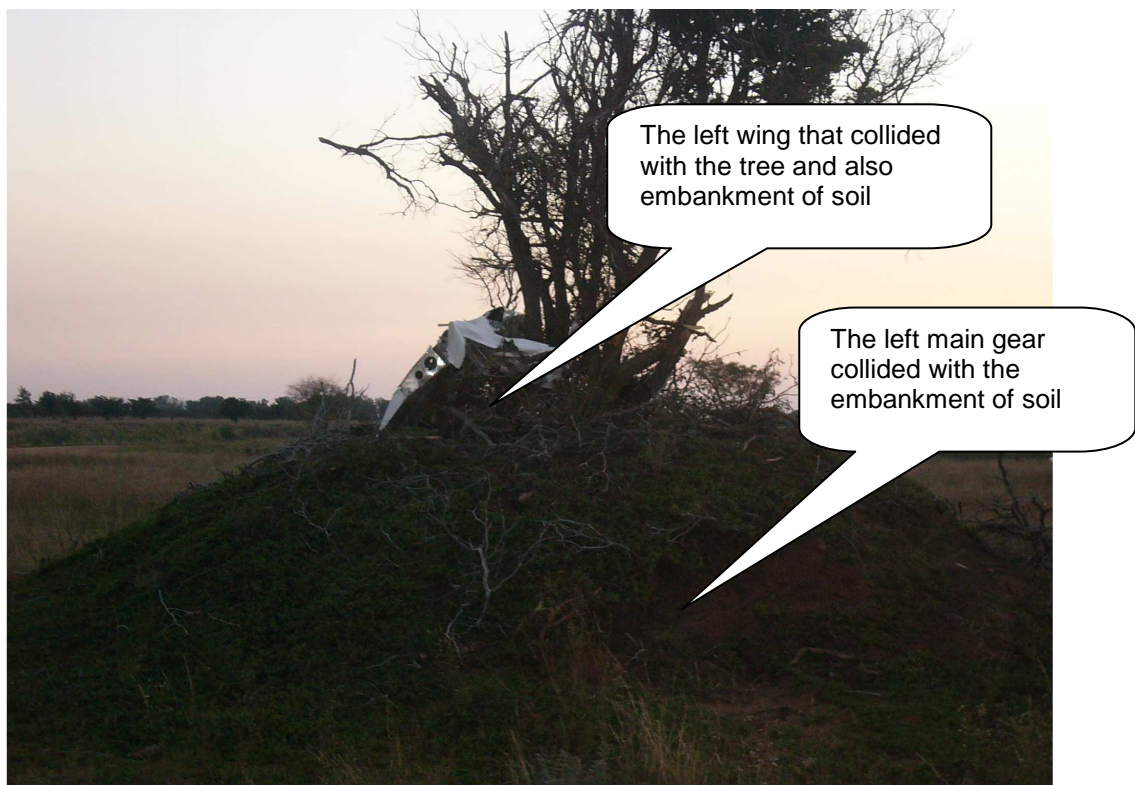
Figure 4 above indicates the separated/failed wing of the aircraft after colliding with the tree.

3.1.9 The left wing collided with the tree which was next to the runway, and separated from the aircraft.

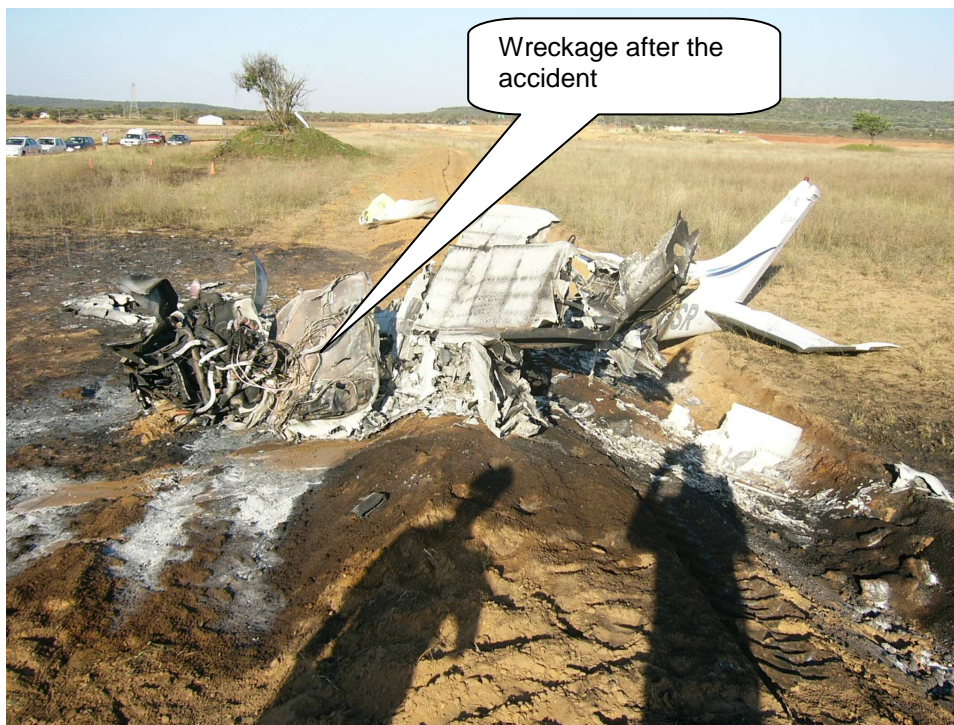
Figure 5 above indicates the main wreckage of the aircraft.

1.14.1 A post-impact fire ensued and destroying the aircraft. The fuel spilled during the impact sequence and caught alight. This was a private aerodrome with no fire rescue services available.
