AIRCRAFT ACCIDENT REPORT AND EXECUTIVE SUMMARY

Reference:	CA18/2/3/8506	
Aircraft Registration	ZU-AFP	Date of Accident	01 June 2008		Time of Accident	0924Z
Type of Aircraft	RV-6 (Low wing fixed wing aircraft)		Type of Operation	Private		
Pilot-in-command Licence Type		Private	Age	68	Licence Valid	Yes
Pilot-in-command Flying Experience		Total Flying Hours	885		Hours on Type	473
Last point of departure		Pietermaritzburg Aerodrome				
Next point of intended landing		Alverstone Farm private airstrip in KwaZulu-Natal Province				
Location of the accident site with reference to easily defined geographical points (GPS readings if possible)						
Threshold of Runway 29 at Alverstone farm (S29°46,521" E030°43',096" Elevation 2730 feet mean sea level)						
Meteorological Information		Surface wind: 230°/10 knots; visibility good. Temperature: 23°C				
Number of people on board	1 + 0	No. of people injured	1	No. of people killed	0	
Synopsis						
<p>On 01 June 2008 at 0900Z, the pilot took off from Pietermaritzburg Aerodrome on a private visual flight rules flight to Alverstone private airstrip. The weather conditions were reported to be fine for the flight, which was estimated to take 10 min

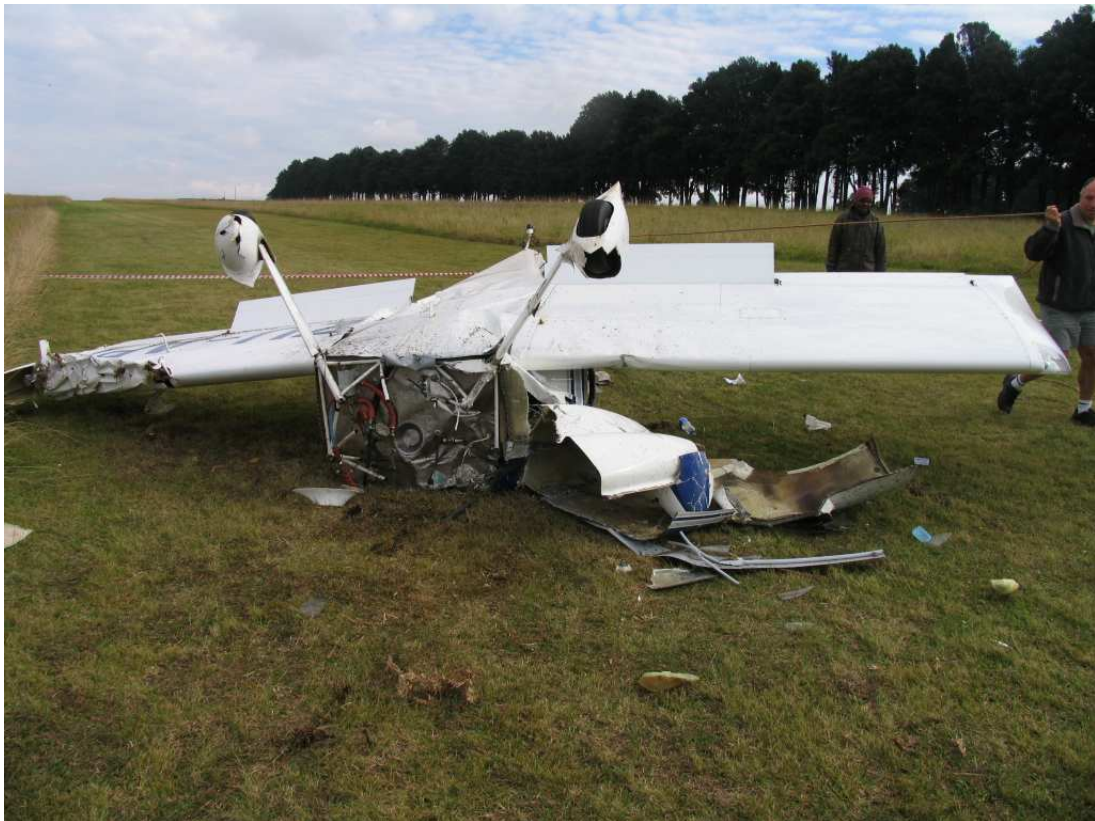
- 1.3.1 The aircraft was destroyed by post-impact forces.

Picture above shows damage to the aircraft.

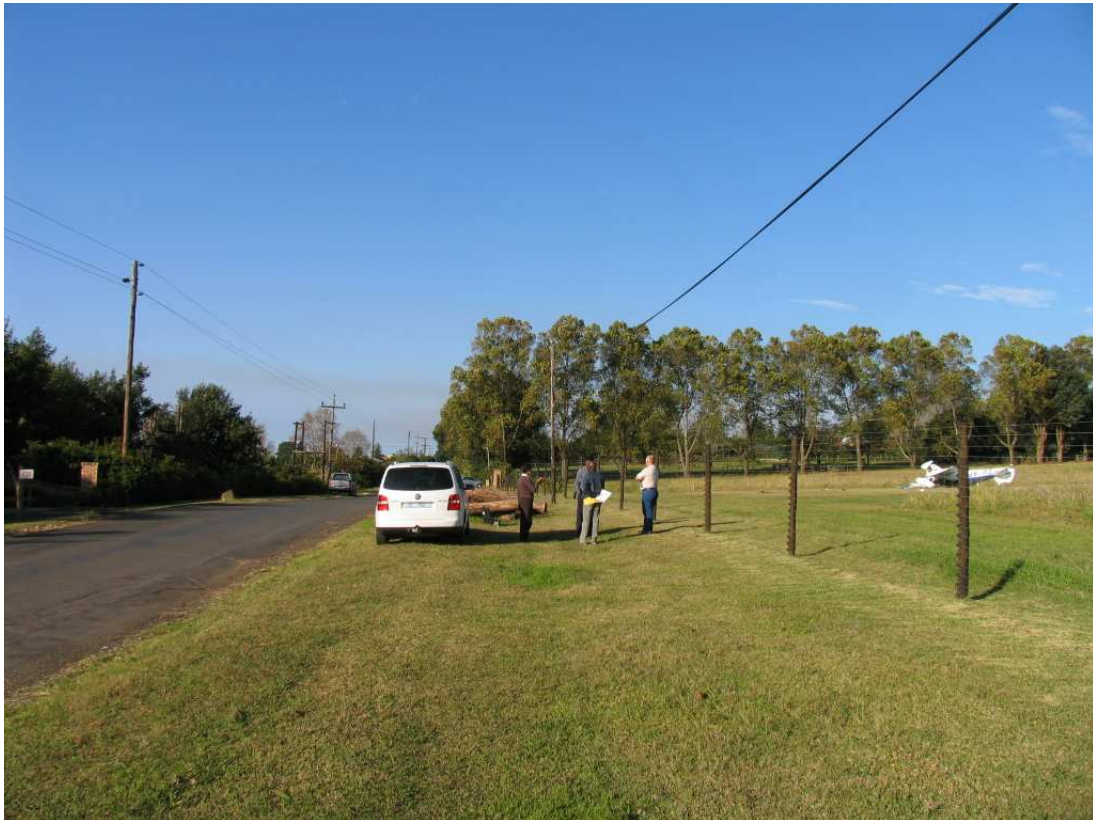
1.4.1 Eskom power lines and Telkom lines which run perpendicular to the runway.

1.10.1 The airstrip is very dangerous to land on; with the obstacles on approach you can only approach at a steep angle to make sure that you have cleared the obstacles and land safely with adequate runway left.

The picture shows the obstacles that run perpendicular to the approach of Runway 29.

The airstrip was unregistered and unmanned.
The airstrip has the hazards of trees, power lines and phone lines on approach for Runway 29.

- 4.1 It is recommended that the SACAA (airport department) in consultation with Eskom should make sure that the power lines on the approach side of the airstrip is properly marked.

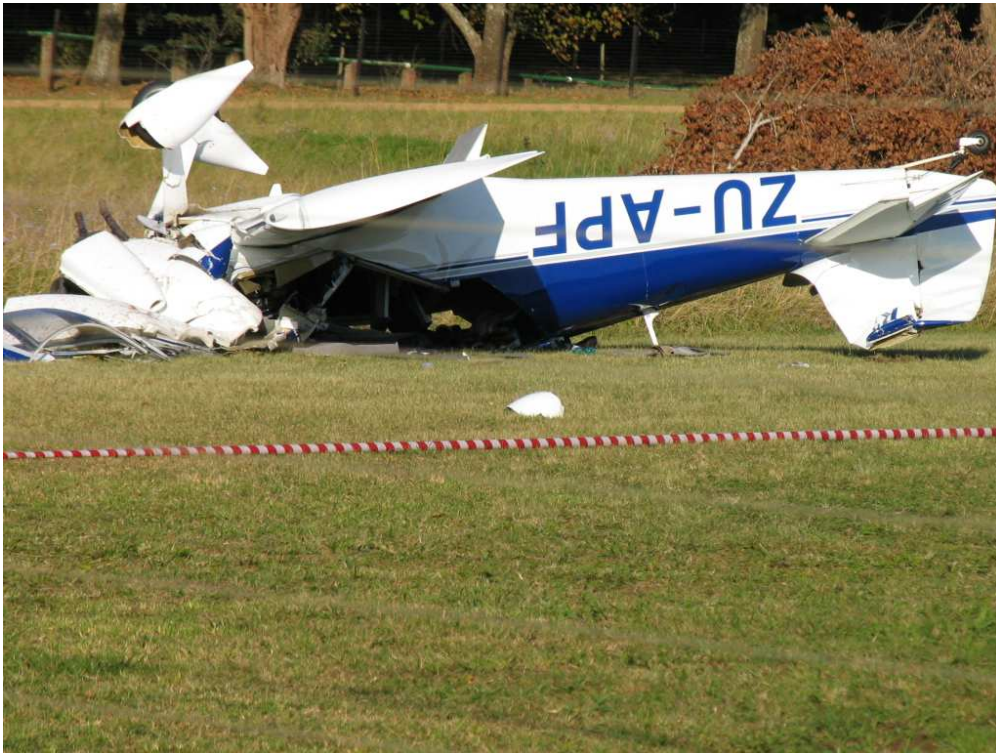
The picture shows the damage on the glass canopy after flipping over on its roof.

1.15.1 The accident was considered survivable as the pilot was properly restrained by safety harness despite the crushed cabin roof and the serious injuries sustained by the pilot.
