AIRCRAFT ACCIDENT REPORT AND EXECUTIVE SUMMARY

Reference:	CA/18/2/3/8534	
Aircraft Registration	ZS-MHA	Date of Accident	24 August 2008		Time of Accident	1145Z
Type of Aircraft	Piper PA28R 200		Type of Operation	Private		
Pilot-in-command Licence Type		Private	Age	25	Licence Valid	Yes
Pilot-in-command Flying Experience		Total Flying Hours	113.4		Hours on Type	19.5
Last point of departure		Rand Aerodrome (FAGM)				
Next point of intended landing		Rand Aerodrome (FAGM)				
Location of the accident site with reference to easily defined geographical points (GPS readings if possible)						
Next to Germiston Golf Course in a stream (GPS co-ordinates: S 26° 13.896' E 028° 08.666')						
Meteorological Information		CAVOK, wind 340° 10 kts, density altitude 7404, QNH 1022 , temperature 23°C				
Number of people on board	1 + 2	No. of people injured	0	No. of people killed	3	
Synopsis						
<p>The aircraft took off from runway 35 on a visual flight rules (VFR) private flight from Rand Aerodrome.</p> <p>According to witnesses, the aircraft was slow and low during the climb phase of the flight. While overhead the golf course, the aircraft lost altitude. The left-hand wing collided with trees and

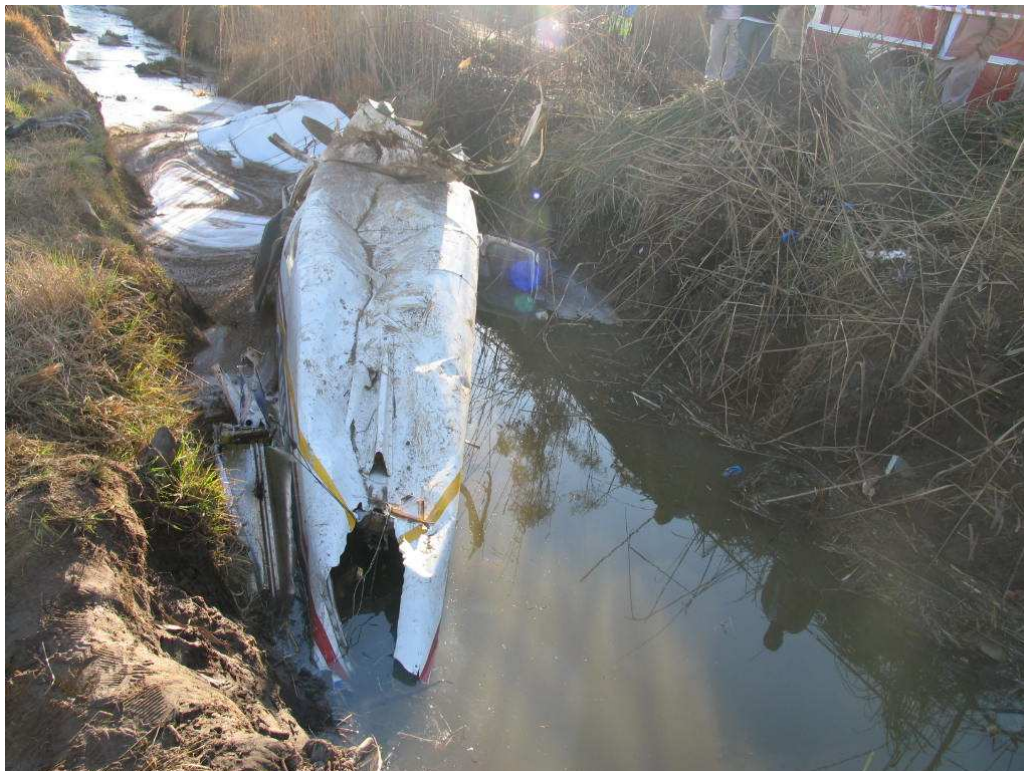
1.3.1 The engine, firewall and the cabin had fire damage, and the wings separated from the fuselage. The aircraft was destroyed in the accident.

Figure 1: The aircraft wreckage in a stream at the golf course

1.12.2.3 The main wreckage was oriented on a bearing of 320° magnetic lying in a shallow stream. The engine was attached to the firewall and the propeller was present on the engine. Black soot and charring was evident on the fuselage around the engine compartment and inside the cockpit on the pilot's seat.

1.12.2.4 Both wings had been cleanly separated at the wing root. The wing spar fracture locations were characterized by bright surfaces, granular in texture, and 45° fracture surfaces. The right wing was orientated parallel with the left side of the fuselage, with the wingtip towards the front of the airplane. The wing had a leading edge indentation at the wing tip. Both the right and left fuel tanks had been breached (25 gallon capacity fuel tanks). The right fuel tank was approximately 1/4 full of fuel. The tail was separated from the empennage, and hung by the rudder and stabilizer control cables. The left stabilizer, vertical stabilizer and rudder were present.

1.12.2.5 The wing root exhibited signatures consistent with overload.

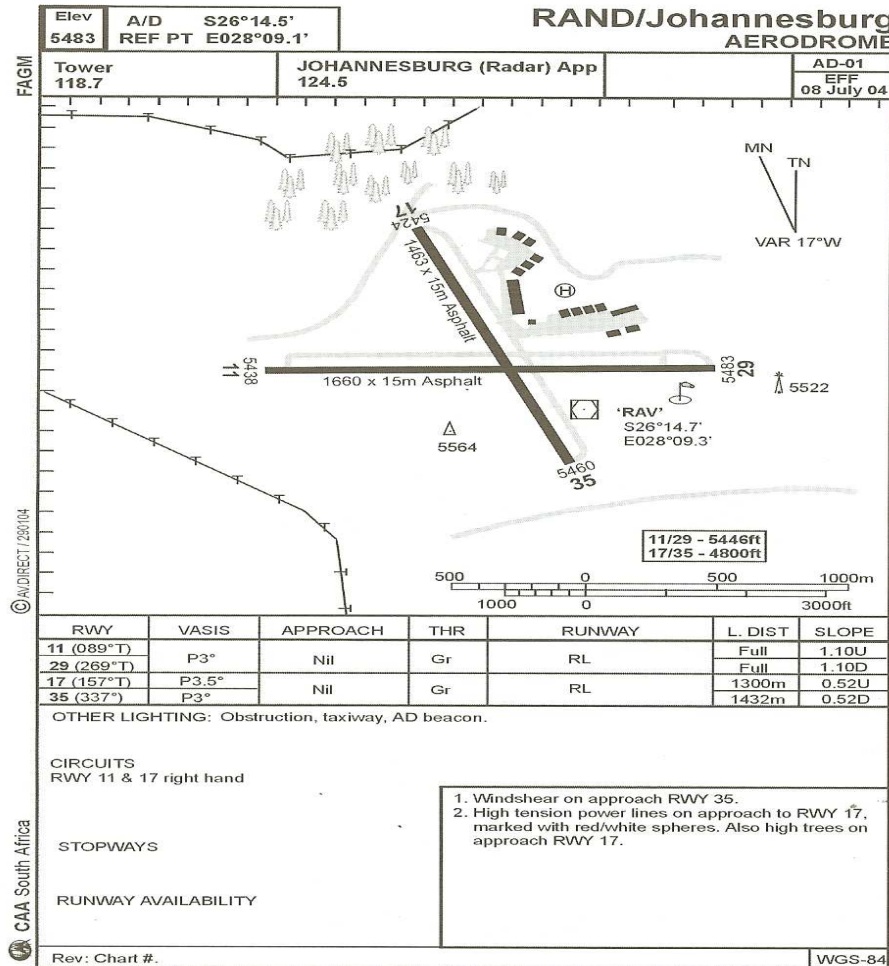
Figure 2: The runway designations at FAGM

1.10.1 The Rand Aerodrome (FAGM) is located in the vicinity of a golf course. The Airport/Facility Directory establishes the airport elevation at 5 483 ft above mean sea level (AMSL), and the runway is oriented in a north-south direction (runways 35 and 17). Runway 35 slopes downward with an altitude difference of 36 ft between ends. The bottom end of runway 35 borders a golf course that has large trees as well as large electricity pylons surrounding the golf course.

1.10.2 The advisory note 2 on the aerodrome information warns of high-tension power lines as well as high trees on approach to runway 17.

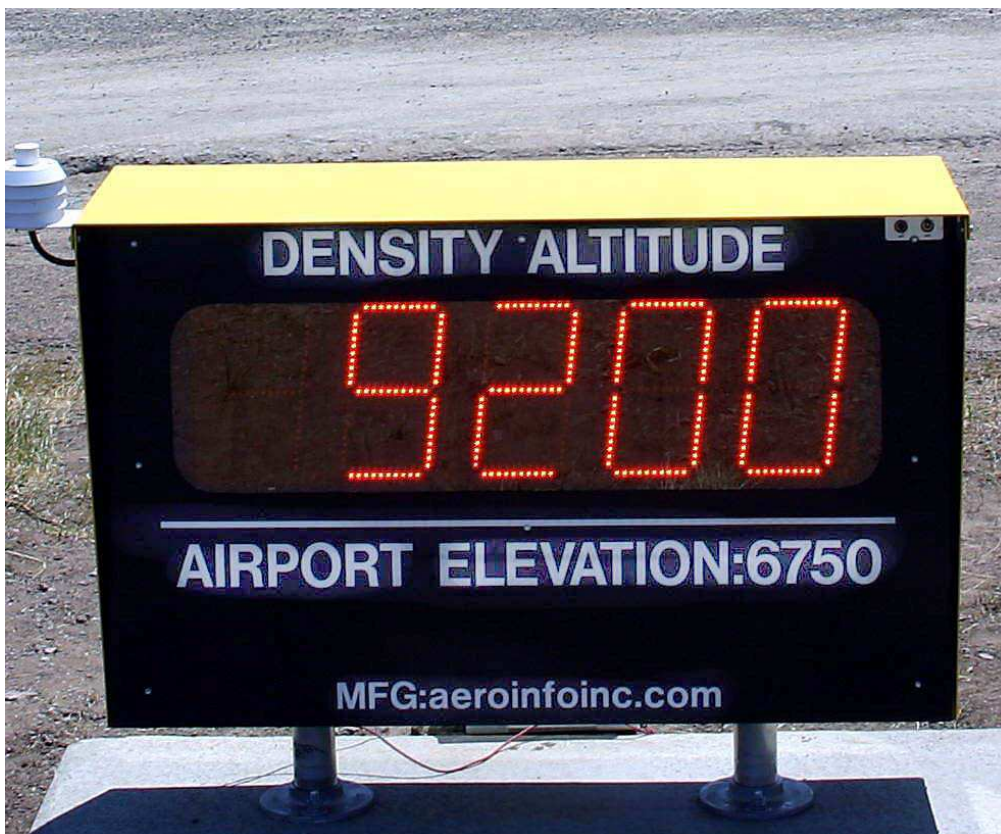
Figure 3: A density altitude indicator at an airport

4.1.1 Density altitude advisories at airports with elevations of 2 000 ft and higher – control towers should broadcast the advisory "Check Density Altitude" when the temperature reaches a predetermined level. These advisories will be broadcast on appropriate tower frequencies or, where available, the ATIS. The ATIS will broadcast these advisories as a part of a Local Airport Advisory.

4.1.2 These advisories should be provided by air traffic facilities as a reminder to pilots that high temperatures and high field elevations will cause significant changes in aircraft characteristics. The pilot retains the responsibility to compute density altitude, when appropriate, as a part of preflight duties.
