AIRCRAFT INCIDENT REPORT AND EXECUTIVE SUMMARY

Reference: CA18/3/2/0681	
Aircraft Registration	ZS-SDA	Date of Incident	24 October 2008		Time of Incident 1215Z
Type of Aircraft	Cessna C172		Type of Operation		Training
Pilot-in-command Licence Type	Student	Age	20	Licence Valid	Yes
Pilot-in-command Flying Experience	Total Flying Hours	46	Hours on Type	14.3	
Last point of Departure	Rand Aerodrome (FAGM)				
Next point of Intended Landing	Rand Aerodrome (FAGM)				
Location of the Incident Site with Reference to Easily Defined Geographical Points (GPS readings if possible)					
Runway 35 at Rand Aerodrome, Gauteng Province					
Meteorological Information	The pilot reported that the weather was fine at the time of the accident.				
Number of People on Board	1 + 0	No. of People Injured	0	No. of People Killed	0
Synopsis	<p>The student pilot was engaged on a solo training flight, practising circuit and landing exercises at Rand Aerodrome when the accident occurred. During a landing, the aircraft ballooned, and in an attempt to recover the pilot landed the aircraft hard on the nose landing gear. The nose landing gear collapsed and the propeller struck the ground.</p> <p>The student sustained

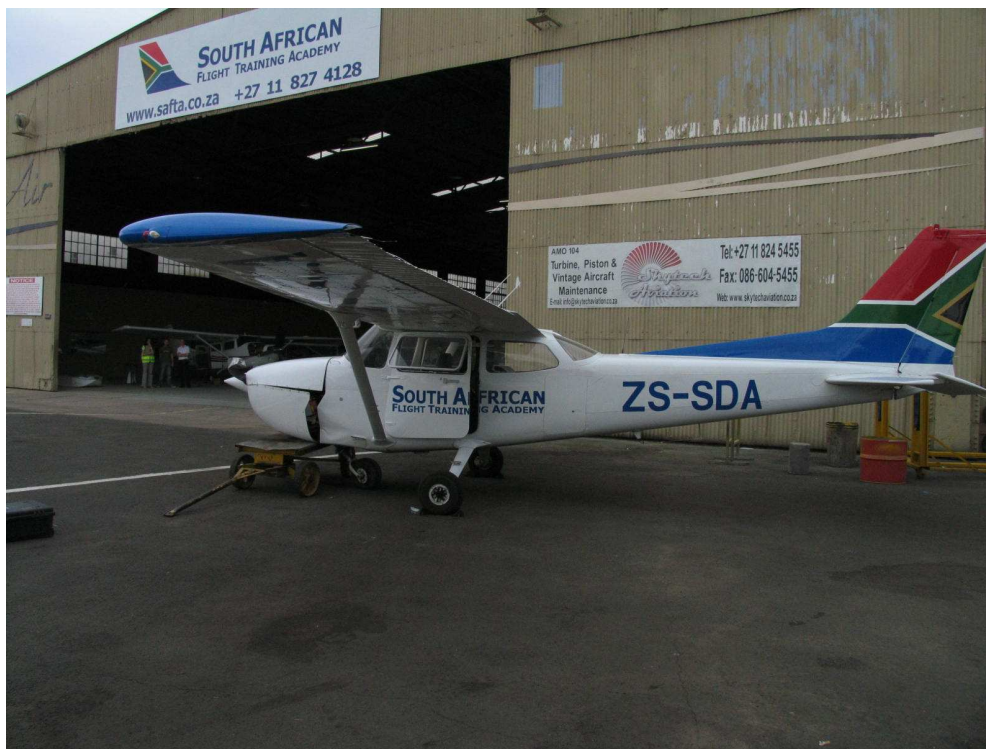
- 1.3.1 The aircraft sustained damage on the nose wheel, the propeller blades, cowling and the fire wall, which broke off.

Figure 1: The aircraft after the accident

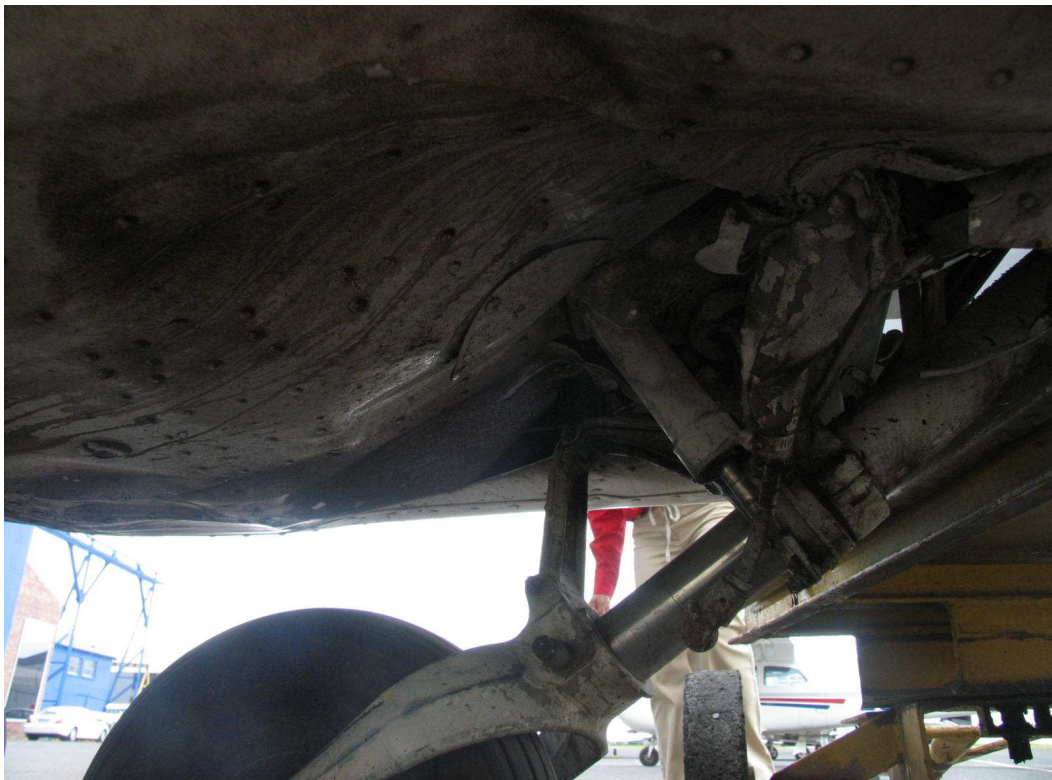
- 1.12.1 During the landing, the aircraft ballooned and in an attempt to recover, the student pilot landed the aircraft hard on the nose landing gear. As a result, the nose landing gear collapsed and the propeller struck the ground. The aircraft came to a halt approximately 20 m from the intersection of runways 35 and 29. The onsite investigations after the aircraft had been recovered to the hanger revealed no anomalies with the control surfaces or control cables.

Figure 2: The collapsed nose wheel of the aircraft

- 3.2.1 The aircraft ballooned during landing and in an attempt to recover, the student pilot landed the aircraft hard on its nose landing gear. As a result, the nose landing gear collapsed.
