AIRCRAFT ACCIDENT REPORT AND EXECUTIVE SUMMARY

Reference:	CA18/2/3/8569	
Aircraft Registration	ZU-DMT	Date of Accident	24 October 2008		Time of Accident	0715Z
Type of Aircraft	Tecnam P92-S Echo		Type of Operation		Training	
Pilot-in-command Licence Type		Commercial	Age	21	Licence Valid	Yes
Pilot-in-command Flying Experience		Total Flying Hours	368.3		Hours on Type	148.1
Last point of departure		Rand Aerodrome (FAGM)				
Next point of intended landing		Rand Aerodrome (FAGM)				
Location of the accident site with reference to easily defined geographical points (GPS readings if possible)						
Farm Rietfontein in the Orange Farm area (GPS position: South 26°28.069' East 027°48.985')						
Meteorological Information		Surface wind; 300°10kt, Temperature; 19°C, with light rain at the time.				
Number of people on board	2 + 0	No. of people injured	0	No. of people killed	2	
Synopsis						
<p>A flight instructor, accompanied by a student pilot departed Rand Aerodrome on a training flight to the general flying area in the Orange Farm area. This was the student pilot's first official training flight following an introductory flight. According to an eyewitness account that was busy cutting gr

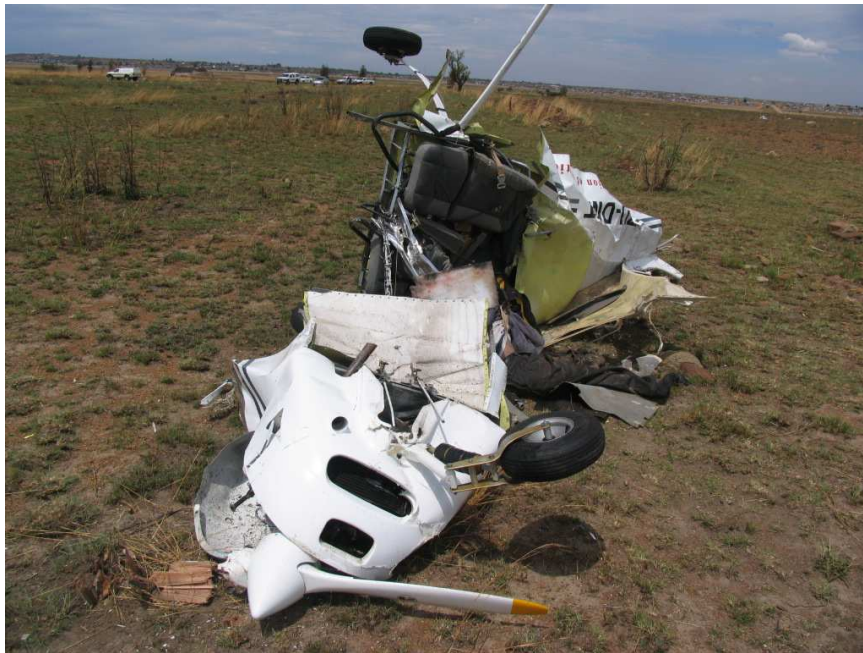
1.3.1 The aircraft was destroyed following an in-flight break-up.

Figure 1. A view of the main fuselage following ground impact.

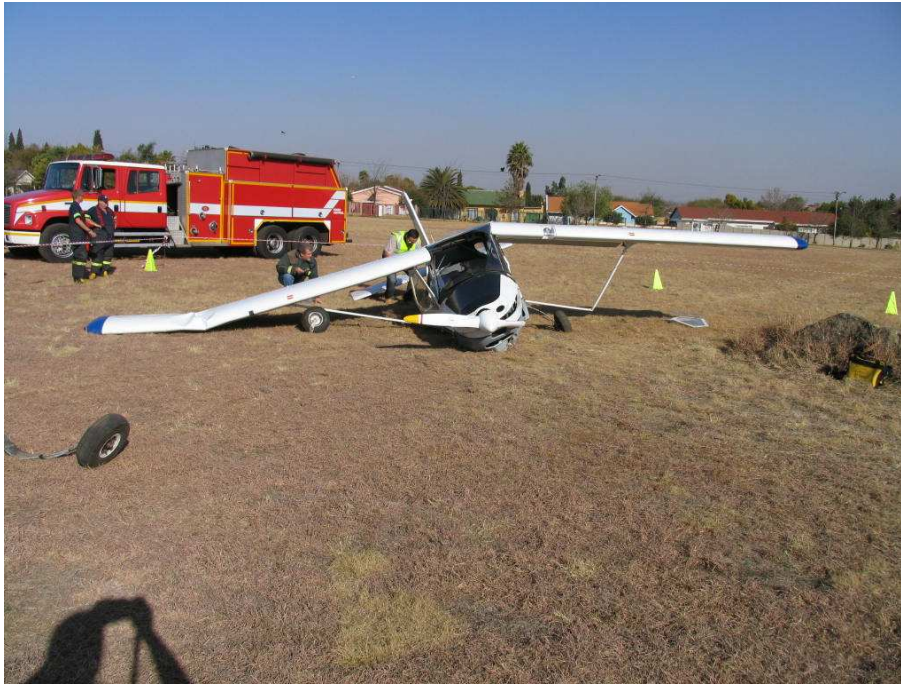
According to an aircraft logbook entry dated 28 July 2008 the aircraft was subjected to an extensive repairs after it was involved in an accident on 29 August 2007. According to available information the aircraft had flown 134.2 hours since the aircraft was released to service following these repairs.

Photo of the aircraft displaying some of the damage suffered in a previous accident (29/08/2007).

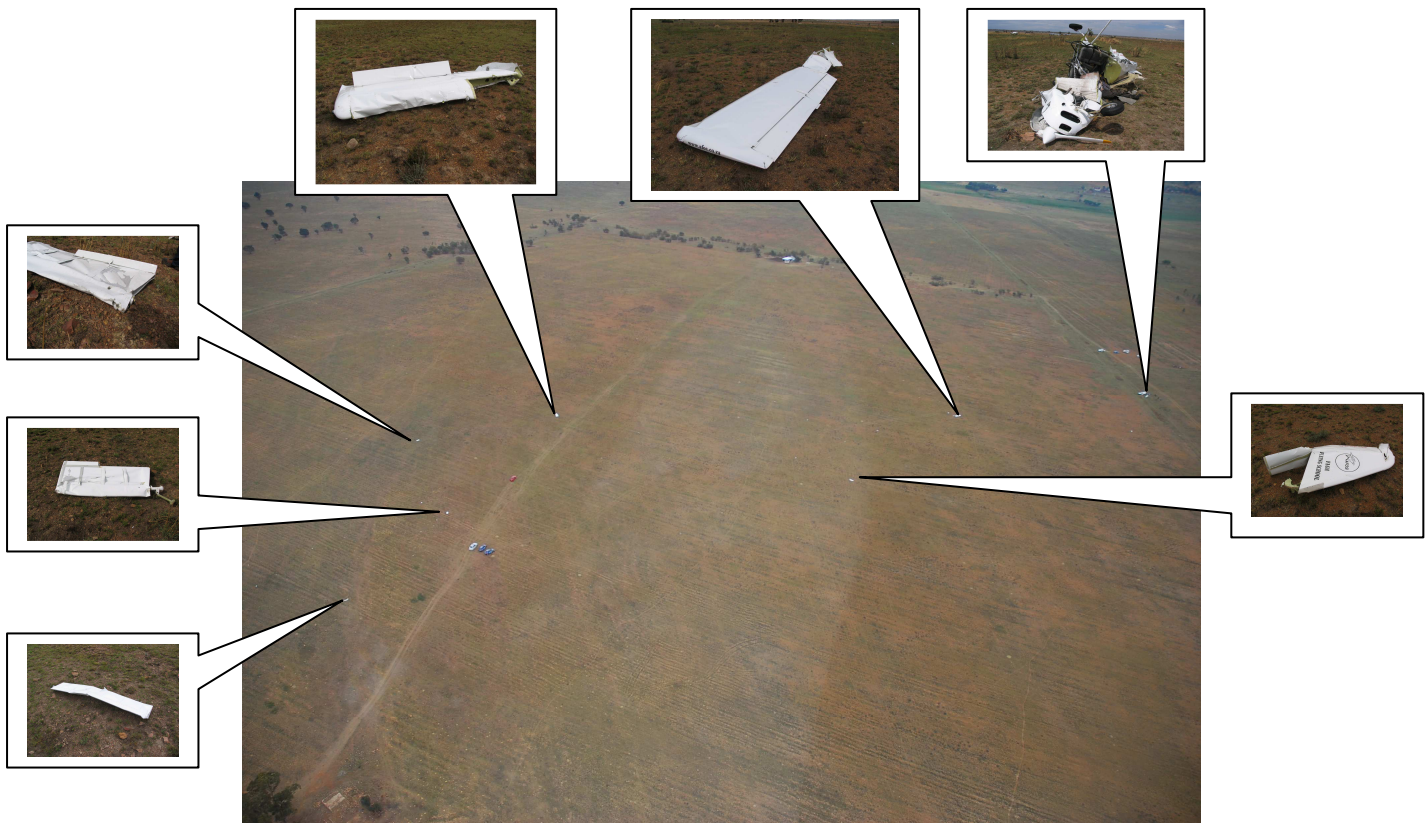
- 1.12.1 The main wreckage (fuselage) of the aircraft as well as several other failed flight surfaces was found in an open piece of grass land. The wreckage trail was in a north north-westerly direction with the main wreckage facing in a westerly direction. The debris was scattered over an area of approximately 710m in length. The aircraft was found to have broken up into ten (10) major sections.

Figure 4. An aerial view of the accident site.

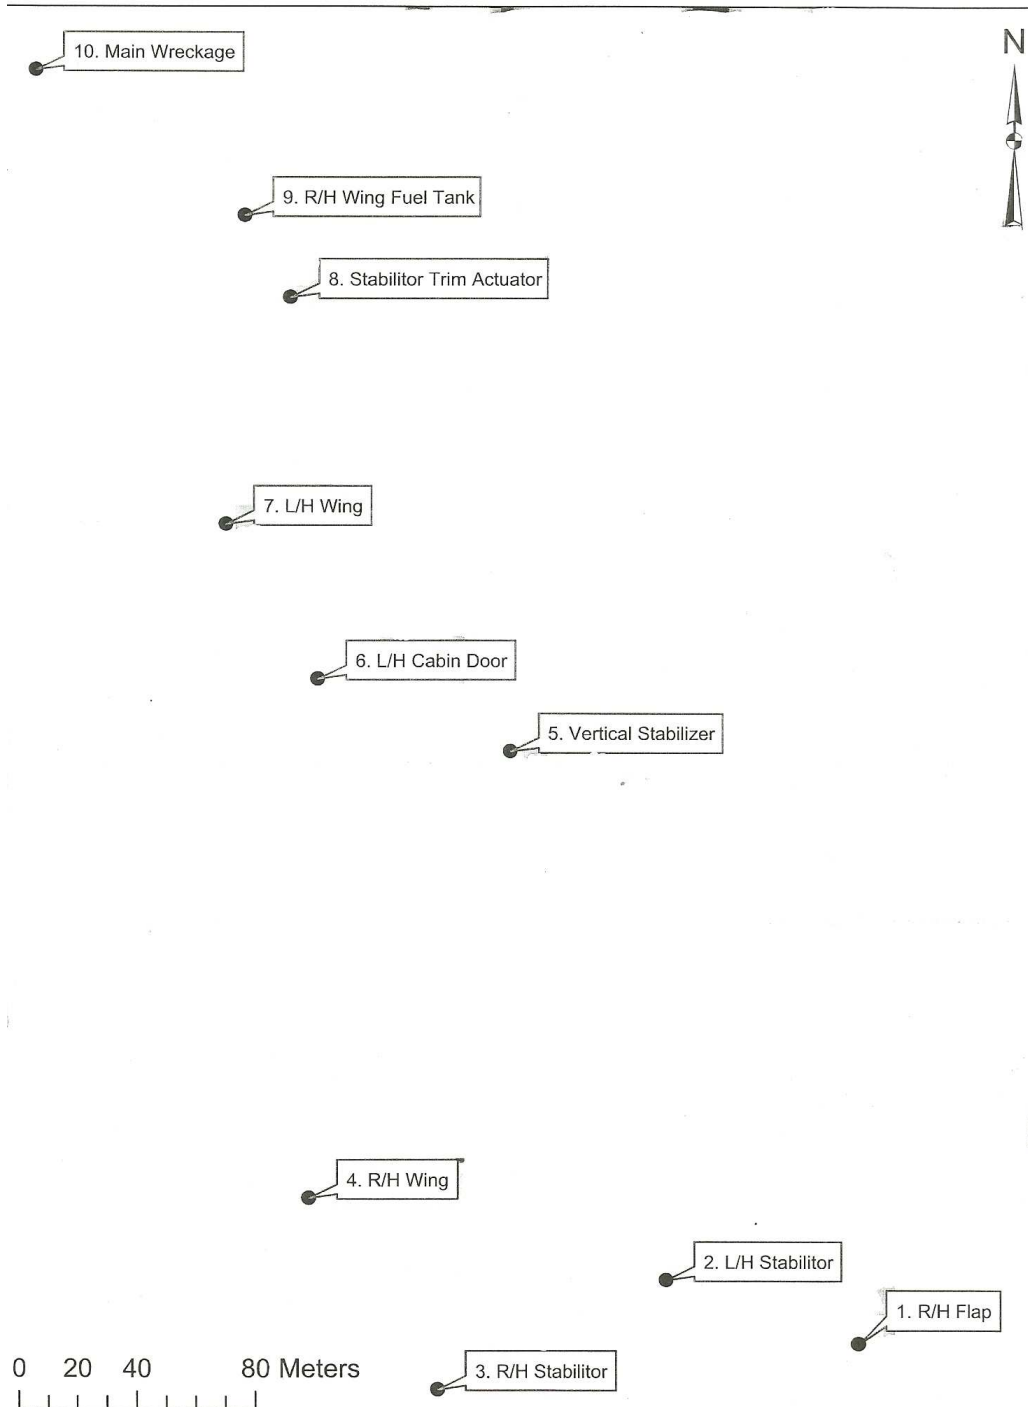
ANNEXURE A**Tecnam P92 S Echo**

- 1.12.2 These sections consisted of the main wreckage, left wing, right wing, vertical stabilizer, left horizontal stabilizer, right horizontal stabilizer, left cabin door, right wing flap, horizontal stabilizer trim actuator and right wing fuel tank.

- 1.12.5 The right wing, which was substantially more deformed than the left wing, was found 503 m from the main wreckage. The wing fuel tank as well as the flap assembly was found to have separated from the wing during the break-up sequence. With the fuel tank assembly being located 78 m from the main wreckage and the flap assembly was 710 m from the main wreckage.

- 1.12.6 The left horizontal stabilizer was 653 m and the right horizontal stabilizer was 650 m respectively from the main wreckage. The horizontal stabilizer trim actuator assembly was found 108 m from the main wreckage.

- 1.12.7 All major components of the aircraft were accounted for. A wreckage diagram could be found attached to this report as Annexure A.
