AIRCRAFT ACCIDENT REPORT AND EXECUTIVE SUMMARY

Reference	CA18/2/3/8579	
Aircraft Registration	ZS-WRF	Date of Accident	12 November 2008		Time of Accident	0715Z
Type of Aircraft	Beaver RX 650		Type of Operation		Private	
Pilot-in-command Licence Type		Microlight	Age	54	Licence Valid	Yes
Pilot-in-command Flying Experience		Total Flying Hours	473.3		Hours on Type	Unknown
Last Point of Departure		Henley Airfield, Gauteng				
Next Point of Intended Landing		Henley Airfield, Gauteng				
Location of the Accident Site with Reference to Easily Defined Geographical Points (GPS readings if possible)						
Plot 25, Klipview, Randvaal (GPS co-ordinates: S26°28.579' E028°03.086')						
Meteorological Information		Wind 340°TN at 5 kts, temperature 21°C, visibility 10 km				
Number of People on Board		1 + 1	No. of People Injured	0	No. of People Killed	2
Synopsis						
<p>On 15 November 2008, the pilot and a passenger took off on a local private flight from Henley Private Aerodrome with the intention of landing back at Henley Private Aerodrome.</p> <p>It was reported that the aircraft was doing a low fly-past within the perimeter of plot 25 in Klipview, Randvaal, when the nose pitched up as if the

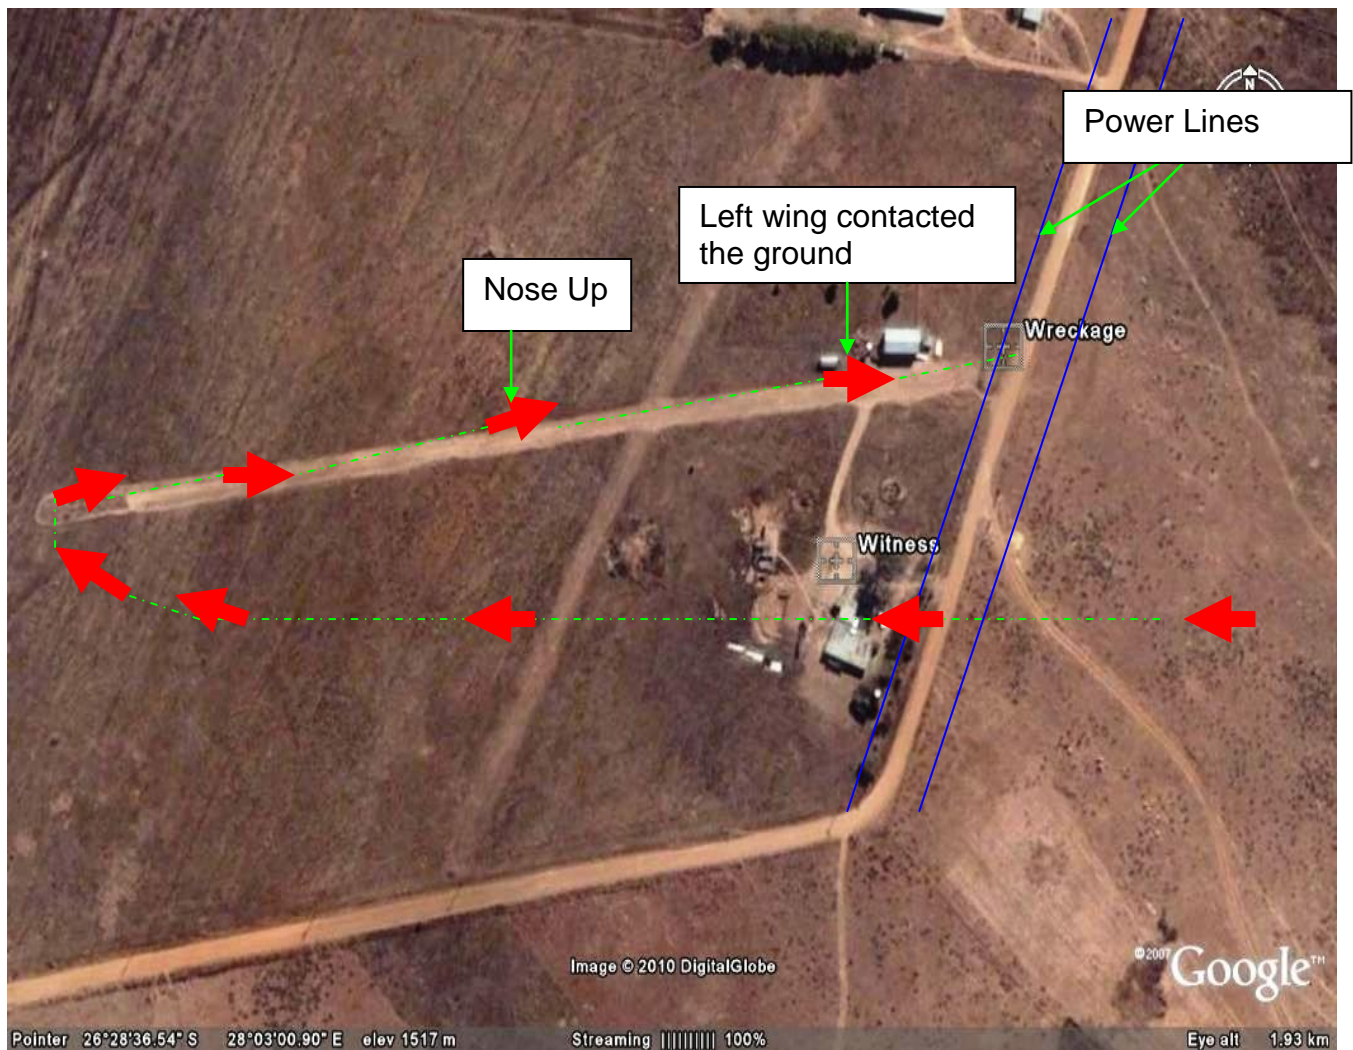
- 1.1.3 When the aircraft was halfway over the runway and at a height level to the house, the nose pitched up as if the pilot was attempting to fly over the power lines. The left wing flipped down and contacted the ground. The aircraft lost directional control and crashed. The pilot was fatally injured and the passenger was seriously injured. The passenger was taken to hospital where he died a few days later as a result of injuries sustained in the accident.

Figure 1: The approximate flight path, position of the witness and wreckage

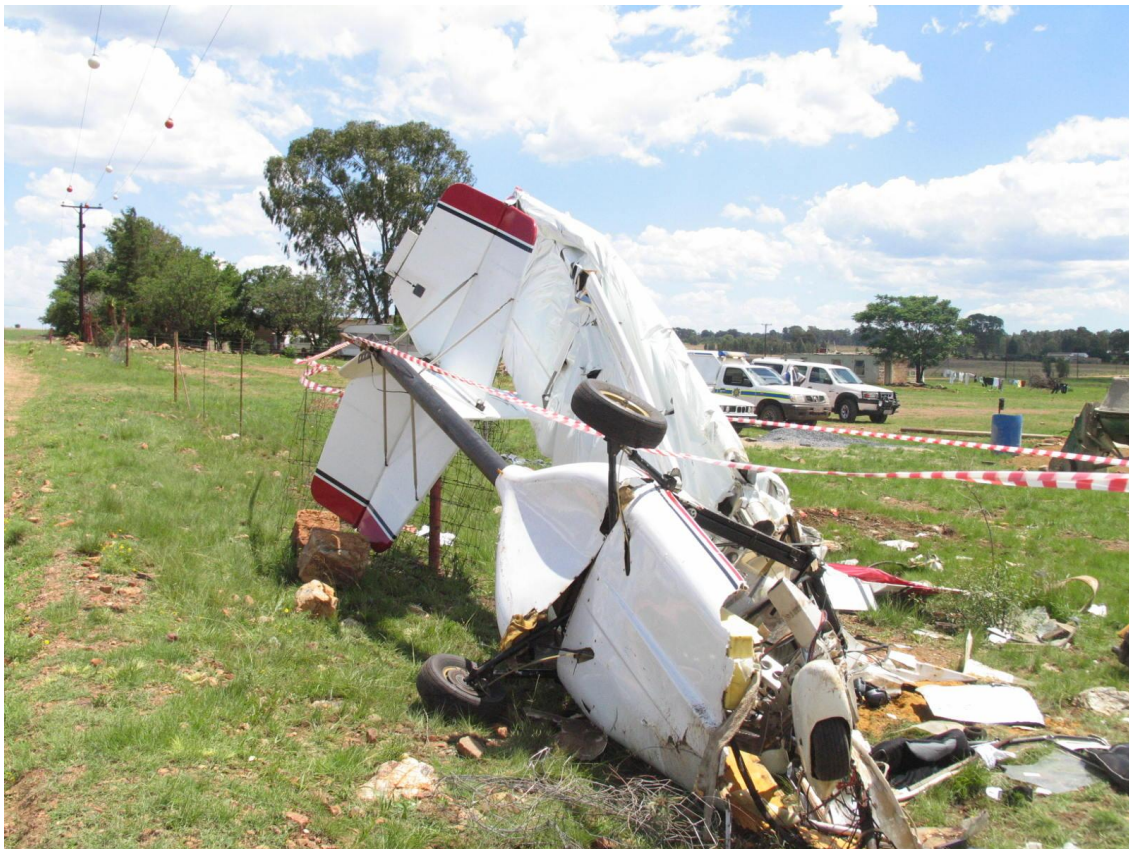
1.3.1 The aircraft was destroyed.

Figure 2: Damage to the aircraft

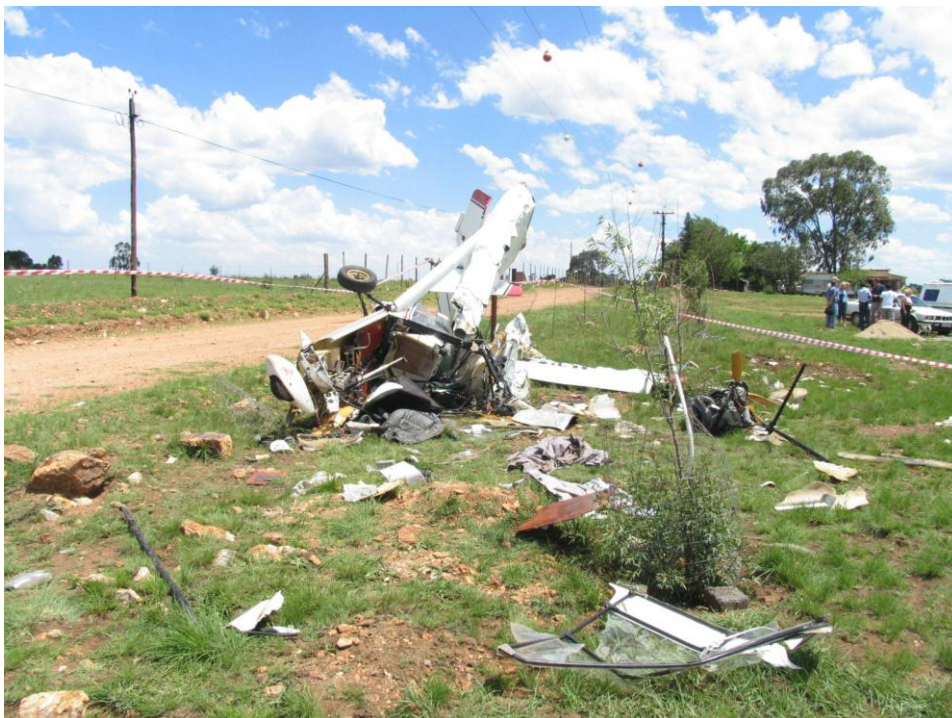
1.12.1 When the aircraft was halfway over the runway and at the approximate height of a house, the nose pitched up as if the pilot was attempting to fly over the power lines. The left wing flipped down and contacted the ground. The aircraft lost directional control and crashed into the ground on its left-hand side, and was stopped by the perimeter fence. The distance from where the wing first made contact with the ground to the main wreckage was approximately 25 m.

1.12.2 The cabin area was destroyed, the engine separated from the airframe and both the wings were destroyed.

Figure 3: The wreckage site and damage to aircraft
