AIRCRAFT ACCIDENT REPORT AND EXECUTIVE SUMMARY

Reference:	CA18/2/3/8606	
Aircraft Registration	ZS-BMG	Date of Accident	14 January 2009		Time of Accident	1328Z
Type of Aircraft	Beech Baron 58		Type of Operation		Private	
Pilot-in-command Licence Type		Airline Transport	Age	39	Licence Valid	Yes
Pilot-in-command Flying Experience		Total Flying Hours	7 979.1		Hours on Type	41.3
Last point of departure		Rand Aerodrome (FAGM)				
Next point of intended landing		Lanseria Aerodrome (FALA)				
Location of the accident site with reference to easily defined geographical points (GPS readings if possible)						
Runway 06R at FALA						
Meteorological Information		The weather was fine.				
Number of people on board	2 + 4	No. of people injured	0	No. of people killed	0	
Synopsis						
<p>On 14 January 2009, the pilot took off on a private flight from FAGM to FALA, where he was cleared to join on a right base for runway 06R. On the base leg, he lowered the landing gear and immediately heard a bang. The flight controls froze, aileron control was lost and the pilot could not turn the aircraft. He declared a Mayday, informing the Air Traffic Controller (ATC) of the problem. The green light indication

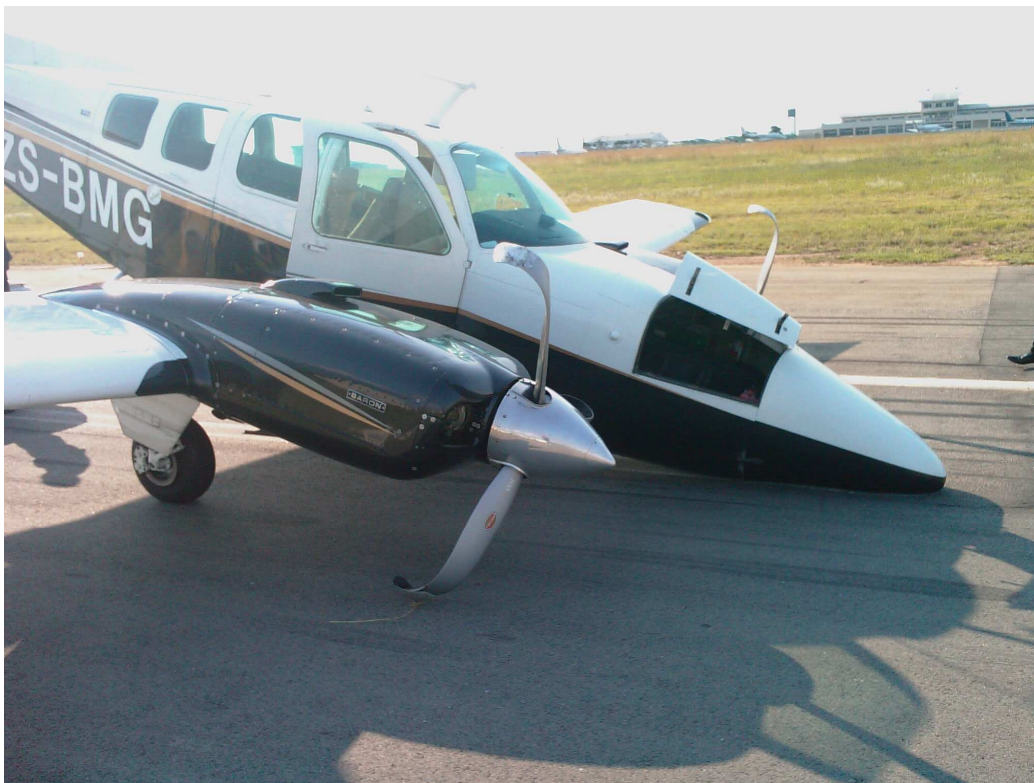
1.3.1 The aircraft sustained damage to the both propellers and the nose cone.

Figure 1. The aircraft after the landing with its nose wheel in a retracted position.

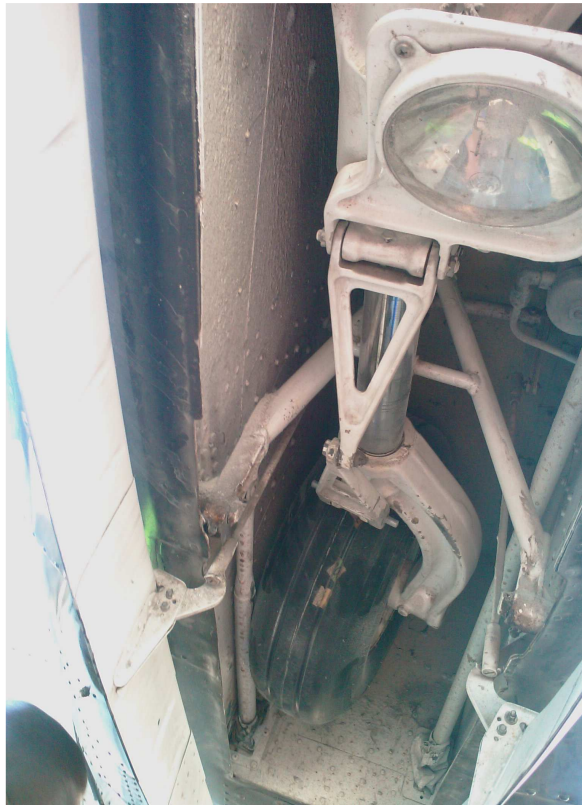
1.16.1 Inspection of the nose gear found that the nose wheel was stuck inside the wheel bay.

Figure 2. The nose wheel stuck in the wheel bay.

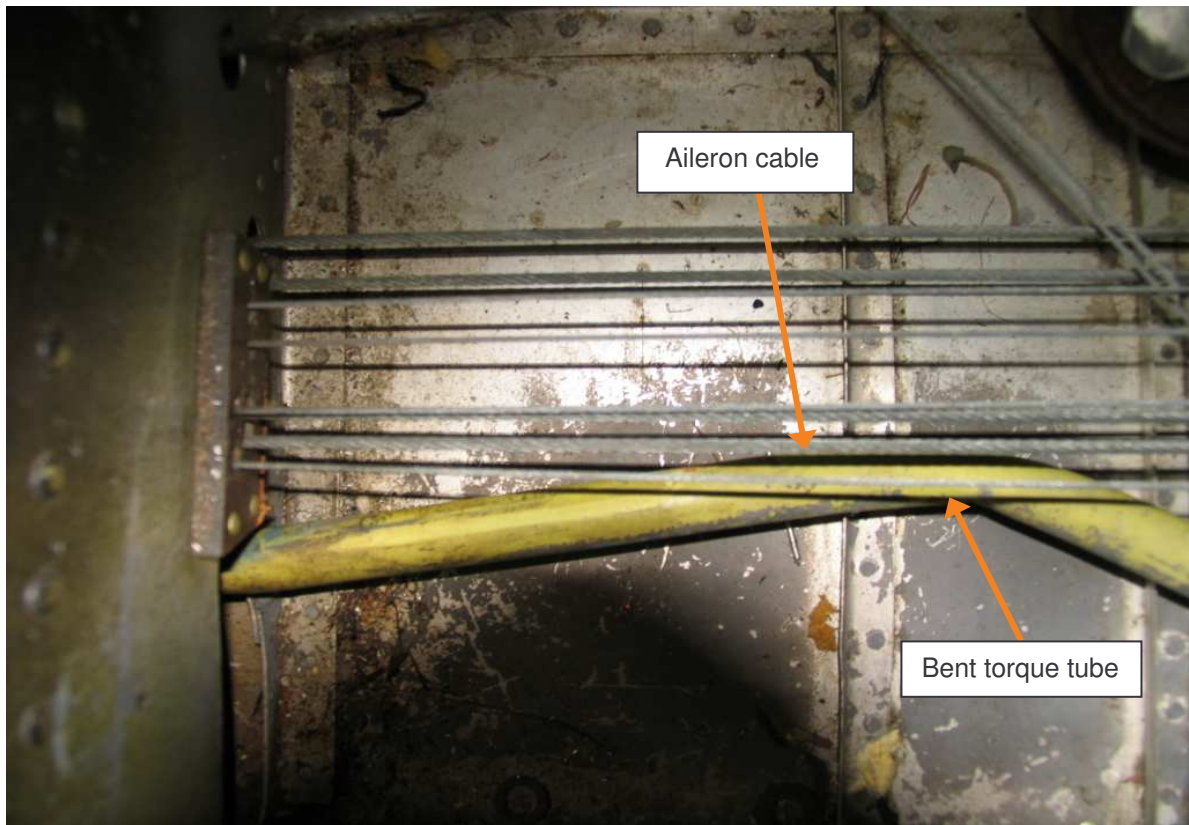
1.16.2 The torque tube was bent. It was also chuffed, indicating that it had rubbed against the aileron cable, and there was green paint on the cable showing where it had been in contact with the torque tube.

Figure 3. View of the wheel bay showing the cables and torque tube.

2.4.3 On arrival at FALA, the undercarriage was lowered during base leg and only the main landing gear extended. Because the nose wheel was stuck in the wheel compartment, the push-pull rod was unable to push the nose-gear; the torque tube bent and pressed against the aileron cable, resulting in a loss of aileron control. The aircraft landed with the nose gear still retracted, and the propellers struck the runway surface.

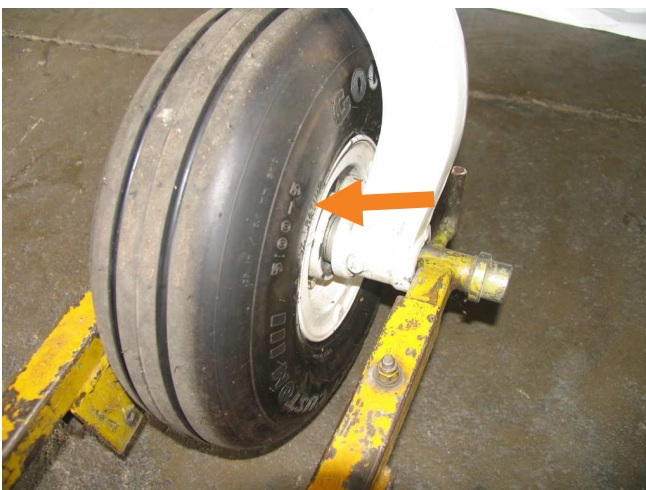
1.16.3 Further investigation revealed that the nose wheel was off-centre because two spacers, instead of one, had been inserted on the right-hand side of the wheel.

Figure 4. Two spacers on the right of the wheel.

2.4.1 The nose wheel was replaced after the tyre change, and two spacers were inserted on one side of the wheel, resulting in its being off-centre.

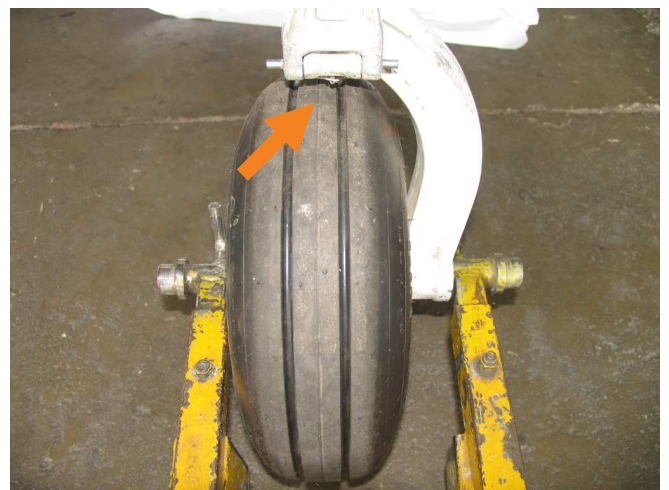
Figure 5. The wheel off-centre.

Make mention that of the fact that both spacers were inserted on one side and nothing on the other side.
