## AIRCRAFT ACCIDENT REPORT AND EXECUTIVE SUMMARY

REVISED REPORT 5 October 2010

Reference	CA18/2/3/8613	
<b>Aircraft Registration</b>	ZS-BRU	<b>Date of Accident</b>	14 February 2009		<b>Time of accident</b>	0730Z
<b>Type of Aircraft</b>	Cessna 182P		<b>Type of Operation</b>	Skydiving		
<b>Pilot-in-command Licence Type</b>		Commercial	<b>Age</b>	33	<b>Licence Valid</b>	Yes
<b>Pilot-in-command Flying Experience</b>		Total Flying Hours	344.5		Hours on Type	30.5
<b>Last point of departure</b>		Cato Ridge Aerodrome, (KwaZulu-Natal province).				
<b>Next point of intended landing</b>		Cato Ridge Aerodrome, (KwaZulu-Natal province).				
<b>Location of the accident site with reference to easily defined geographical points (GPS readings if possible)</b>						
Cato Ridge at KwaXimba village, GPS co-ordinates: S 29°40.272' E 030°37.183' Elevation 1476 feet AMSL.						
<b>Meteorological Information</b>		Surface wind: 030° at 3 knots; Temperature: 27°C; Visibility: +10 km.				
<b>Number of people on board</b>	1 + 6	<b>No. of people injured</b>	5	<b>No. of people killed</b>	1

<b>Probable Cause</b>						
Unsuccessful forced landing, following an engine failure in-flight.						
<b>Contributory

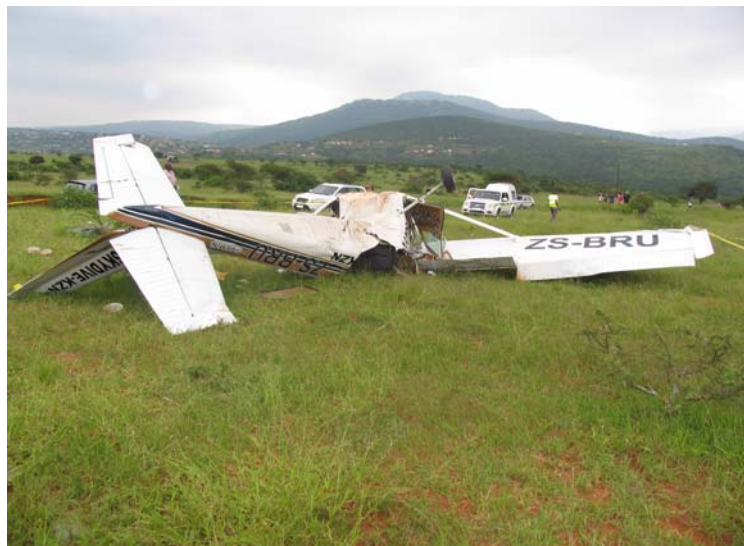
1.3.1 The aircraft was destroyed during the accident sequence.

Figure 2: View of the wreckage after impact.

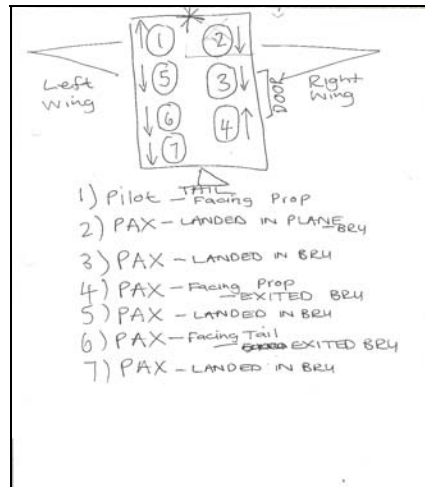
Figure 3: Indicating the seating arrangements on the accident aircraft

In this case, the front seat (co-pilot) and the rear seats were removed from the aircraft. As the passengers did not occupy any fixed seats, the centre of gravity (c of g) position could not be determined with any accuracy, but is not considered to have been a factor in the cause of the accident. With two skydivers leaving the aircraft, the aircraft weight would have been reduced accordingly with an associated forward movement of the c of g.

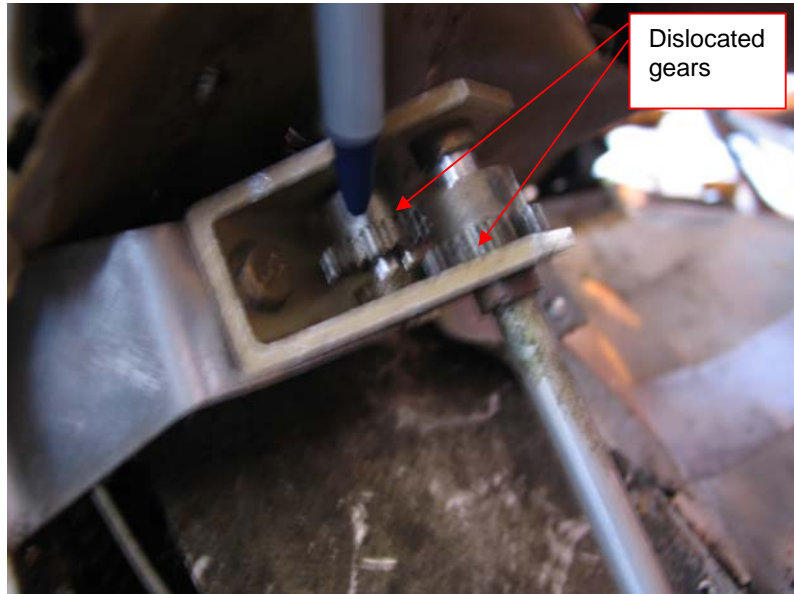
1.12.4 The destruction of the cockpit prevented the pre-impact position of the fuel selector and the fuel shut-off valve from being determined.

Figure 5: View of the fuel selector valve with dislocated gears under the cockpit floor panel.

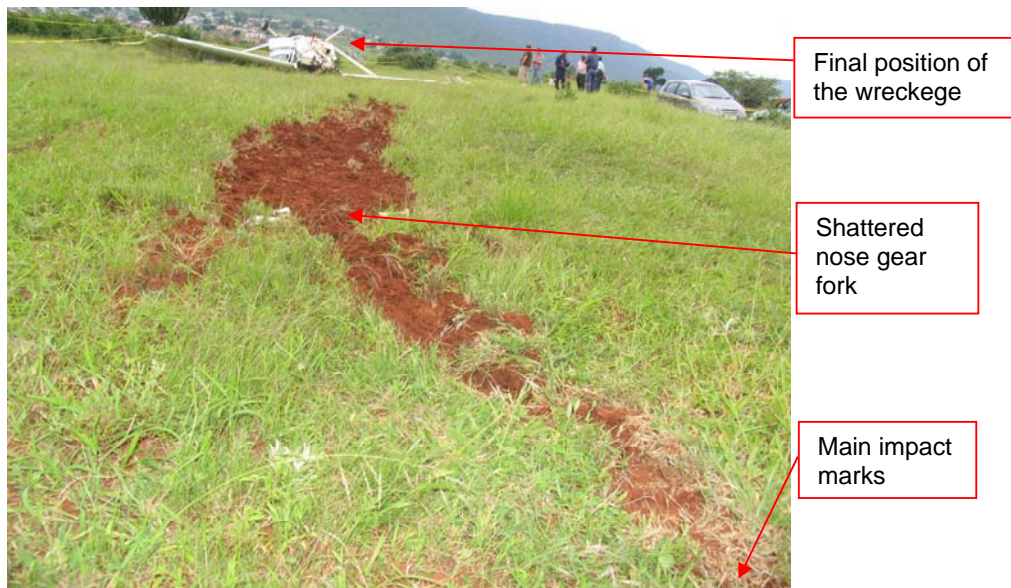
1.12.1 The aircraft struck the ground in a steep nose-down attitude and flipped over. Both wings and the fuselage showed severe damage. There was no evidence of in-flight structural failure.

Figure 6: First point of impact and final position of the main wreckage.

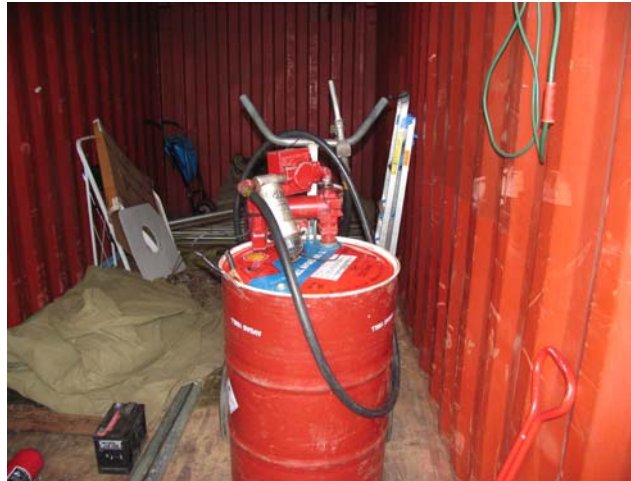
1.16.1 During the on-site investigation, fuel (AVGAS LL 100) for the reciprocating engine was found in both tanks. The aircraft was refueled from drums kept at the aerodrome in a shipping container and the possibility existed that the fuel could have been contaminated with water. Fuel samples were taken from both the aircraft's tanks and analysed. No abnormalities were found or identified. The remaining fuel quantity onboard the aircraft could however not be determined nor whether any water was present in the fuel tanks.

Figure 7: Indicating the drum from which the aircraft was refueled and way it was stored..

- 2.9 Although the aircraft was refuelled from drums kept at the aerodrome in a shipping container protected from the sun and weather, what is of concern was how the drums where stored. This is a potential hazard. If it is necessary to use this type of storage, the drums or cans should be stored off the ground and on their sides. Extraordinary precautions are necessary to eliminate the hazards of water and other contaminants.

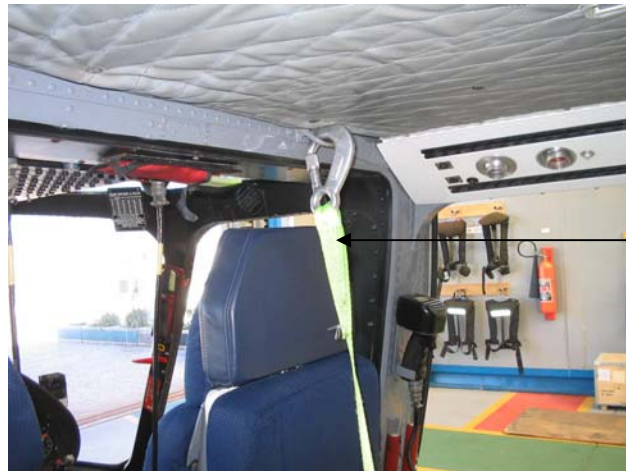
1.15.4 The passenger, a minor child who went along for the flight, was not properly restrained in the aircraft. During the investigation it was found that the child was “hooked up” and attached to a strong point in the aircraft with a monkey chain/belt. When the aircraft started experiencing problems, the child was released from the “hooked up” position and was sitting on the lap of the AFF student skydiver, whilst he was sitting on the floor of the aircraft with his back against the back of the pilot’s seat.

Monkey chain/belt attached to a strong point in the aircraft.

Figure 10: A view/illustration of a “monkey chain/belt” being secured to the roof structure of an aircraft.
