AIRCRAFT ACCIDENT REPORT AND EXECUTIVE SUMMARY

Reference:	CA18/2/3/8622	
Aircraft Registration	ZS-SVM	Date of Accident	3 March 2009		Time of Accident	0410Z
Type of Aircraft	Beechcraft B36TC		Type of Operation		Private	
Pilot-in-command Licence Type		Private	Age	58	Licence Valid	Yes
Pilot-in-command Flying Experience		Total Flying Hours	1 070.9		Hours on Type	8.6
Last point of departure		FAKM (Kimberley)				
Next point of intended landing		FALY (Ladysmith)				
Location of the accident site with reference to easily defined geographical points (GPS readings if possible)						
FAKM (Kimberley)						
Meteorological Information		According to the official weather report, fine weather conditions prevailed at the time and place of the accident				
Number of people on board	1 + 1	No. of people injured	0	No. of people killed	2	
Synopsis						
<p>On 3 March 2009, the pilot, accompanied by a passenger, intended to depart from Kimberley aerodrome to Ladysmith aerodrome as per his flight plan submitted to Kimberley ATC.</p> <p>It would appear that the engine lost power or failed during take-off and the pilot failed to maintain flying speed, resulting in the aircraft stalling and crashing.</p> <p

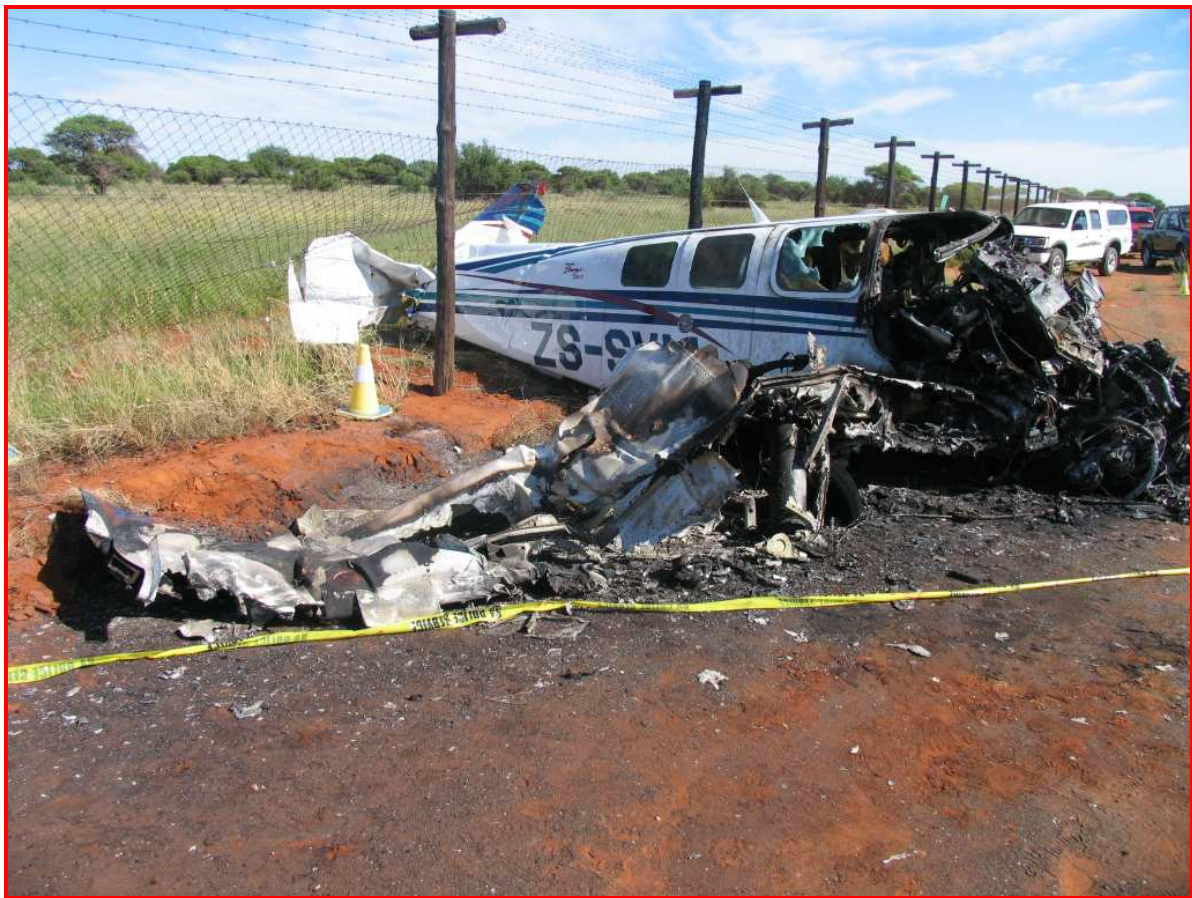
- 1.3.1 In addition to the impact damage, the aircraft also sustained extensive fire damage after the impact and was destroyed.

Figure 1. The wreckage after the accident.

- 1.14.1 The aircraft erupted in fire during the initial impact and was destroyed as a result of the post-impact fire. There were no indications of any in-flight fire.

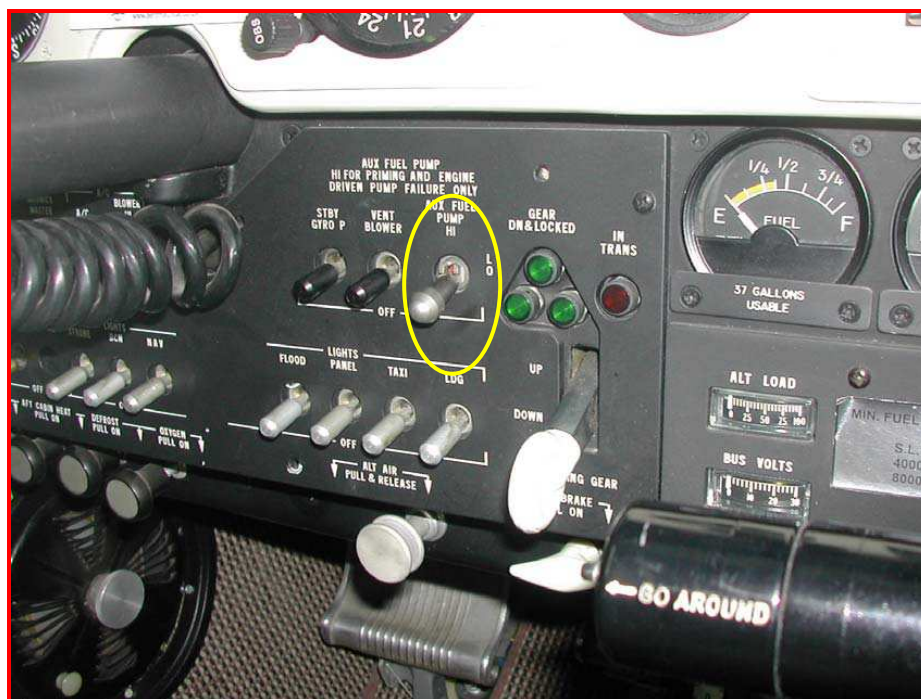
- 1.16.5.1 The auxiliary fuel pump switch is located to the left and next to the green lights indicating when the landing gear is down and locked. The landing gear selector lever is located to the right, below the green lights.
- 1.16.5.2 The photograph from the accident aircraft clearly shows the auxiliary fuel pump switch in the "HI" position and the landing gear selector in the DOWN position.
- 1.16.5.3 Inspection of the auxiliary fuel pump switch did not reveal any damage apart from fire damage.

Figure 2. The auxiliary fuel pump switch in the OFF position.

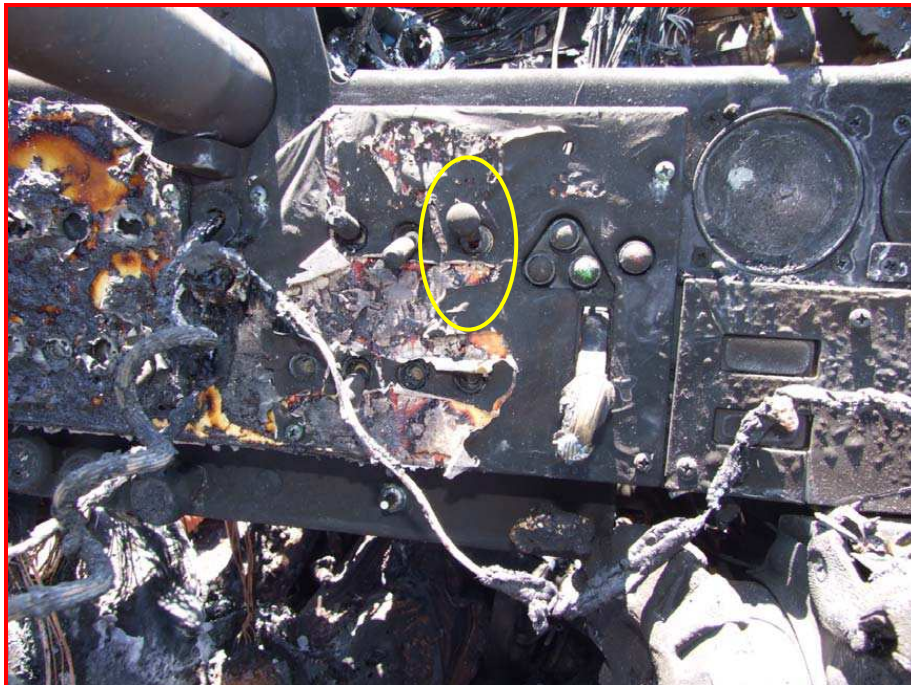
Figure 3. The auxiliary fuel pump switch in the HI position on the accident aircraft.

- 2.3 During follow-up testing, it was determined that the engine had failed 11 seconds after the electric auxiliary fuel pump was switched onto high at maximum power and with the mixture setting on full rich. The auxiliary fuel pump switch is located to the left and next to the green lights indicating when the landing gear is down and locked. The landing gear selector lever is located to the right, below the green lights. During the take-off, the aircraft was observed to perform abnormal manoeuvres before it nose-dived into the ground. With the above in mind, it is the opinion of the investigator-in-charge that the pilot intended to retract the landing gear after rotation but accidentally switched the auxiliary fuel pump on to the high position. This would have resulted in the engine losing power or even failing as a result of an over-rich mixture setting. At the time, the pilot most probably attended to the reason for the engine power-loss and failed to maintain flying speed, which resulted in the aircraft stalling. All of the above occurred at low altitude and the pilot had insufficient time to effect a recovery.

- 2.4 Except for fire damage, there was no indication of any other damage to the auxiliary fuel pump switch. This is a “gated” switch, i.e. it must be pulled out before it can be switched into a different position. Bumping it upwards would cause damage to the switch. Since there was no damage evident, other than fire damage, it can be assumed that the switch was accidentally switched on by the pilot.

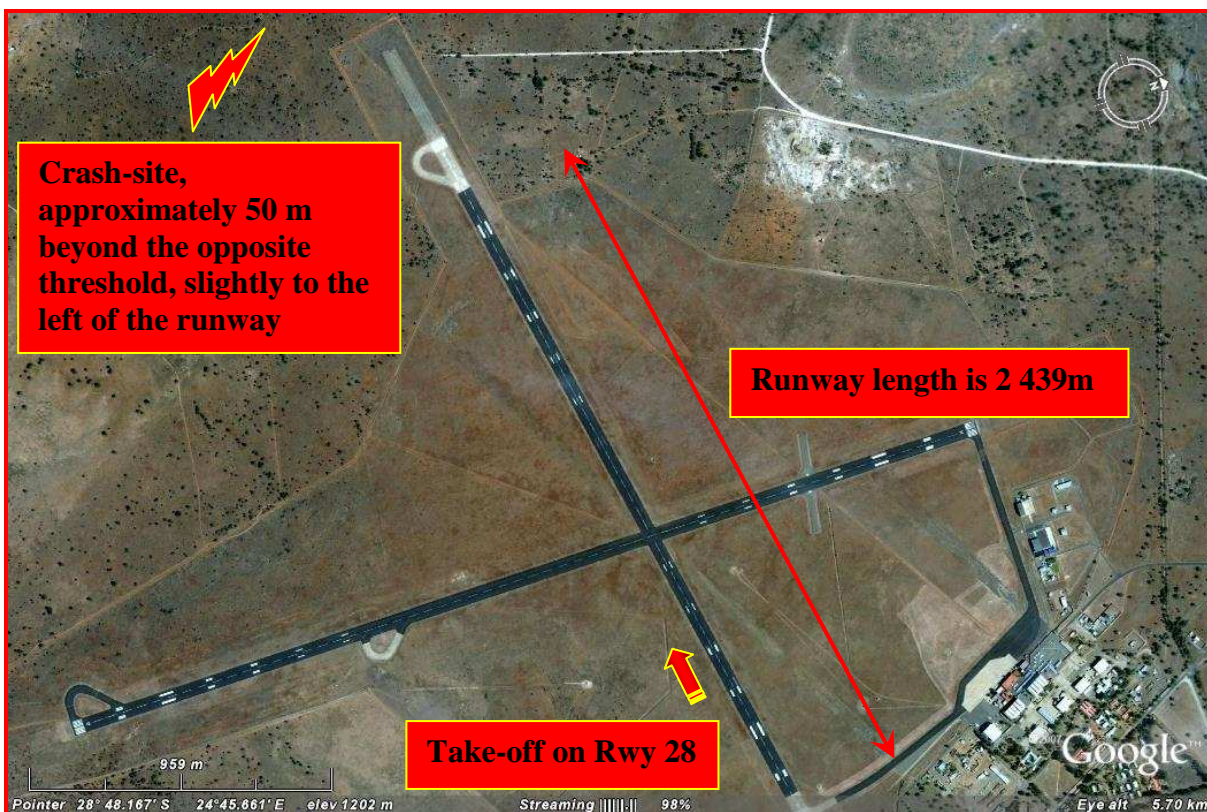
- 1.12.1 The aircraft struck the ground approximately 50 m beyond the threshold of Runway 10 in a nose-down and left-wing-low attitude. It then swung around to face in a direction of approximately 100°M.
- 1.12.2 The tail section of the aircraft made contact with the airport perimeter fence.

- 1.18.7 The aircraft rotated before the intersection of Runway 02/20. Passing west of the intersection (approximately 50 m), still on the runway heading, the pilot called "Mayday, Mayday!".
- 1.18.8 Airports Company South Africa (ACSA) were alerted and the ATC observed the aircraft sinking towards the runway. The aircraft regained altitude to about 200 ft but the left wing dropped by 45°. The pilot recovered the aircraft to straight and level flight.
- 1.18.9 After reaching the upwind threshold of Runway 28, the aircraft crashed left to the centreline of Runway 28 and exploded on impact.
- 1.18.10 The fire and rescue services were on the scene at 0612Z, a mere 1 minute after being alerted of the emergency.
- 1.18.11 The pilot submitted a flight plan at Kimberley Aerodrome for a flight from Kimberley to Ladysmith.

Figure 4. The runway used for take-off and the position of the accident site.
