AIRCRAFT ACCIDENT REPORT AND EXECUTIVE SUMMARY

Reference:	CA18/2/3/8650	
Aircraft Registration	ZU-ERJ	Date of Accident	12 May 2009		Time of Accident	0800Z
Type of Aircraft	Savannah Z236		Type of Operation		Private	
Pilot-in-command Licence Type		Microlight	Age	62	Licence Valid	Yes
Pilot-in-command Flying Experience		Total Flying Hours	314,3		Hours on Type	31,7
Last point of departure		Summit Aerodrome				
Next point of intended landing		Summit Aerodrome				
Location of the accident site with reference to easily defined geographical points (GPS readings if possible)						
Runway 01 at Summit Aerodrome in Midrand Gauteng, (GPS position S25°55'59,0" E028° 04'34,0")						
Meteorological Information		Fine weather prevailed, Temperature: 18 °C; Wind speed: light and variable; Visibility: CAVOK				
Number of people on board	1 + 0	No. of people injured	0	No. of people killed	0	
Synopsis						
<p>On 12 May 2009, the pilot, who was the sole occupant on board, was on a private flight when the incident occurred.</p> <p>According to the pilot, he elected to land on Runway 01 which was the first time he was landing on it. With the wind conditions reported being calm, the pilot stated that it wa

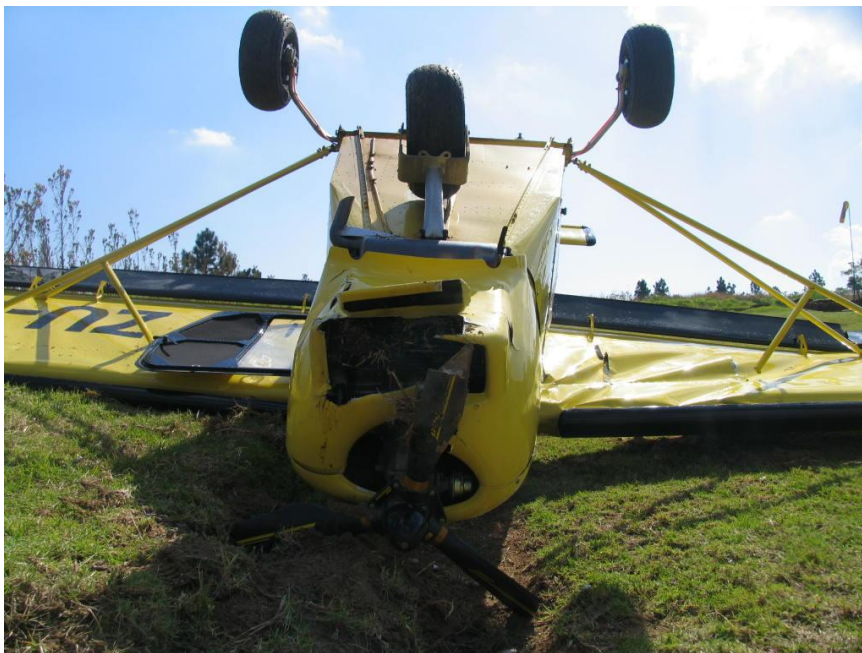
1.3.1 The aircraft sustained damage to the wings, propeller and nose gear.

Photo 1: Broken propeller, collapsed nose gear and damaged wings

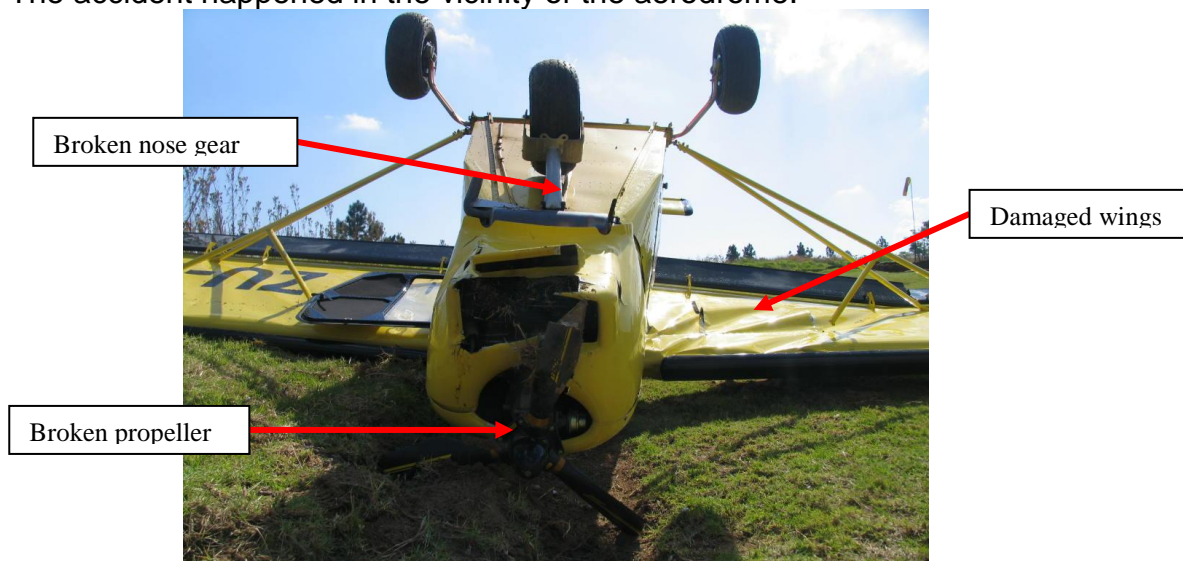
Photo 2: Showing damage to the aircraft

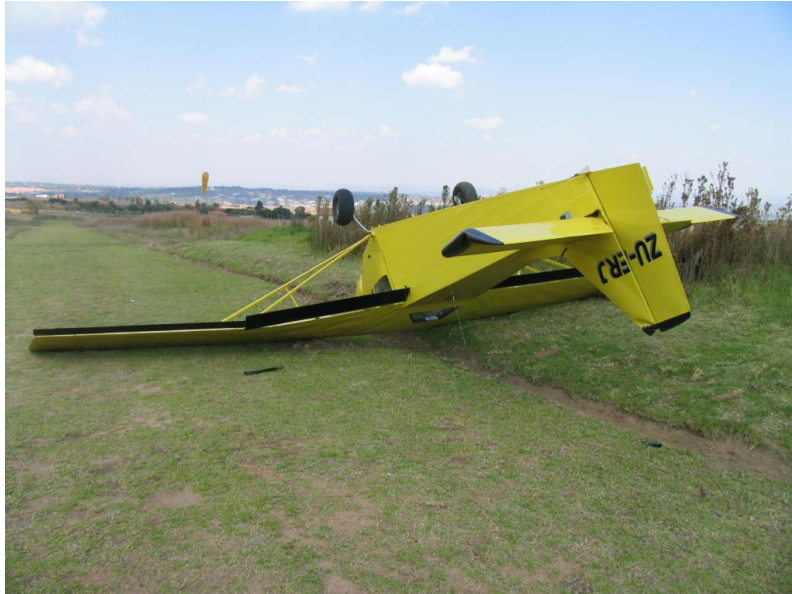
1.12.2 The aircraft landed on Runway 01 and veered off to the left. The left wheel caught a ditch on the runway edge, resulting on the aircraft flipped over and came to rest in an inverted position.

Photo 3: Showing inverted aircraft

2.5 The pilot made an error of judgement while landing on a runway with an upward slope. It was his first landing on this runway and he lost directional control during the landing, followed by the left wheel entering a ditch. The propeller hit the ground, and the nose gear to break off and the aircraft to flip over.

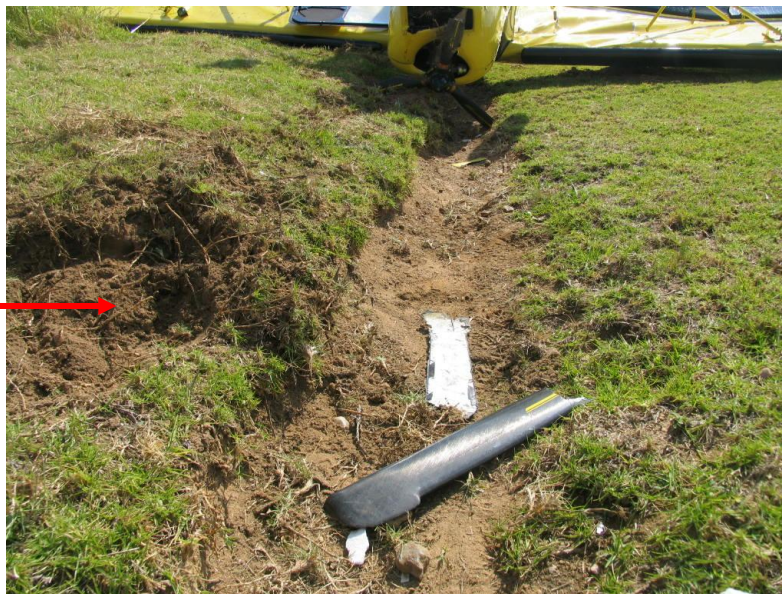
Propeller strike

1.12.3 The propeller struck the ground.

Photo 4: Showing the propeller impact
