AIRCRAFT ACCIDENT REPORT AND EXECUTIVE SUMMARY

Reference:	CA18/2/3/8656	
Aircraft Registration	ZS-LTJ	Date of Accident	18/05/2009		Time of Accident	1000Z
Type of Aircraft	Cessna 210N		Type of Operation		Private	
Pilot-in-command Licence Type		Commercial	Age	39	Licence Valid	Yes
Pilot-in-command Flying Experience		Total Flying Hours	1 056		Hours on Type	20
Last point of departure		Private runway near Moketsi, Limpopo Province				
Next point of intended landing		Tzaneen Aerodrome (FATZ), Limpopo Province				
Location of the accident site with reference to easily defined geographical points (GPS readings if possible)						
Runway 24 Tzaneen Aerodrome (S 23° 49.413' E 030° 19.505;), at an elevation of 1 914 ft						
Meteorological Information		Surface wind 225°M at 5 kts, visibility >10 km, temperature 22°C				
Number of people on board	1 + 0	No. of people injured	0	No. of people killed	0	
Synopsis						
<p>On 18 May 2009, the aircraft was flown on a ferry flight from a private aerodrome near Moketsi to Tzaneen Aerodrome (FATZ).</p> <p>The pilot elected to land on runway 24 at Tzaneen Aerodrome (FATZ). Approximately 800 m after the aircraft touched down, both main landing gear struts

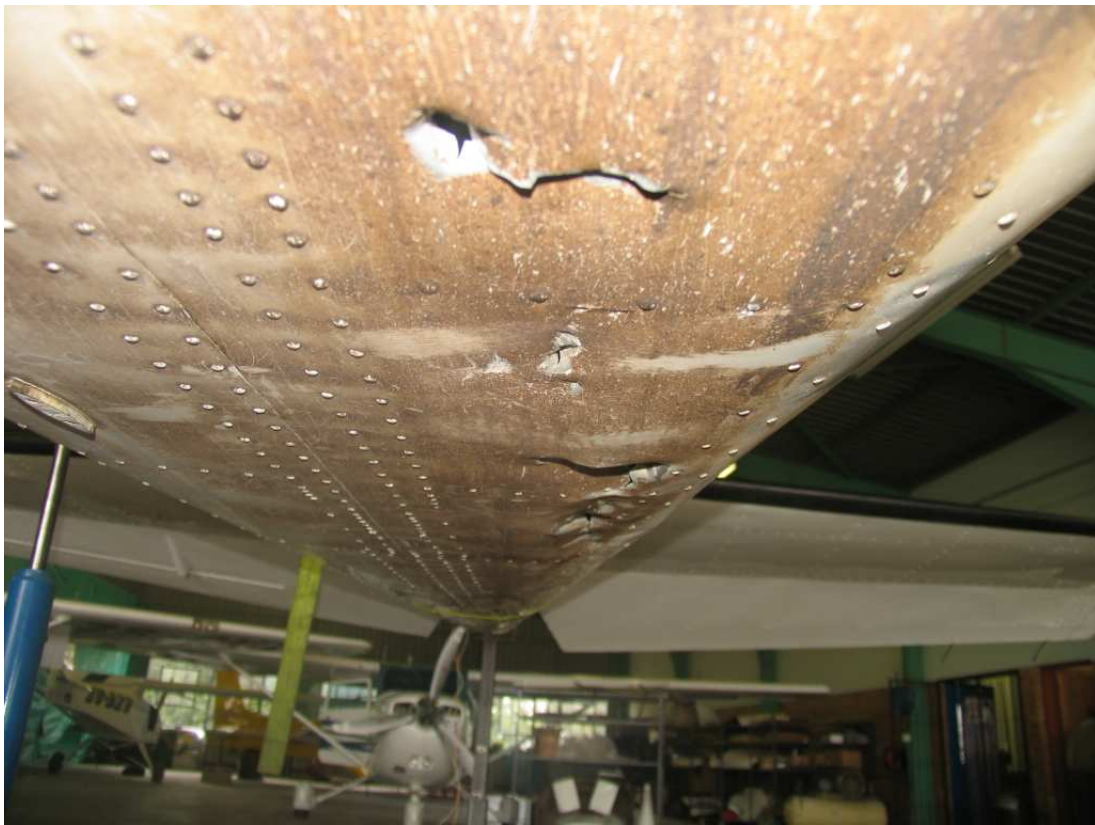
- 1.3.1 Damage was caused to the lower fuselage area and the right-hand horizontal stabiliser (Figure 2 and Figure 3).

Figure 2: Damage to the lower fuselage of the tail section

- 2.10 Due to the low speed at the time the landing gear collapsed, only minor damage was caused to the horizontal stabiliser and the underside of the tail section.

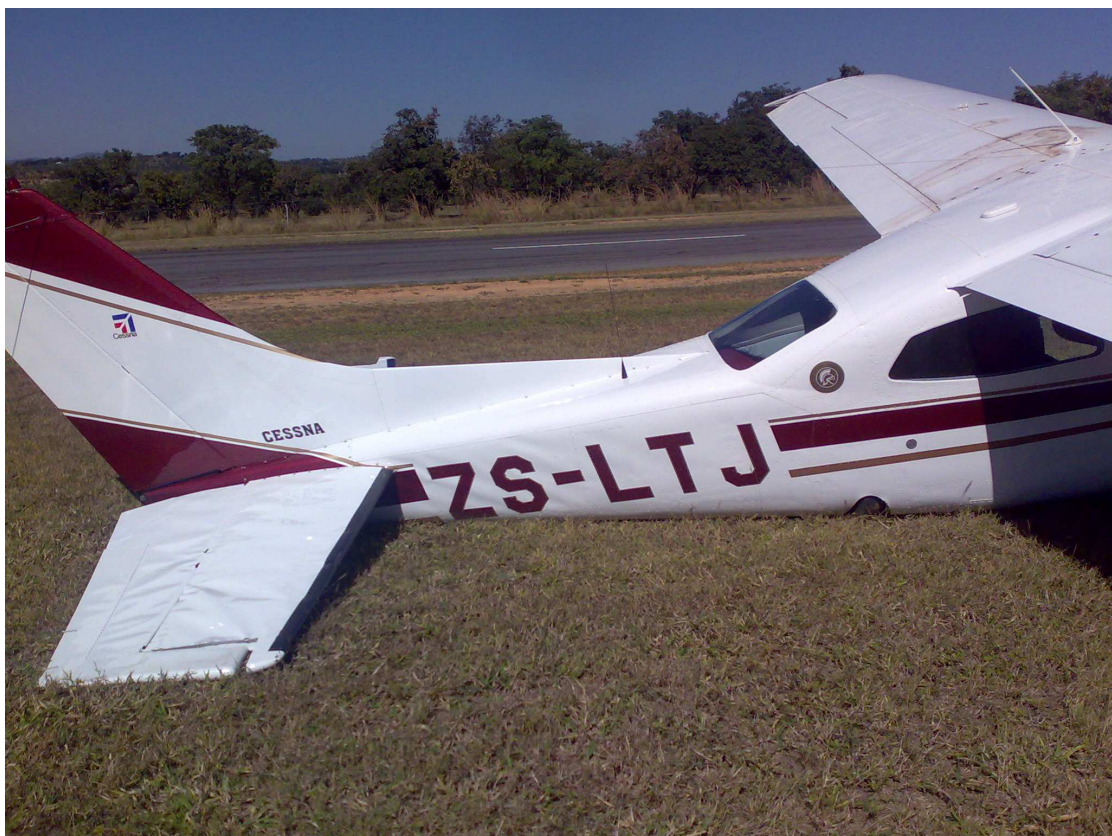
Figure 3: Damage to the right-hand horizontal stabiliser
