AIRCRAFT ACCIDENT REPORT AND EXECUTIVE SUMMARY

Reference:	CA18/2/3/8661	
Aircraft Registration	ZS-RJW	Date of Accident	03 June 2009		Time of Accident	0850Z
Type of Aircraft	Alouette III SE 3160		Type of Operation		Ferry Flight	
Pilot-in-command Licence Type		Commercial	Age	31	Licence Valid	Yes
Pilot-in-command Flying Experience		Total Flying Hours	500.0		Hours on Type	400.0
Last point of departure		Stutterheim – Eastern Cape				
Next point of intended landing		Hogsback – Eastern Cape				
Location of the accident site with reference to easily defined geographical points (GPS readings if possible)						
Hogsback landing zone.						
Meteorological Information		Surface wind: light variable, Temperature: 11°C, Visibility: <10000m, Cloud cover: 7/8, Cloud base: 7500 feet.				
Number of people on board	1 + 1	No. of people injured	0	No. of people killed	0	
Synopsis						
<p>On Wednesday, 03 June 2009 at 0630Z, an Alouette III ex-military helicopter took off from an open grass field at Stutterheim and flew in a westerly direction to Hogsback. The pilot accompanied by a passenger flew the helicopter on a ferry flight which was under Visual Flight Rules by day. The initial information about

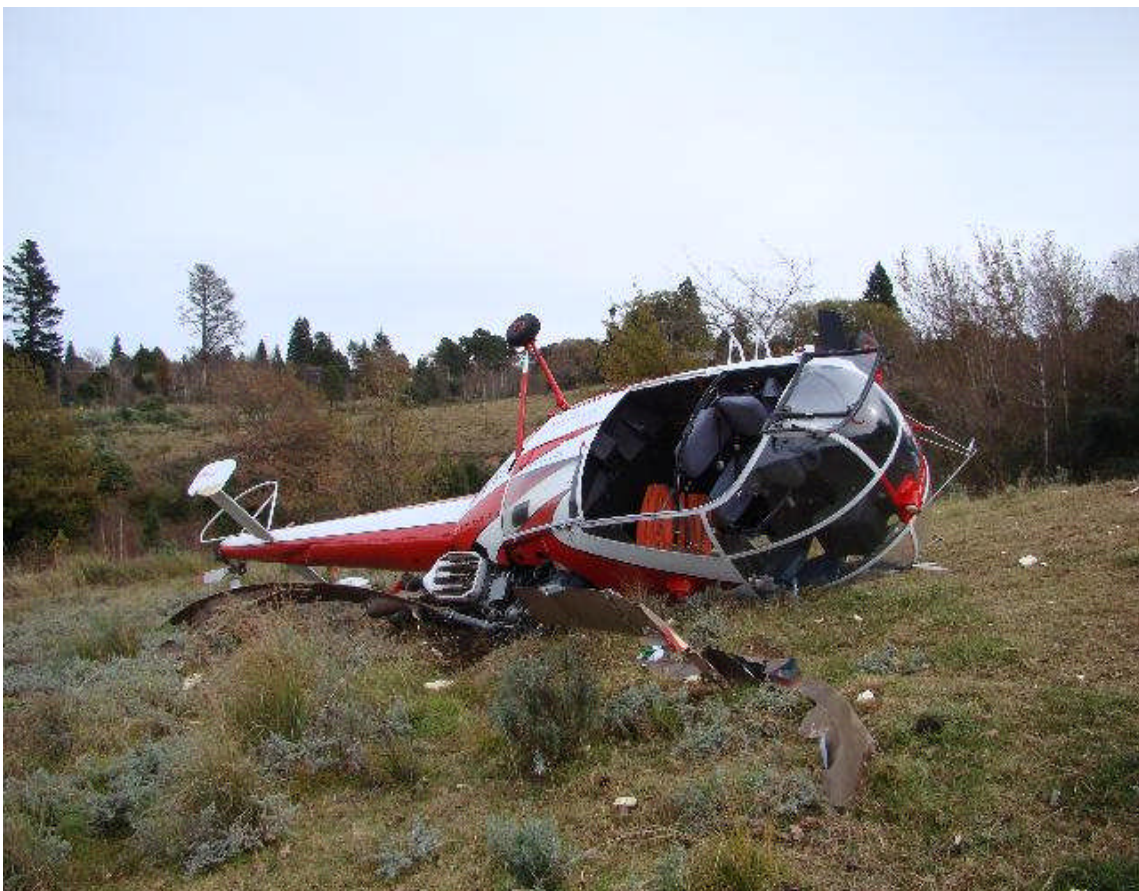
1.3.1 The helicopter sustained substantial damage in the accident.

Figure 1: Showing damage caused to helicopter.

1.12.1 The helicopter was approaching an open grass field for landing at Hogsback. When the landing gear touched down on the ground, the torque of the main rotor caused the helicopter to yaw and roll over onto its right side and the rotor struck the ground. The helicopter sustained substantial impact damage. The damage caused to the structure was mainly to the right side of the airframe. The main and tail rotors of the helicopter were still rotating when it rolled over onto its right side. The rotor blades struck ground and damaged. The engine was also damaged as a result of the accident. The damage caused to the engine was due to the helicopter rolling over onto the right side.

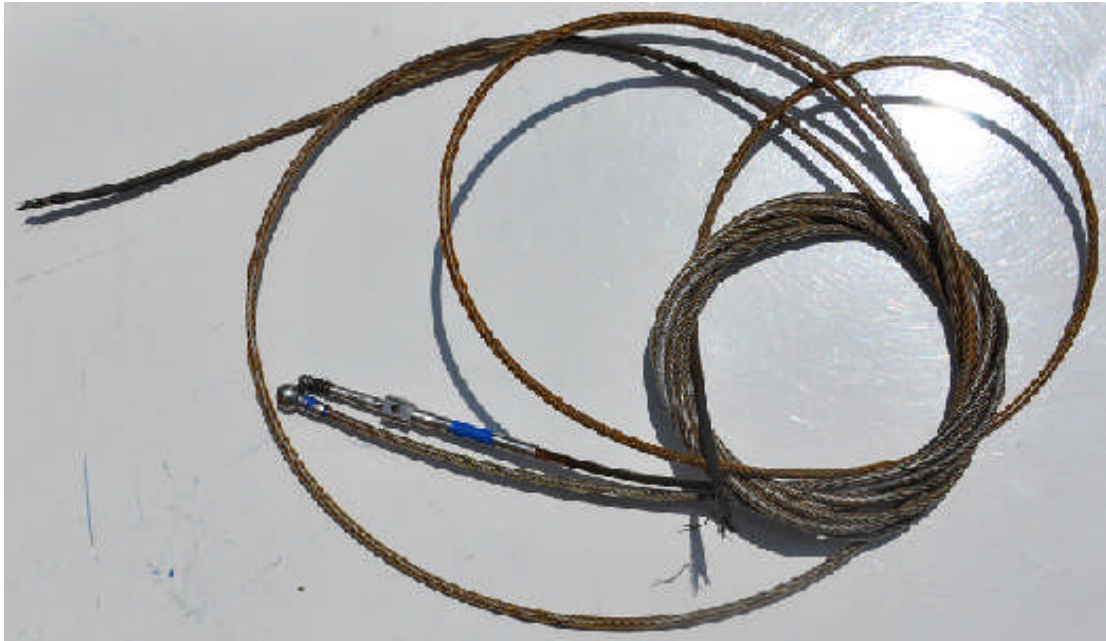
- 1.6.8 During the recovery of the wreckage from the accident site, it was established that one of the tail rotor control cables had failed. The broken tail rotor cable was removed from the wreckage for further investigation.

Figure 2: Showing tail rotor cable removed from wreckage.

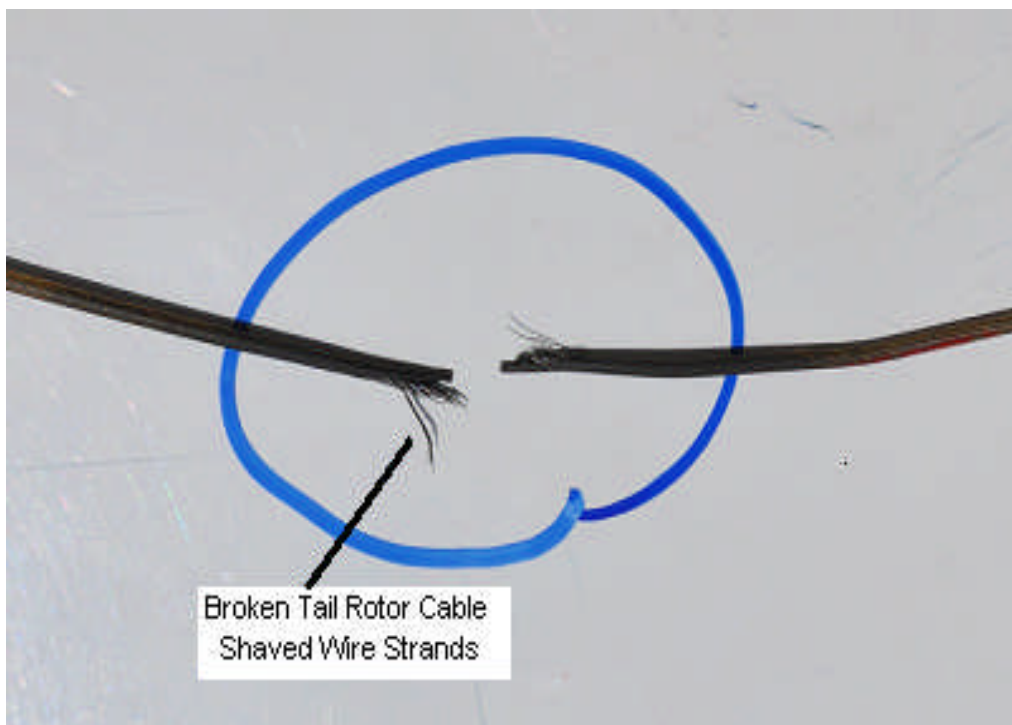
Figure 3: Indicating area where cable broke or shaved through the wire strands.

- 1.16.5 After the tail rotor cable was closely examined, it was found that the control cable was covered by mixture of dust and oil. The substance was on the cable but limited to the area where contact is made with the pulley. Both the cable and pulley are supposed be uncontaminated and have smooth surface. It appears as though the mixture of dust and oil on the cable became a sticky compound which resulted in roughness between the two moving parts and contributed to the destruction of the protective material around the cable. Friction between the parts generated heat and eventually weakening the structure of the control cable. The control cable chafed through and broke.

- 3.1.13.1 The tail rotor cable failed.
- 3.1.13.2 There was a contaminant that appeared like combination of dust and oil on the cable.
- 3.1.13.3 The cable broke as a result of friction between the cable and pulley. The cable chafed through and failed.

- 3.2.1 There was combination of dust and oil found on the tail rotor cable and pulley, which resulted in friction between the two parts.

- 1.16.6 According to maintenance manual, the cable should be tensioned correctly. All dust and oil should be cleaned from the cable and pulleys during maintenance. The pulleys should be rotated to change the area of contact between the cable and pulley. These actions will prevent development of a groove into the pulley by the cable.

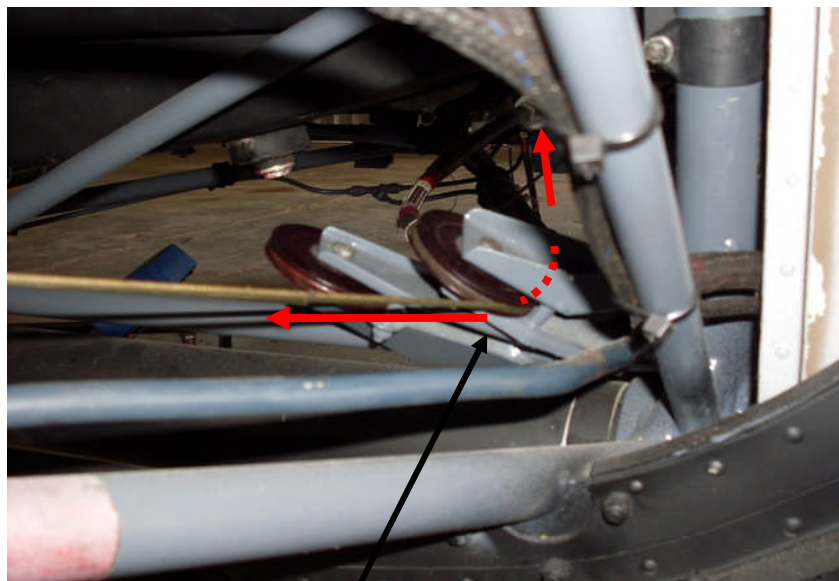
1.16.4 The helicopter was examined in the investigation to determine which location on the airframe, the cable broke. It was found that the cable broke at the first set of pulleys underneath in the floor structure of the helicopter. Based on the fact that the pulleys were not easily accessible, it was not possible for the pilot to detect any problems with the tail rotor cable during the pre-flight inspection of the aircraft. The identified location in the floor of the helicopter will only be inspected during routine maintenance or at Mandatory Periodic Inspection (MPI).

Figure 7: Showing location where the tail rotor control cable failed at the pulley.
