AIRCRAFT ACCIDENT REPORT AND EXECUTIVE SUMMARY

Reference: CA18/2/3/8686	
Aircraft Registration	ZU-RIT	Date of Accident	30 August 2009		Time of Accident 0728Z
Type of Aircraft	Sanka AK 1-3		Type of Operation		Private
Pilot-in-command Licence Type		Commercial	Age	49	Licence Valid Yes
Pilot-in-command Flying Experience		Total Flying Hours	1 017		Hours on Type 178.9
Last point of departure		Klaserie, Limpopo Province			
Next point of intended landing		Rhenosterkop, Nelspruit, Mpumalanga Province			
Location of the accident site with reference to easily defined geographical points (GPS readings if possible)					
Heidelberg Valley, 5 km from White River. GPS coordinates: S25°21.277' E030°57,972')					
Meteorological Information		Surface wind: 270°/4 kts; Temperature: 23°C; Visibility: CAVOK			
Number of people on board	1 + 2	No. of people injured	0	No. of people killed	1 + 2
Synopsis					
<p>On 30 August 2009, the pilot and two passengers were on a private flight from Klaserie in Limpopo to Rhenosterkop near Nelspruit. At 0711Z, the pilot established radio contact with Kruger Mpumalanga International tower on frequency 119.2 MHz, stating that he was inbound from Klaserie, and requesting

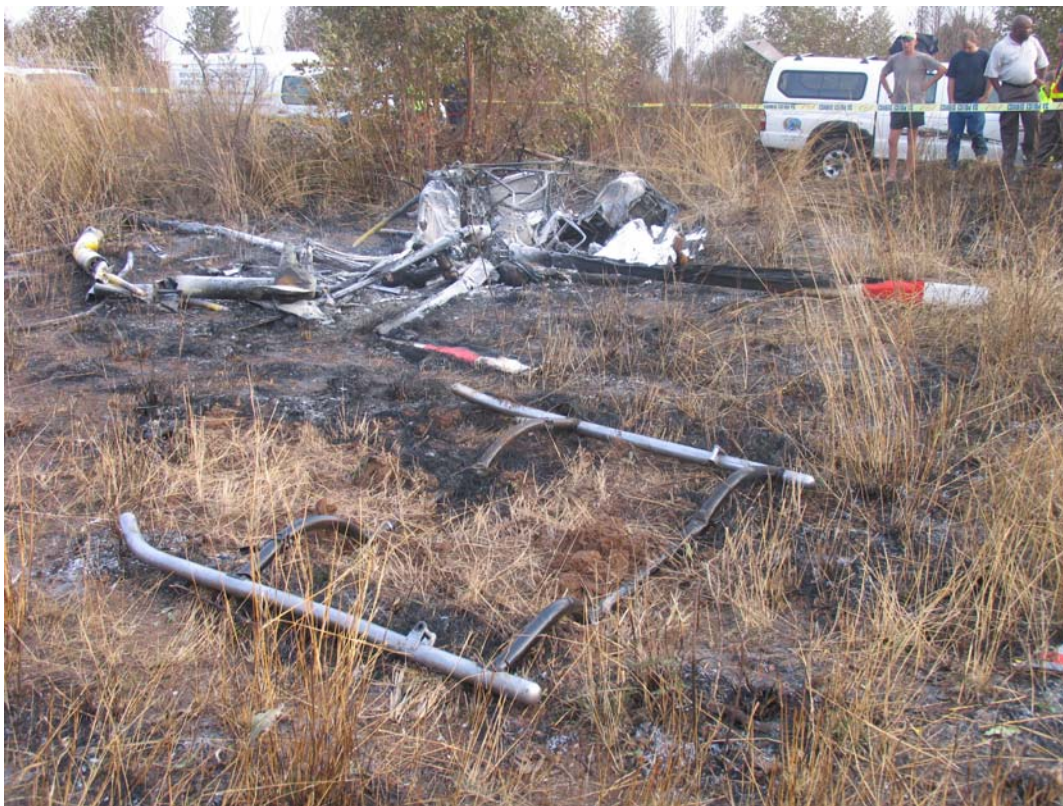
1.3.1 The helicopter was completely destroyed on impact and by the post-impact fire.

Figure 1. The wreckage of the helicopter.

- 1.14.1 A post-impact fire erupted during the impact sequence and destroyed what remained of the aircraft.

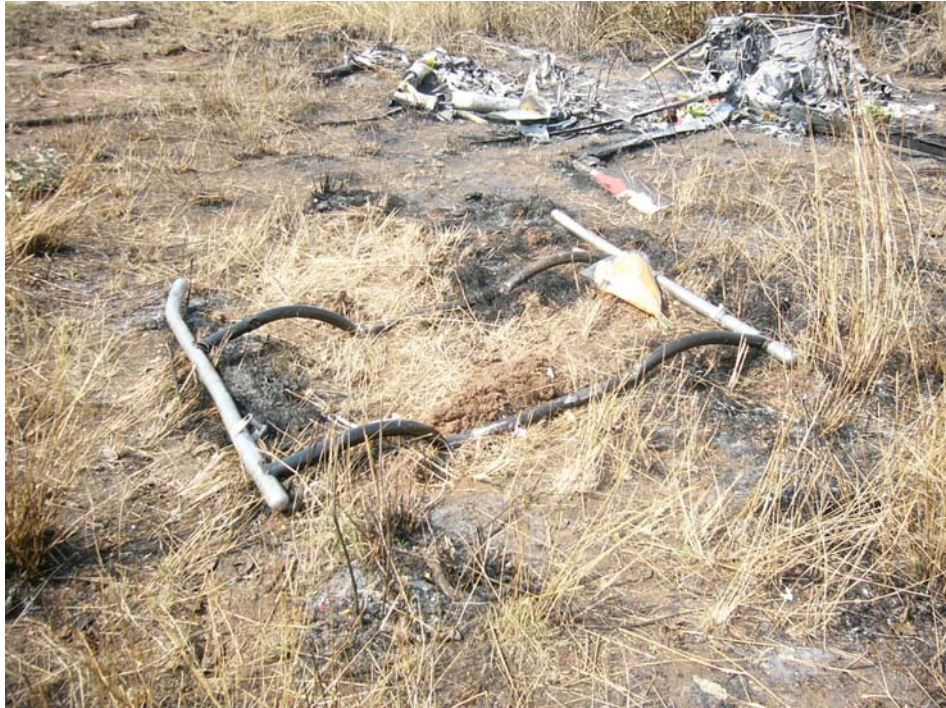
- 1.11.1 The accident site was a level grassy area near a bluegum plantation. Ground scarring and debris at the initial impact point indicated that the helicopter had descended more or less vertically, at low forward airspeed, and in a straight and

level attitude. The helicopter was on a south-easterly heading on impact. The nature of the accident site and the ground scarring suggest that the pilot might have been attempting a forced landing.

- 1.11.2 The helicopter was completely destroyed by the impact forces and the fire that erupted. There was no evidence of structural in-flight failure, as all control surfaces were accounted for on site.

Figure 2. The wreckage distribution.
