# AIRCRAFT ACCIDENT REPORT AND EXECUTIVE SUMMARY

Reference:	CA18/2/3/8691	
<b>Aircraft Registration</b>	<b>ZS-AKS</b>	<b>Date of Accident</b>	6 September 2009		<b>Time of Accident</b>	1330Z
<b>Type of Aircraft</b>	Piper Cherokee PA28-140		<b>Type of Operation</b>		Private	
<b>Pilot-in-command Licence Type</b>		Private	<b>Age</b>	29	<b>Licence Valid</b>	Yes
<b>Pilot-in-command Flying Experience</b>		Total Flying Hours	89.8		Hours on Type	44.5
<b>Last point of departure</b>		Rand Aerodrome (FAGM) (Gauteng province)				
<b>Next point of intended landing</b>		Rand Aerodrome (FAGM) (Gauteng province)				
<b>Location of the accident site with reference to easily defined geographical points (GPS readings if possible)</b>						
Vanderbijlpark. GPS position: S 26°34.26' E 027° 41.12' Elevation: 4 570 ft AMSL						
<b>Meteorological Information</b>		Temperature: 20°C; Cloud cover: Clear skies; Visibility: 10 km				
<b>Number of people on board</b>	1 + 1	<b>No. of people injured</b>	2	<b>No. of people killed</b>	0

**Name of Owner/Operator** : Aero Precision CC  
**Manufacturer** : Piper Aircraft Corporation  
**Model** : Piper PA28-140  
**Nationality** : South African  
**Registration Mark

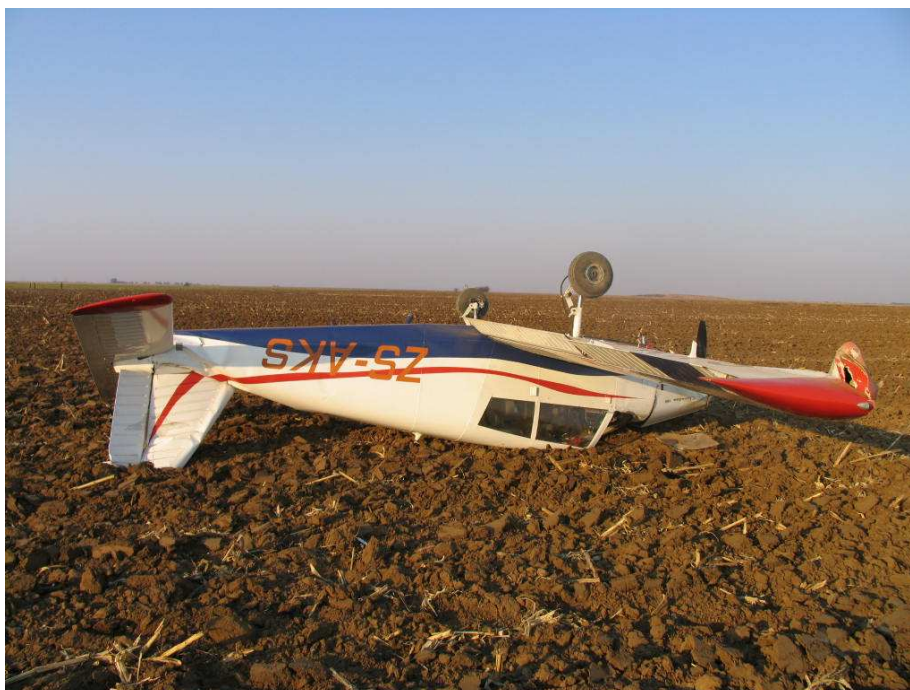
- 1.1.3 The pilot and passenger immediately unbuckled themselves and climbed out. They both suffered minor injuries. The aircraft's nose strut broke, and wings, the engine cowling, the propeller blades and the tail section were substantially damaged. The pilot phoned the operator, who informed the police and paramedics. They were quickly on the scene to render assistance and secure the area. The pilot and passenger were taken to Union Hospital for treatment.

- 1.3.1 The aircraft was substantially damaged.

Figure 1. The aircraft after nosing over in the ploughed field.

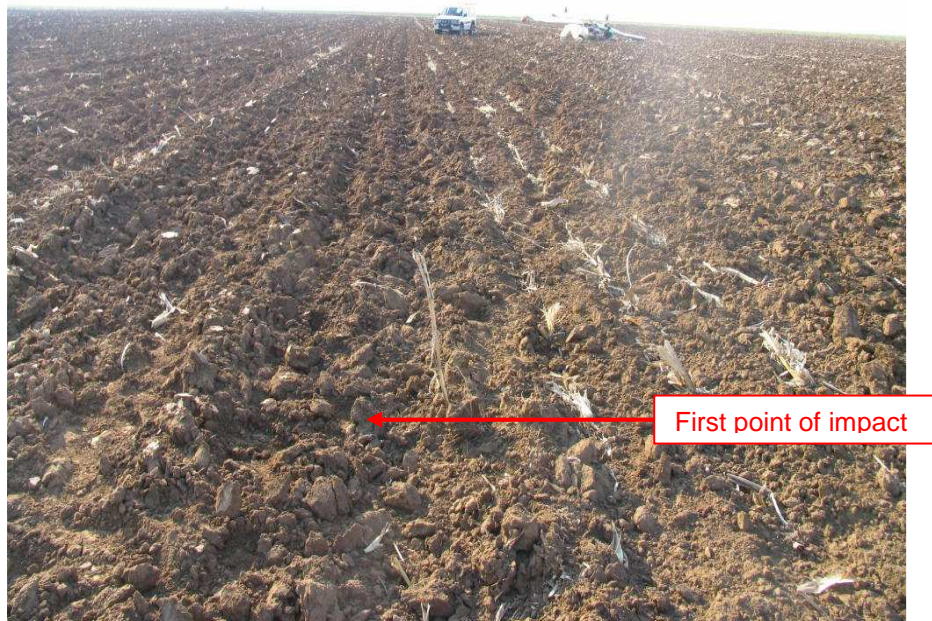
- 1.12.1 The accident occurred on a maize field. The wings, engine cowling, cabin roof and tail section were extensively damaged and the nose strut broke off.
- 1.12.2 The propeller showed signs of the engine operating at a low power setting at the time of impact. Both tanks were still intact and had enough fuel. Both flaps were extended.

**Figure 2.** First point of impact and the final position of the wreckage.

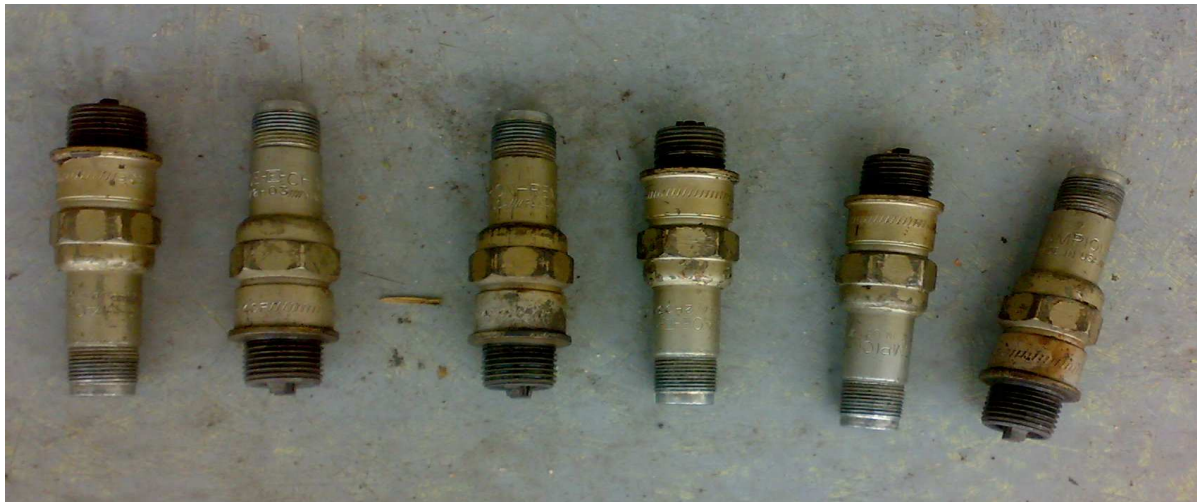
- 1.16.5 Six other spark plugs from the faulty cylinders – numbers 1, 2 and 4 – were removed. These were inspected and their insulator noses found to be covered with a thick brown/yellowish glazing. This glazing results from high engine loading after extended operation, becomes conductive and causes misfiring. The exterior of several of the plugs was also rusted.

**Figure 3.** The six spark plugs from cylinders 1, 2 and 4.

- 2.6 It was discovered that the engine was operating on only one cylinder; the other three cylinders were not functioning due to faulty spark plugs, which caused abnormal combustion and subsequent loss of engine power. New spark plugs were fitted and the engine restarted. It then met all the parameters and power was increased in stages until it was evident that the engine was capable of operating at full power.

- 2.7 Although spark plugs and other ignition components sometimes fail before their scheduled service time, it is highly unlikely that these six spark plugs became unserviceable simultaneously. Of particular concern here is when last these spark plugs were replaced.

- 2.8 According to the manufacturer, spark plugs should be inspected and tested during every MPI, and if they are in good condition and still serviceable, they can continue to be used. From the condition of the sparkplugs in question, it appears that they were not replaced during the MPI on 23 January 2009 and therefore might have been in service for a considerable period. In conclusion, the engine failure was due to collective complacency by the AMO and the operator.

- 1.16.6 The spark plugs were cleaned, tested and found to be unserviceable. New spark plugs were then fitted. The engine was started and all parameters were met. The engine operated normally and power was increased in stages until it was evident that it was capable of operating at full power.

- 4.1 It is recommended that the SACAA must verify the airworthiness status of all aircraft maintained over the past twelve months by the Aircraft Maintenance Organisation (AMO) whose approval was revoked.
