AIRCRAFT ACCIDENT REPORT AND EXECUTIVE SUMMARY

Reference:	CA18/2/3/8697	
Aircraft Registration	ZS-RYT	Date of Accident	09 October 2009		Time of Accident	1730Z
Type of Aircraft	Robinson R44 II		Type of Operation		Private	
Pilot-in-command Licence Type		Private Pilot Licence	Age	42	Licence Valid	No
Pilot-in-command Flying Experience		Total Flying Hours	450.8		Hours on Type	Unknown
Last point of departure		Ermelo Airfield (FAEO, Mpumalanga province)				
Next point of intended landing		Ermelo Airfield (FAEO, Mpumalanga province)				
Location of the accident site with reference to easily defined geographical points (GPS readings if possible)						
Pampoenkraal Farm (S26° 46' 51.81" E030° 23' 23.86")						
Meteorological Information		Surface wind: 170 at 08 knots; Temperature: 17°C, Thunderstorms and Rain				
Number of people on board	1 + 1	No. of people injured	0	No. of people killed	2	
Synopsis						
<p>The pilot, accompanied by a passenger took off from Ermelo to Springbokfontein Farm in Mpumalanga. When the helicopter reached overhead the destination, the pilot realised that he could not land due to low cloud and poor visibility, and called his wife to inform her that they would be

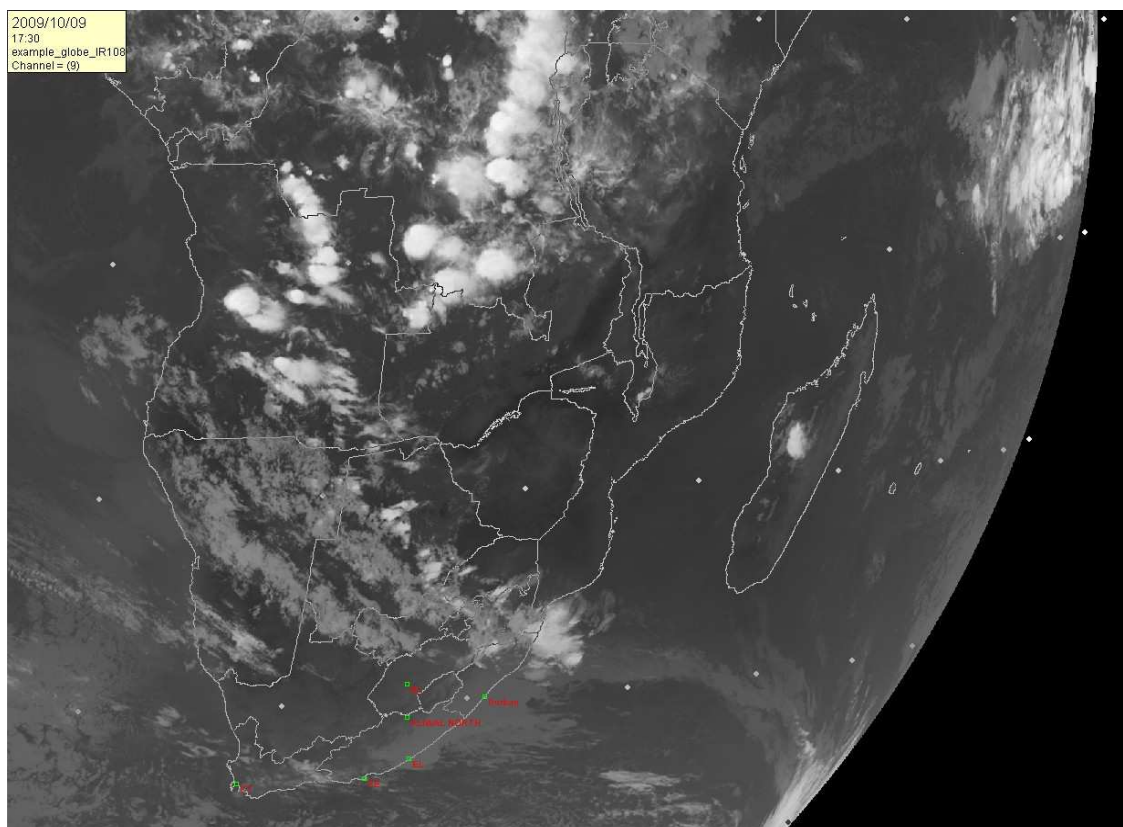
The satellite image below shows a band of thunderstorm activities stretching from central Botswana, to Pilanesburg area, northern Gauteng, towards Witbank and Ermelo area and exiting the country around Maputo. This band of thunderstorm falls over the area of the aircraft accident.

Figure 1: Satellite image dated 9 October 2009. A band of thunderstorm activity can be seen stretching from central Botswana to Maputo, covering the Pilanesberg, northern Gauteng, Witbank and Ermelo areas. These thunderstorms fall over the accident site.

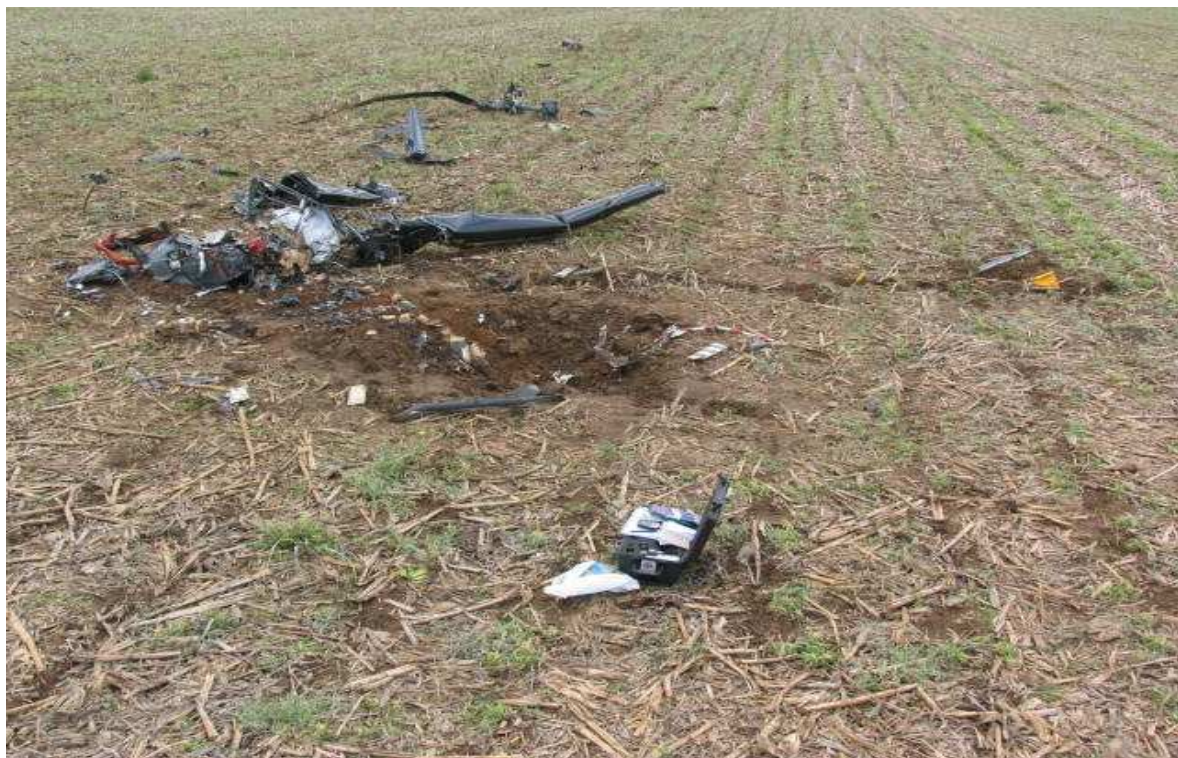
1.12.1 The helicopter was destroyed in the accident. It broke up on impact, with the debris spreading over an area of about 600m². Ground marks/scars indicate that the helicopter impacted the ground at a very steep, nose down attitude and at a high velocity.

1.12.2 Evidence also suggests that when the helicopter impacted the ground, the engine, which is situated behind the fuselage (for this type of helicopter), broke off from its frame and sliced through the fuselage. It was found embedded approximately one metre into the ground.

1.12.3 Onsite investigation revealed that the main rotor of the helicopter was turning at impact as this is evidenced by the way one half (blade) of the main rotor had dug into the ground.

Figure2: Photo showing the main wreckage.

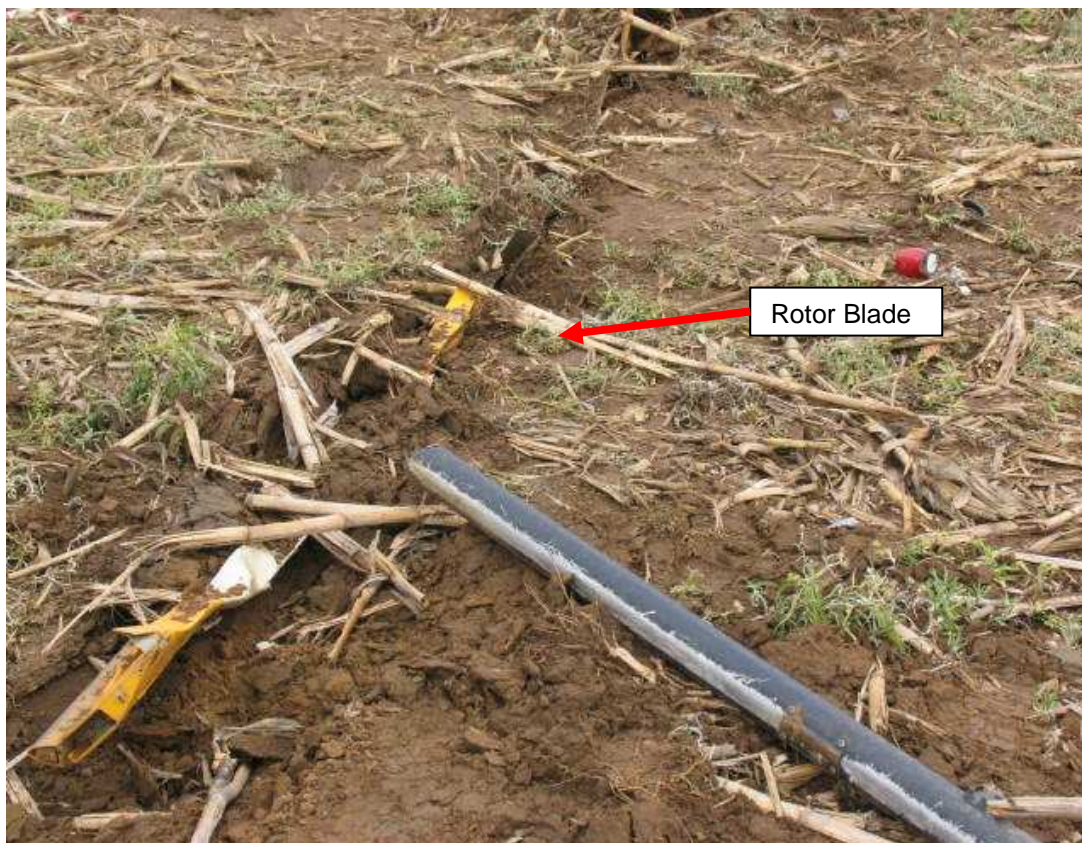
1.16.1 Onsite investigations indicated that the engine was running at the time of accident. This is supported by the fact that one half (blade) of the main rotor was imbedded into the ground showing rotation at impact. Even though the engine could not be run due to impact damage visual examination revealed that there was no malfunction at the time of the accident.

Photo 2: Showing main rotor blade imbedded into the ground
