AIRCRAFT ACCIDENT REPORT AND EXECUTIVE SUMMARY

Reference:	CA18/2/3/8734	
Aircraft Registration	ZU-CWW	Date of Accident	09 January 2010		Time of Accident	1000Z
Type of Aircraft	Marabou Stork		Type of Operation		Private	
Pilot-in-command Licence Type		Private pilot	Age	53	Licence Valid	Yes
Pilot-in-command Flying Experience		Total Flying Hours	420.0		Hours on Type	350
Last point of departure		Rhino Park Aerodrome – Gauteng.				
Next point of intended landing		Rhino Park Aerodrome – Gauteng.				
Location of the accident site with reference to easily defined geographical points (GPS readings if possible)						
Rhino Park Aerodrome next to Runway 03.						
Meteorological Information		Wind direction: 30°/08 kts, Temperature: 21°C, Visibility: <10 km, Cloud base: SCT at 2500 ft, Cloud cover: SCT at 3500 ft.				
Number of people on board	1 + 1	No. of people injured	0	No. of people killed	0	
Synopsis						
<p>According to the pilot, he decided to fly from Rhino Park Aerodrome to Petit Aerodrome at 1000Z. The pilot noted that the surface wind was 030°/8 kts, directly down Runway 03. As the runway was muddy due to rain the previous day, he elected to take off from the grass surface to the le

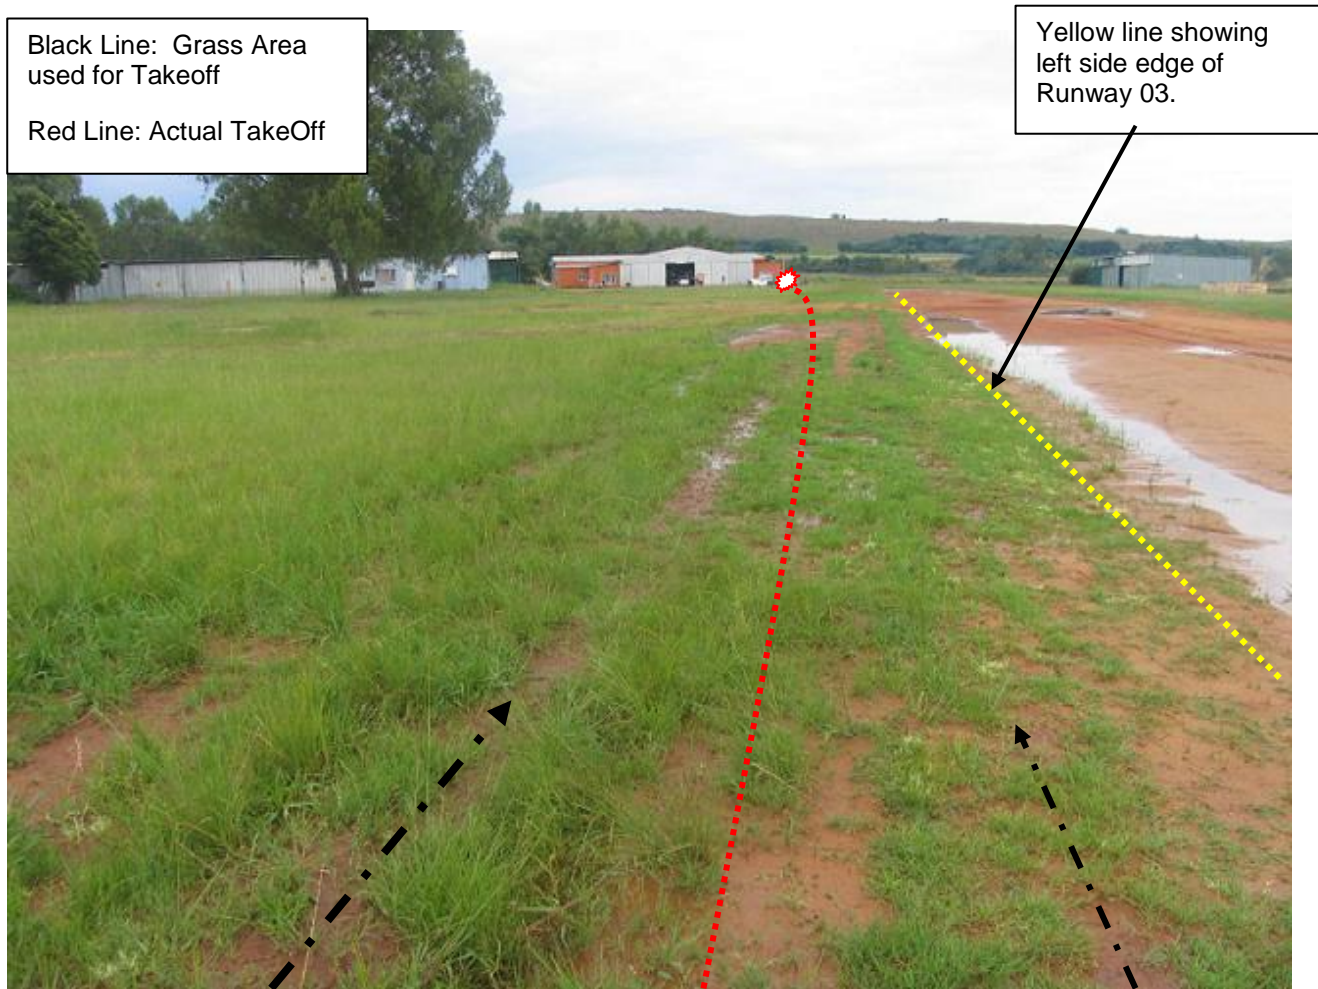
Figure 1, showing the location of the grass area where the aircraft started the takeoff run.

- 1.18.3 The aircraft was taking off from a grass surface on the left side of Runway 03. The grass was not even and this made it possible for pools of water to form. Due to the wetness, the soil which was not covered by grass also became muddy and slippery. According to the markings that were found on the ground indicating main and tail wheels, the indication is that the takeoff run was affected by the wet ground. The markings show that the pilot was struggling to keep the aircraft straight according to the runway centre line. At some places the pilot was avoiding going through the pools of water.

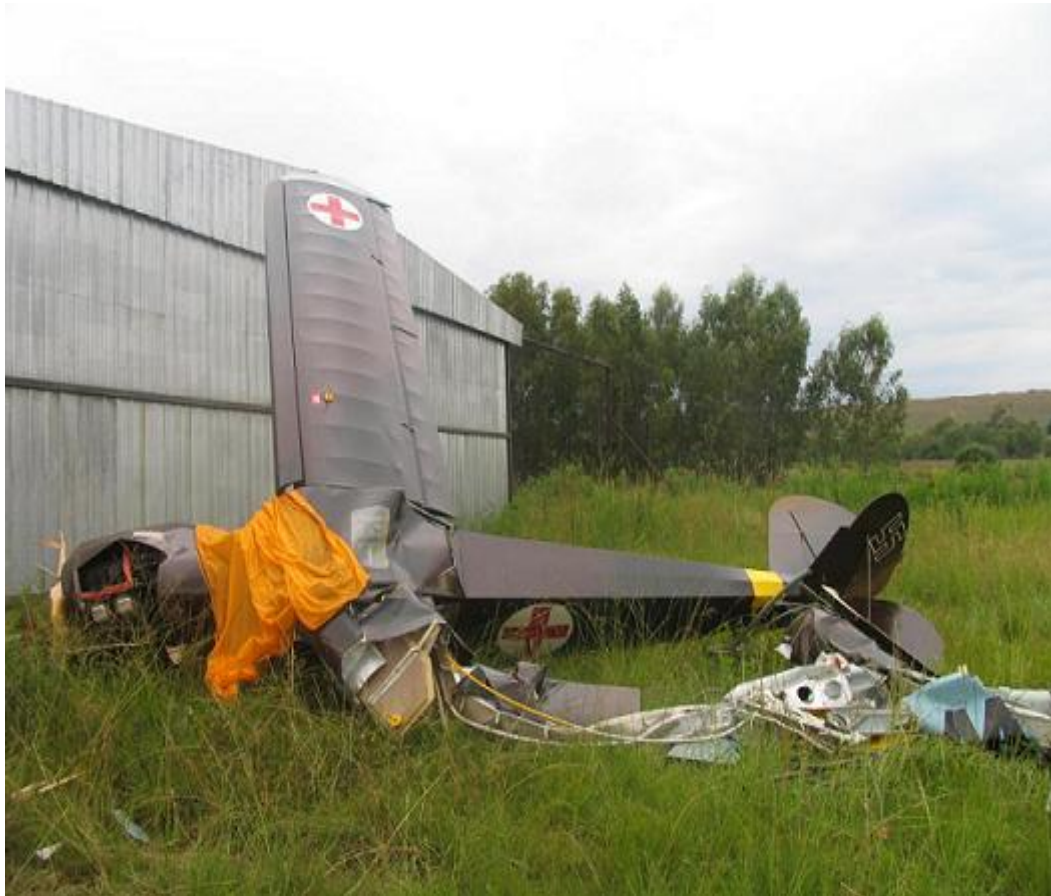
1.3.1 The aircraft sustained substantial damage in the impact sequence.

Figure 2, showing damage caused to the aircraft in the accident.

- 2.5 The left wing collided with the hangar. The force with which the wing impacted the hangar was very hard and resulted in total destruction of the wing. The extent of damage caused to the wing rendered the aircraft unfit for flight.

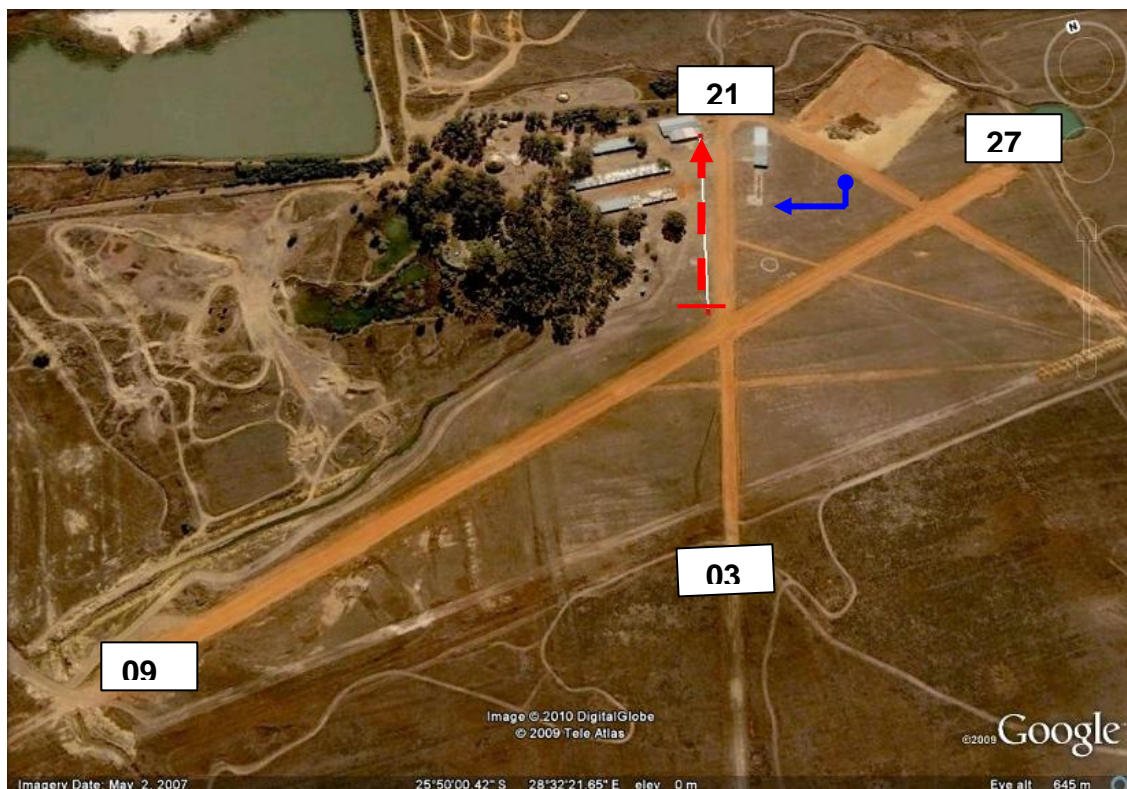
Figure 4, showing an aerial view of the aerodrome and location where the aircraft was taking off.

1.10.3 The figure above shows the aerial view of the aerodrome. During the on-site investigation, it was discovered that the runways at the aerodrome did not have identification markings. The location of the hangars on the left side of Runway 03 was not at the recommended minimum safe distance (40 metres) from the runway.

- 3.1.14 The distance between the hangar buildings and Runway 03 was found to be too close to the runway.
- 3.1.15 The aerodrome is privately owned and managed. The aerodrome does not have a licence and was not required to comply with applicable regulations.

- 4.1 It is recommended that the Director for Civil Aviation should document minimum procedures for private aerodromes, in terms of safety requirements.

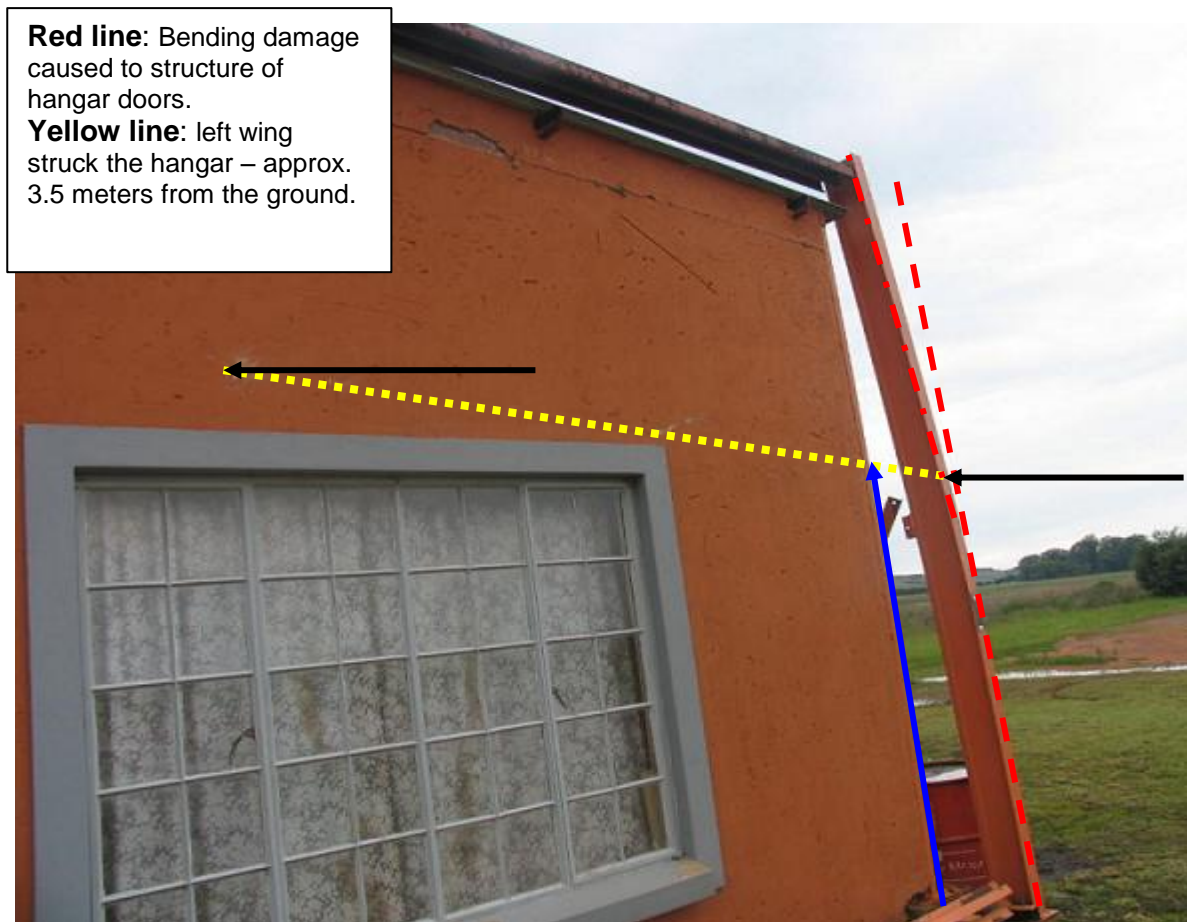
- 1.4.1 The aircraft collided with a hangar. There was minor damage caused to the hangar structure.

1.12.1 The aircraft was taking off in a north-westerly direction from the grass on the left side of Runway 03 at Rhino Park Aerodrome. During the takeoff run, the left-side wing of the aircraft collided with a hangar structure. The wing struck the hangar wall at a height of approximately 3.5 metres from the ground. The aircraft then swung to the left side wall of the hangar. The nose section struck the wall approximately 500 centimetres from the ground.

Figure 5, showing the height at which the left wing struck the hangar and damage caused to structure of hangar doors.

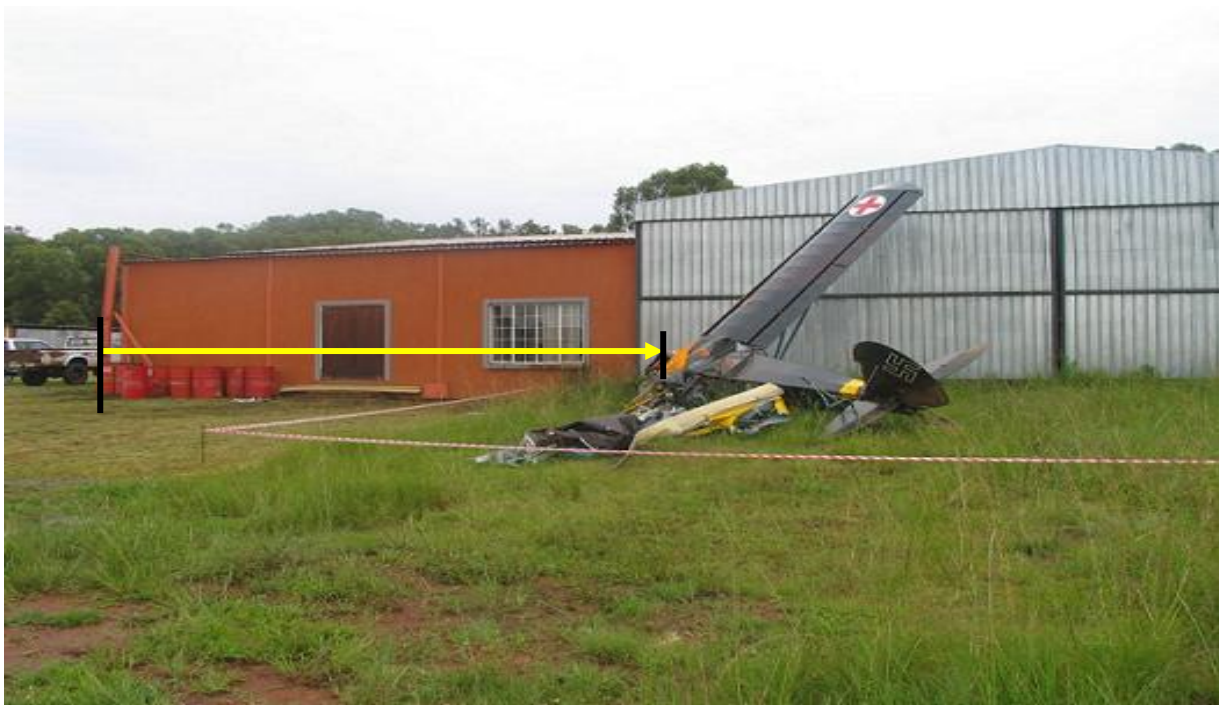
Figure 6, showing location where wreckage came to rest

on the left side of the hangar.

- 1.12.4 The main wheel on the left side broke off and separated from the aircraft in the impact sequence. The aircraft came to rest on its left side and on the left side of the hangar. The wreckage was approximately 5 meters away from the initial point of impact.
