AIRCRAFT ACCIDENT REPORT AND EXECUTIVE SUMMARY

| | | | | Reference: | CA18/2/3/8746 | |
| Aircraft Registration | ZS-PNM | Date of Accident | 03 February 2010 | | Time of Accident | 0420Z |
| Type of Aircraft | Cessna 206 Stationair | | Type of Operation | Private | | |

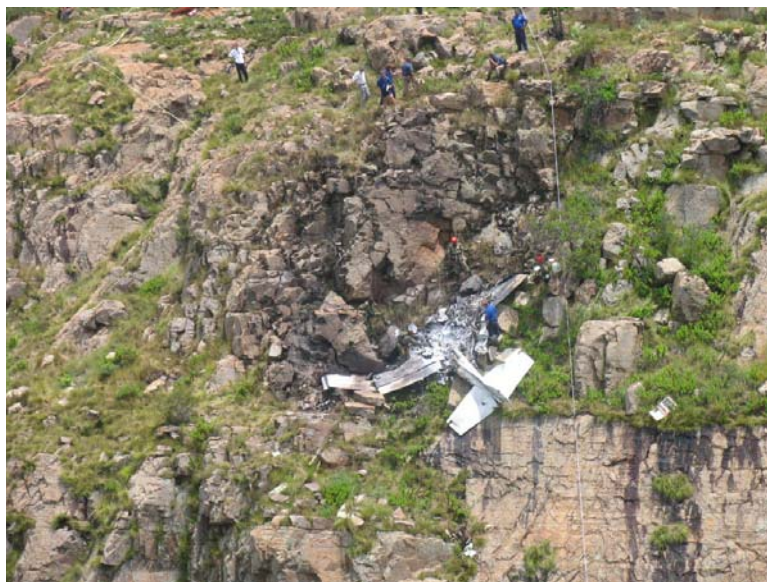
- 1.3.1 The aircraft was destroyed by post-impact fire.

Figure 1: Showing location of the wreckage on the Magaliesberg Mountain

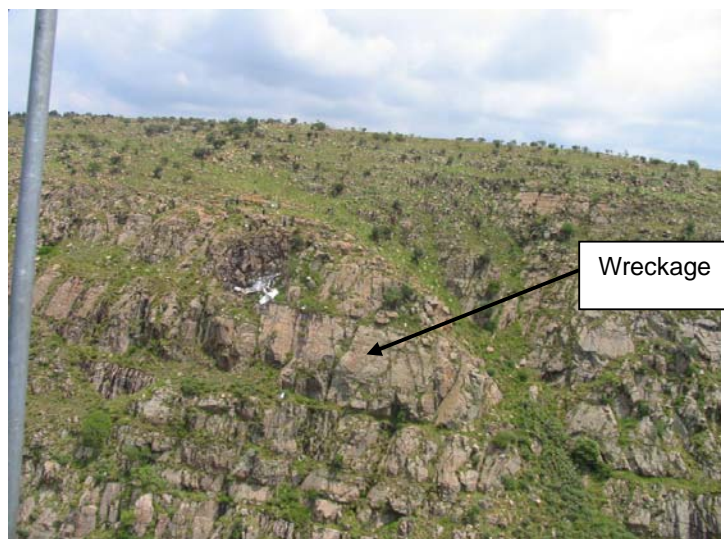
Figure 2: Showing where the wreckage impacted the side of the mountain

1.12.1 The aircraft impacted the mountainside at an angle with a left wing tip impacting first, then the nose section and right wing, followed by eruption of a post-impact fire.

1.12.2 The maximum elevation of the Magaliesberg Mountain in the area of the accident is 5319 feet and the aircraft impacted the mountain at 5165 feet.
