## AIRCRAFT ACCIDENT REPORT AND EXECUTIVE SUMMARY

Reference: CA18/2/3/8755	
<b>Aircraft Registration</b>	<b>ZS-PYL</b>	<b>Date of Accident</b>	12 February 2010		<b>Time of Accident</b> 1400Z
<b>Type of Aircraft</b>	Reims-F172M		<b>Type of Operation</b> Private		
<b>Pilot-in-command Licence Type</b>		Private	<b>Age</b>	29	<b>Licence Valid</b> Yes
<b>Pilot-in-command Flying Experience</b>		Total Flying Hours	79,1		Hours on Type 76,7
<b>Last point of departure</b>		Rand Aerodrome (FAGM)			
<b>Next point of intended landing</b>		Rand Aerodrome (FAGM)			
<b>Location of the accident site with reference to easily defined geographical points (GPS readings if possible)</b>					
Open field at Tulisa Park near Alberton. GPS Position (S 26°14'52.3" E 28°06'43.2")					
<b>Meteorological Information</b>		Surface wind: 240°/8 kt, temperature: 29 °C, Visibility: CAVOK			
<b>Number of people on board</b>	1+2	<b>No. of people injured</b>	0	<b>No. of people killed</b>	0

## AIRCRAFT ACCIDENT REPORT

**Name of Owner/Operator** : Aero Diesel Technology CC  
**Manufacturer** : Reims Aviation SA  
**Model** : F172M  
**Nationality** : South African  
**Registration Marks** : ZS-PYL  
**Place** : Tulisa

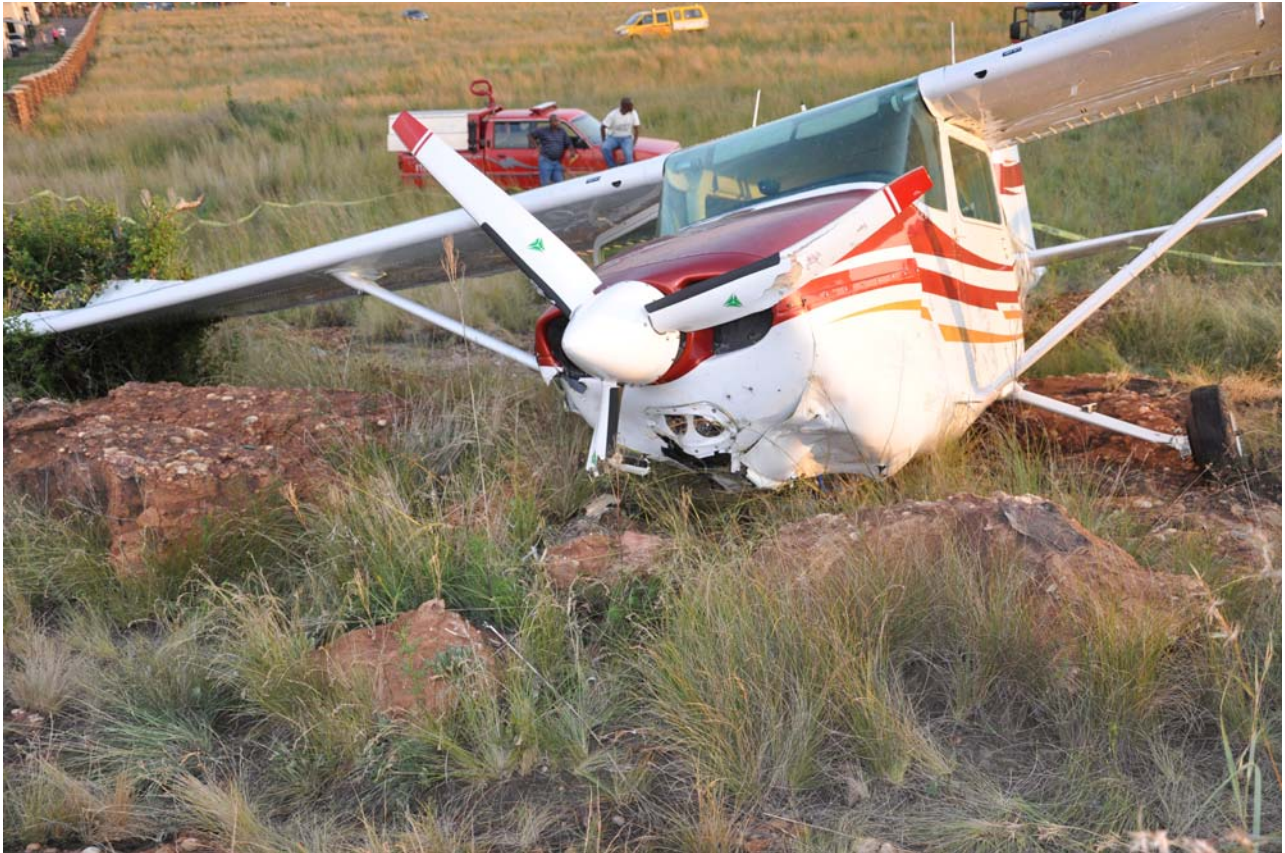
**FIGURE 1** Damage to the aircraft

- 1.3.1 The aircraft sustained substantial damages to the nose and right landing gears, the right wing, the propeller as well bottom side of the engine cowling.

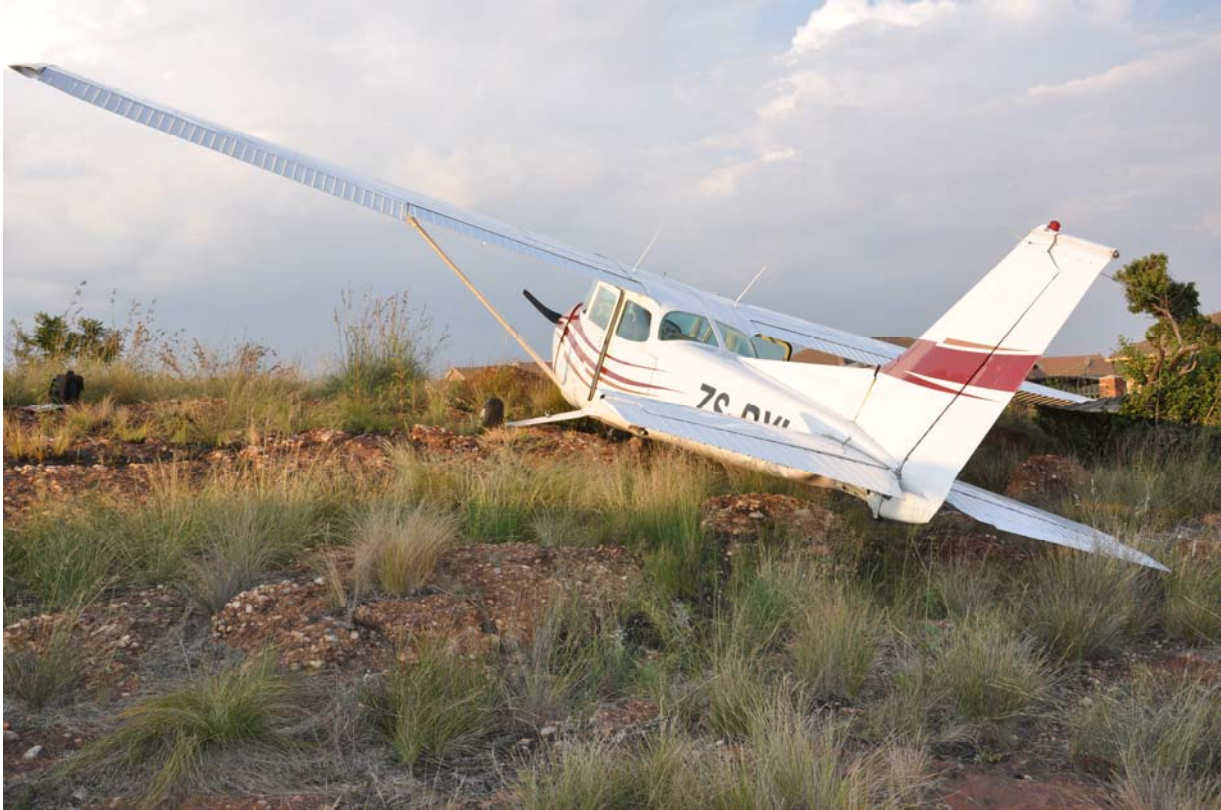
**FIGURE 2      Wreckage site**

1.12.1 The accident site was rocky terrain at Tulisa Park near Alberton. Evidence of airframe damage indicated that the aircraft had struck the ground on a south-easterly heading, while in a slight nose-down and right-wing-low attitude.

- (i) On-site inspection of the wreckage revealed that all of the structural damage was consistent with the impact; nothing was found to suggest that there had been any pre-impact failure of the primary structure. Approximately 50 litres of fuel was drained from the fuel tanks.
