**Rejected takeoff after the takeoff
decision speed ' V_1 ', Boeing B737-800,
at Eindhoven Airport**

4 June 2010

The Hague (project number 2010040)

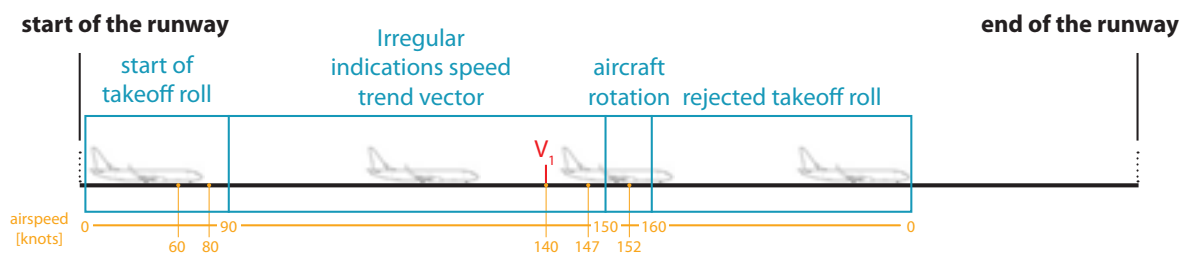
Figure 5: Timeline of takeoff with the four events which will be analyzed in this paragraph in more detail.

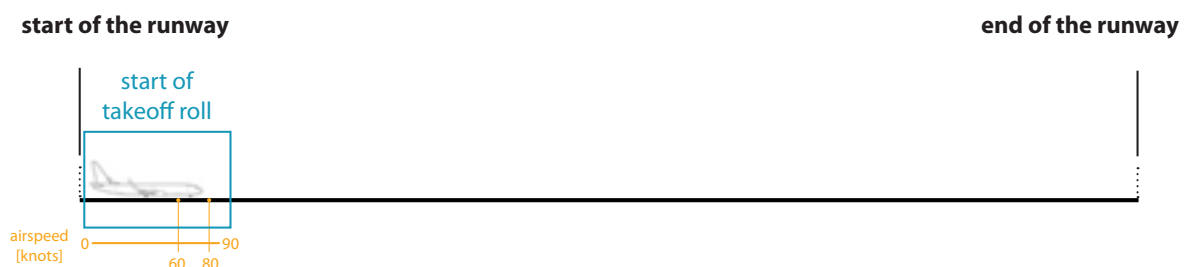
The flight data shows a deviation in aircraft heading at low airspeed. The analysis of engine parameters flight data during this timeframe does not show engine asymmetry or large differences in engine performance which could explain the observed heading changes.

Figure 6: Timeframe start of takeoff roll, from standstill to 90 knots computer airspeed.

The data from the flight data recorder shows that the aircraft reacted to the given rudder pedal inputs and it was possible to get the aircraft lined up with the runway. The tiller which controls the nose steering of the aircraft is not recorded, heading changes as a result could not be analyzed. The changes in aircraft heading could possibly be related to over controlling the aircraft or an outside disturbance.

Another possible cause of atmospheric disturbance is gusty winds or turbulence created by buildings or structures near the runway. The reported weather conditions from air traffic control at the time of the event indicated a wind speed up to 10 knots. Prior to and after the event the meteorological information does not show the presence of gusting conditions. At the airport structures and buildings are present which could create turbulence. However given the distance between the buildings and the runway with the reported wind conditions it is unlikely that turbulence was generated by buildings. No information to substantiate either possibility or any other explanation which may have caused heading changes could be determined.

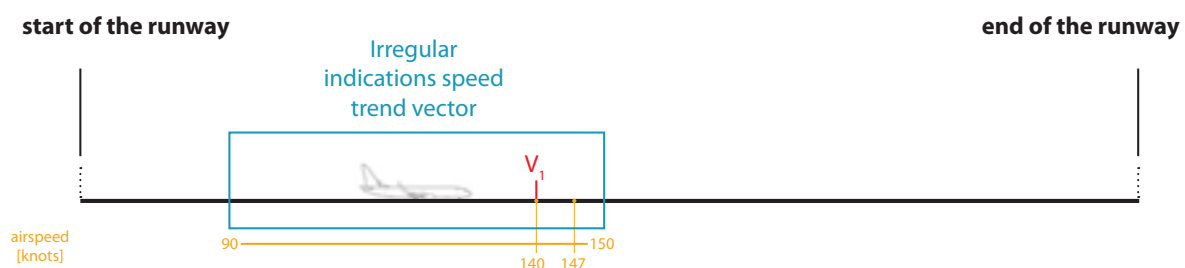
Figure 7: Timeframe airspeed from 90 to 150 knots where irregular speed trend vector was observed.

The captain as the pilot monitoring should be observing and verifying conditions of aircraft systems during the takeoff roll. The captain had noticed a large positive speed trend vector but deemed this not an issue for takeoff. The first officer also observed an irregular speed trend vector during the takeoff roll. This implies that the instruments in cockpit were showing large deviations which were noticed by both crewmembers.

Although the recorded airspeed was only available from the captain's side it is likely that similar deviations occurred on the first officer's side. However, since the available airspeed data was from the captain's side only, a definitive conclusion could not be reached. It is possible that some sort of atmospheric disturbance occurred which explains the sharp deviation in computed airspeed. A explanation or cause for a atmospheric disturbance could not be determined. However in the previous timeframe, start of takeoff roll, an atmospheric disturbance was deemed to be the likely cause.

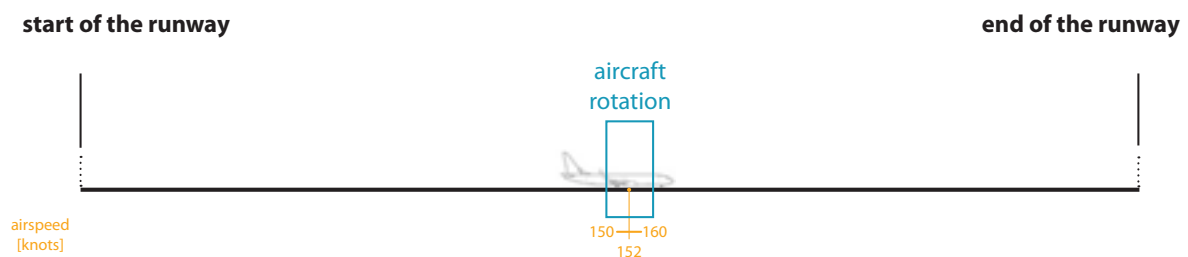
Figure 8: Timeframe between 150 and 160 knots where the aircraft rotated.

Data on the flight data recorder shows that around the time of rotation of the aircraft, large lateral accelerations (left and right movement) were recorded. The heading of the aircraft subsequently changed and the rudder pedals were used to align the aircraft back to the runway heading. These large lateral accelerations occurred around the same time the control column was moved aft in order to rotate the aircraft. The lateral accelerations were quite large and could have induced a feeling (tactile input) to the first officer which gave him the impression the aircraft was unsafe to fly. This input may have led the first officer to deem the aircraft to be unsafe to fly and reject the takeoff.

The reason for the large lateral accelerations was probably caused by an external, possibly atmospheric, phenomena. This would be a third time an anomaly could be related to an outside atmospheric phenomena. Up to this moment in time no warnings or failures were recorded on the flight data recorder.

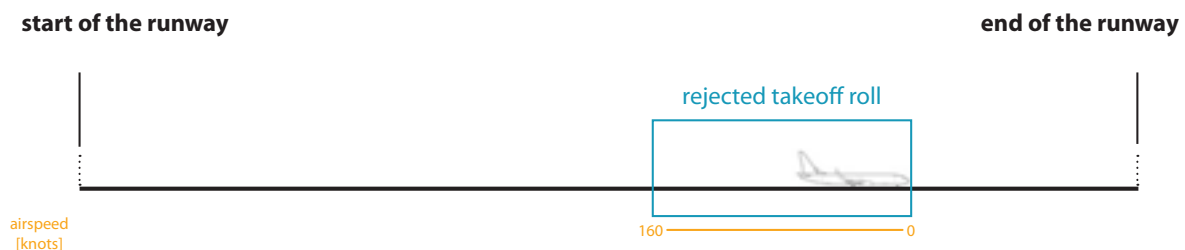
Data from the autothrottle and flight data recorder indicated that the takeoff was rejected at 152 knots, which was above the 141 knots V_1 speed determined by the crew. The applicable V_1 speed was obtained prior to takeoff from the regulated takeoff mass (RTOM) tables presented in the aircraft manual. Included in this manual are circumstances in which the V-speed need to be adjusted (runway condition, runway slope, wind conditions or temperature etc). On the day of the event no adjustments were made nor were they required.

Figure 9: Timeframe of the rejected takeoff starting from the maximum of 160 knots to standstill.

The available runway length at Eindhoven and weather conditions at the day of the event were not a limiting factor for the aircraft. Favourable conditions (aircraft weight and good runway friction) were present. The friction coefficient of 0.81 means that the braking action was good. The runway length of 3000 metres was sufficient and the flight crew elected to request exit GOLF during taxi, thereby utilising the full length of the runway. The aircraft stopped approximately 500 metres from the runway end despite rejecting the takeoff at a speed above V_1 .

The information available in this investigation and the flight data show that the aircraft systems were operating normally and no warnings were given for system malfunctions. The collected information further shows that during the takeoff roll the aircraft experienced an undetermined atmospheric disturbance. The first officer felt and interpreted this disturbance as an unsafe condition to continue the takeoff. This feeling led to the decision to reject the takeoff after the takeoff decision speed V_1 .

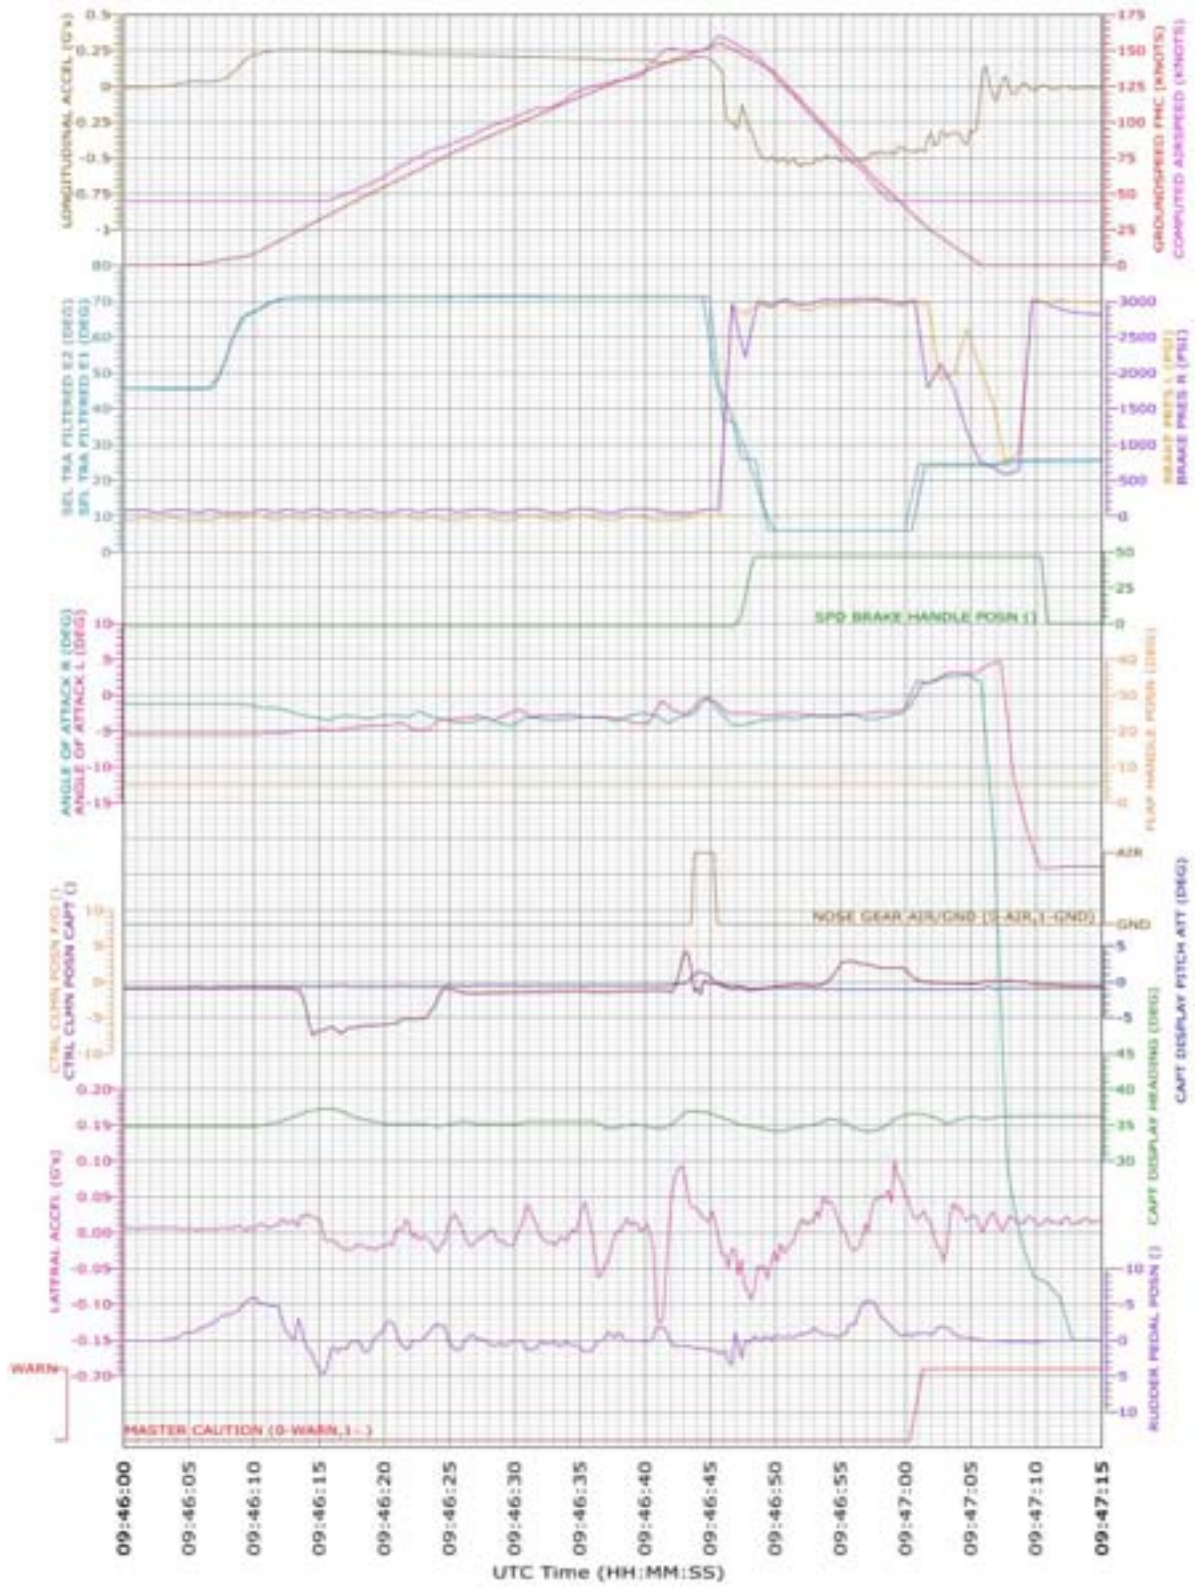
Figure 14: Flight Data Recorder plot.

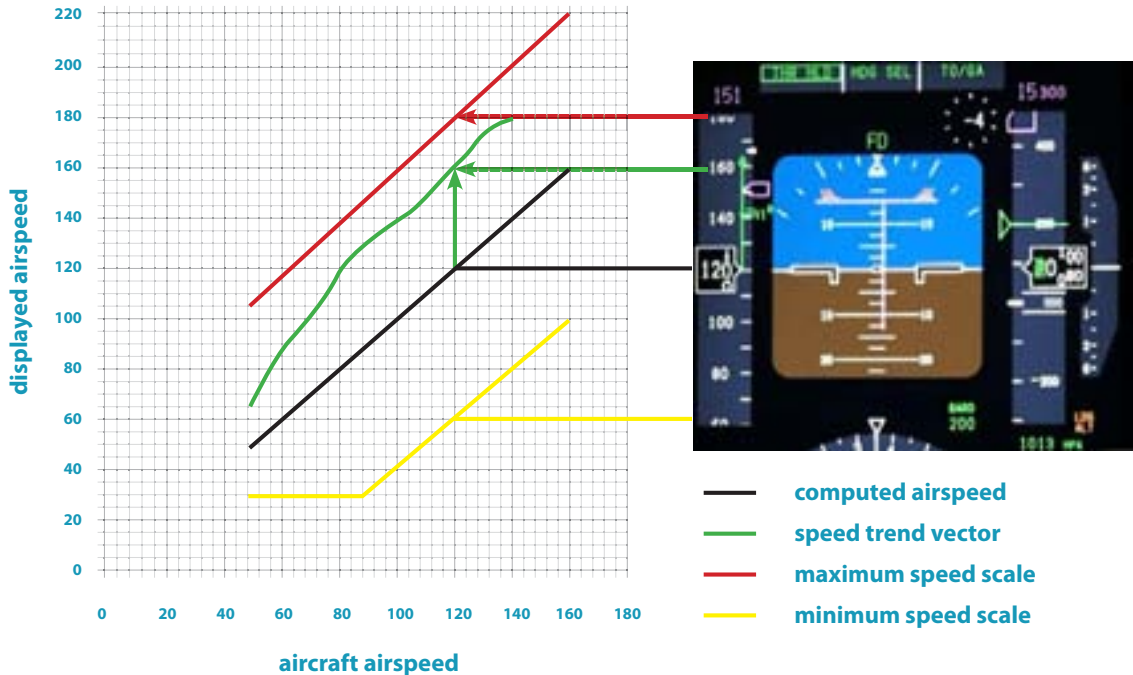
Apart from the operational investigation, the B737-800 simulator tests were also conducted to determine the length of the speed trend vector during the takeoff roll. Using video equipment the length of the arrow was recorded and analysed later. These tests and video analysis showed that on average the speed trend vector length was approximately 40-45 knots. The maximum the tip of the speed trend vector arrow can point to is 60 knots. During the takeoff roll the length of the speed trend arrow was about 2/3 of the maximum length.

Figure 15: Graphical representation of the recorded airspeed and speed trend vector length.

In Figure 15, the yellow and red line depicts the minimum and maximum displayed airspeed on the moving scale tape. In black the displayed airspeed is shown and in green the airspeed which the tip of the speed trend vector. The length of the speed trend vector on the display is the vertical difference between the displayed airspeed (black) and the tip of the speed trend vector (green).
