AIRCRAFT ACCIDENT REPORT AND EXECUTIVE SUMMARY

Reference:	CA18/2/3/8816	
Aircraft Registration	ZS-RME	Date of accident	02 July 2010		Time of Accident	1345Z
Type of Aircraft	Eurocopter EC 120B		Type of Operation	Training		
Pilot-in-command Licence Type	Airline transport	Age	43	Licence Valid	Yes	
Pilot-in-command Flying Experience	Total Flying Hours	6 895.4		Hours on Type	75.6	
Last point of departure	Cape Town international airport - FACT (Western Cape province).					
Next point of intended landing	Cape Town international airport – FACT (Western Cape province).					
Location of the accident site with reference to easily defined geographical points (GPS readings if possible)						
General fling area at GPS position determined as South 33° 58' 12.34" East 18° 36' 34.30".						
Meteorological Information	Surface wind 190° @ 5 knots, temperature 22°C, visibility +10 km.					
Number of people on board	1 + 1	No. Of people injured	0	No. Of people killed	0

Probable Cause						
Unsuccessful autorotation resulting into hard landing due to undetermined loss of engine power.						
IARC Date		Release Date

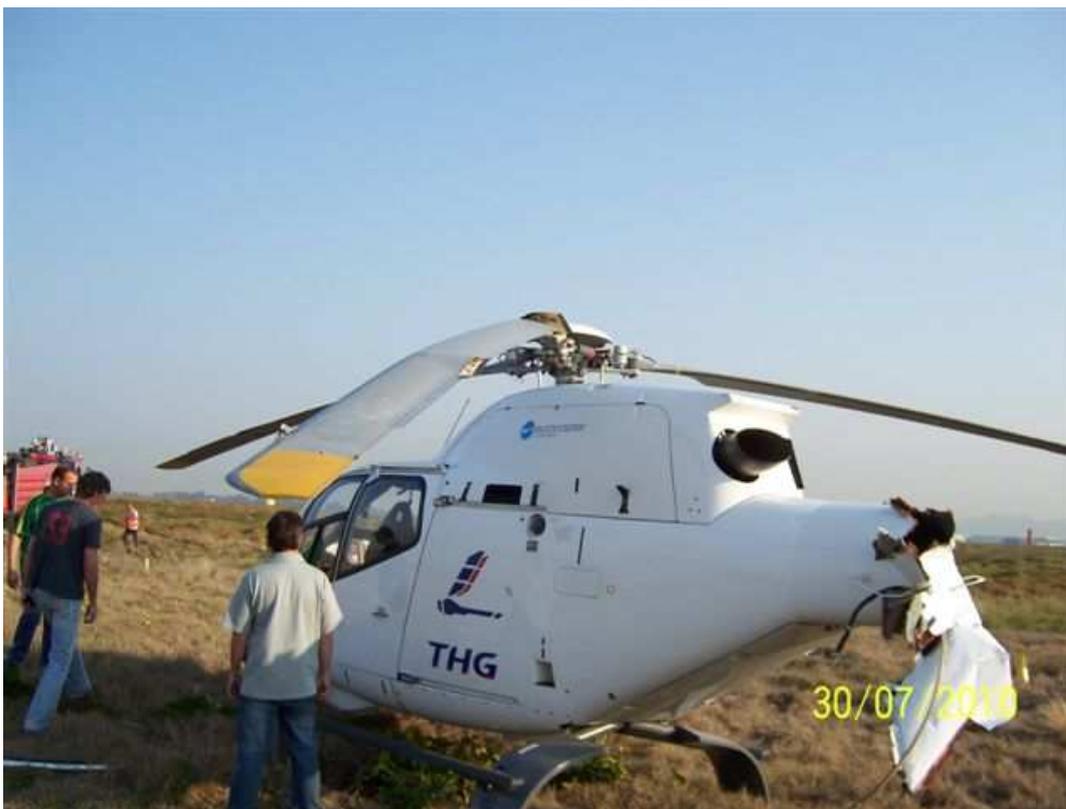
1.3.1 The main rotor blades made contact with the tail boom and the tail boom was chopped off. The main rotor blades were damaged, the pitot tube was damaged and the right hand wind screen broke during the accident sequence. **Note:** In order to determine the full extent of the damage, the helicopter would have to undergo extensive inspection due to the unknown stresses placed on the airframe and the skids.

Figure 1: View of the helicopter at the accident site.

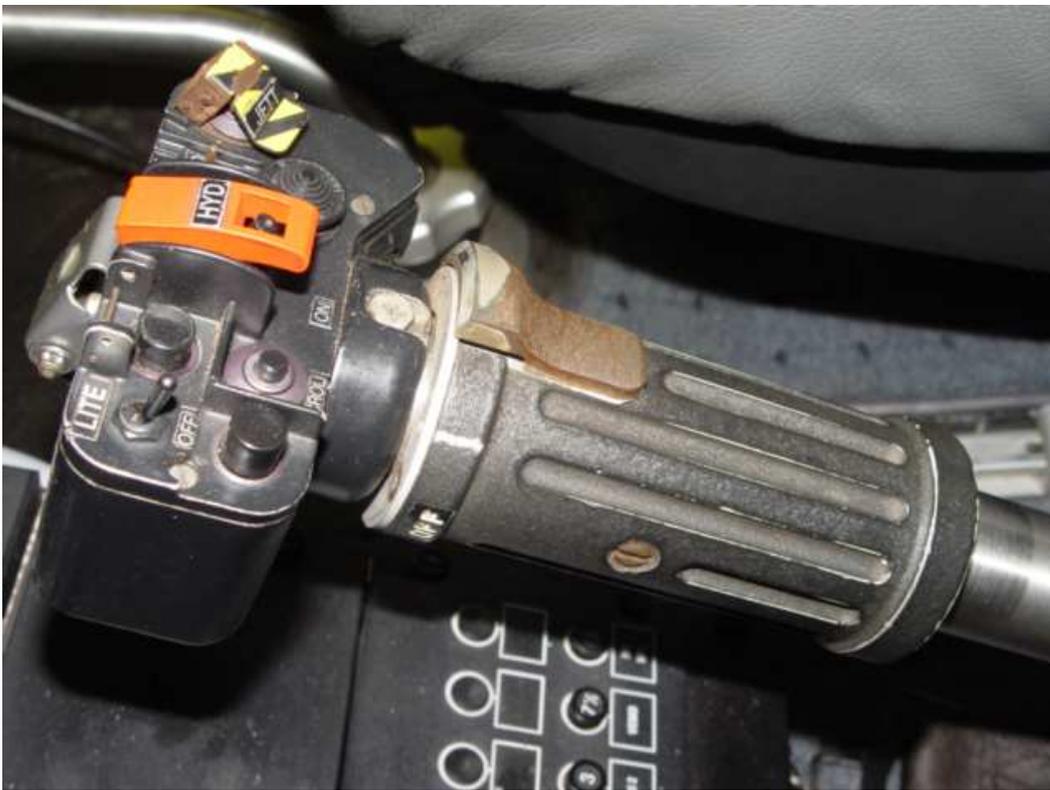
1.12.1 The aircraft landed on threshold runway 34 and after landing the tail boom was chopped off. The wind screen was damaged, pitot tube was damaged and the main rotor blades were damaged during the accident sequence. The position of the twist grip was on fully open position (flight idle) at the time of inspection and the indication on the fuel control unit (FCU) quadrant was on 60°.

Figure 2: Position of the twist grip as found after the accident.

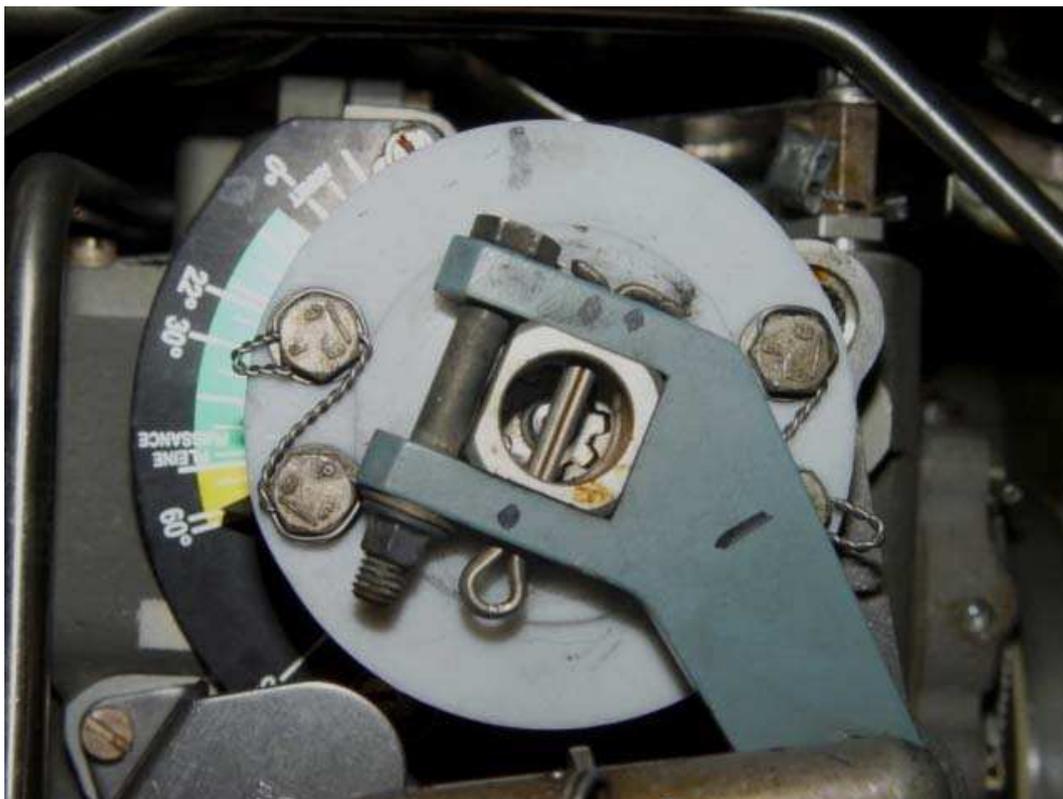
Figure 3: Quadrant position on 60°.

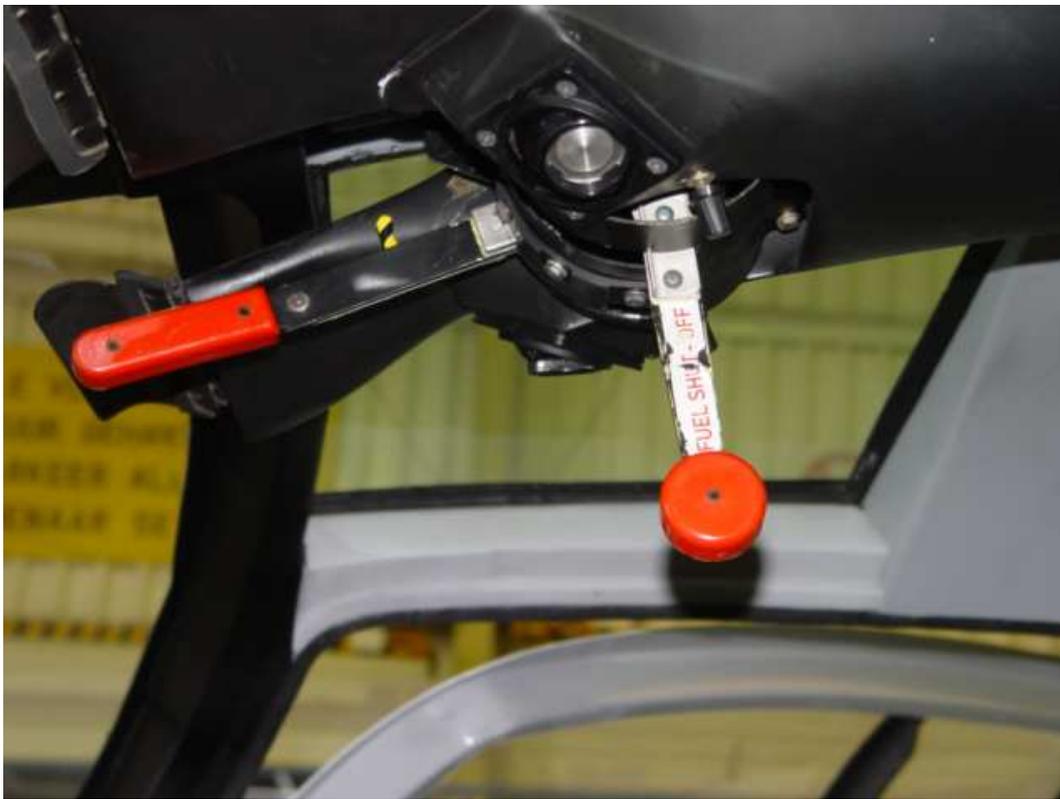
1.12.2 The fuel shut off valve was found in OFF/Closed position.

Figure 4: View of the fuel shut off valve on the aircraft cockpit roof.

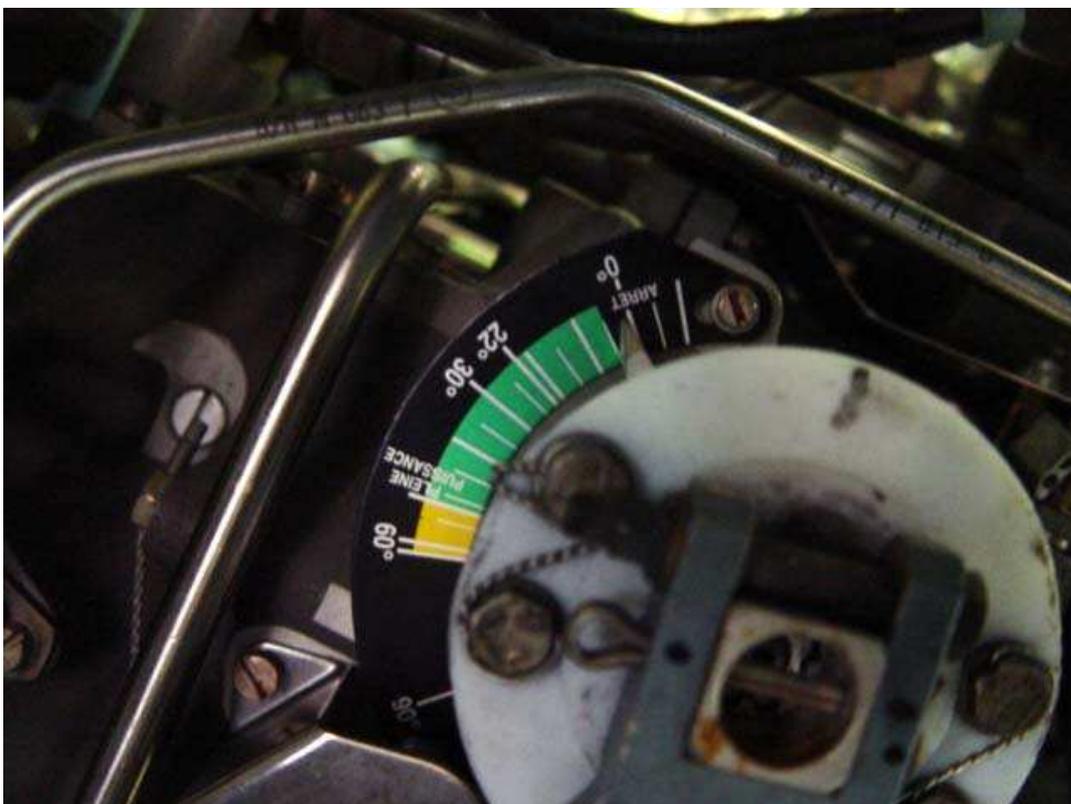
- The aircraft was energized and again they tried to turn the twist grip without activating the solenoid and it was not possible.
- Power turbine rotation was free without evidence of metal spatter, blade tip rubbing or visual evidence of over temperature and showed a positive connection to the main gear box drive.
- Functioning of the cyclic and collective controls confirmed that the control systems from the pilot inputs to the hydraulic servos were correctly connected and capable of functioning appropriately.
- With the battery selected 'ON' it was noted that appropriate pitch change movement of the blade roots took place when the cyclic and collective controls were operated.
- They activated the solenoid and turned the twist grip to off position and the indication on the quadrant was +1 degrees. See figure 5 below.

Figure 5: View of the fuel control unit (FCU) quadrant.

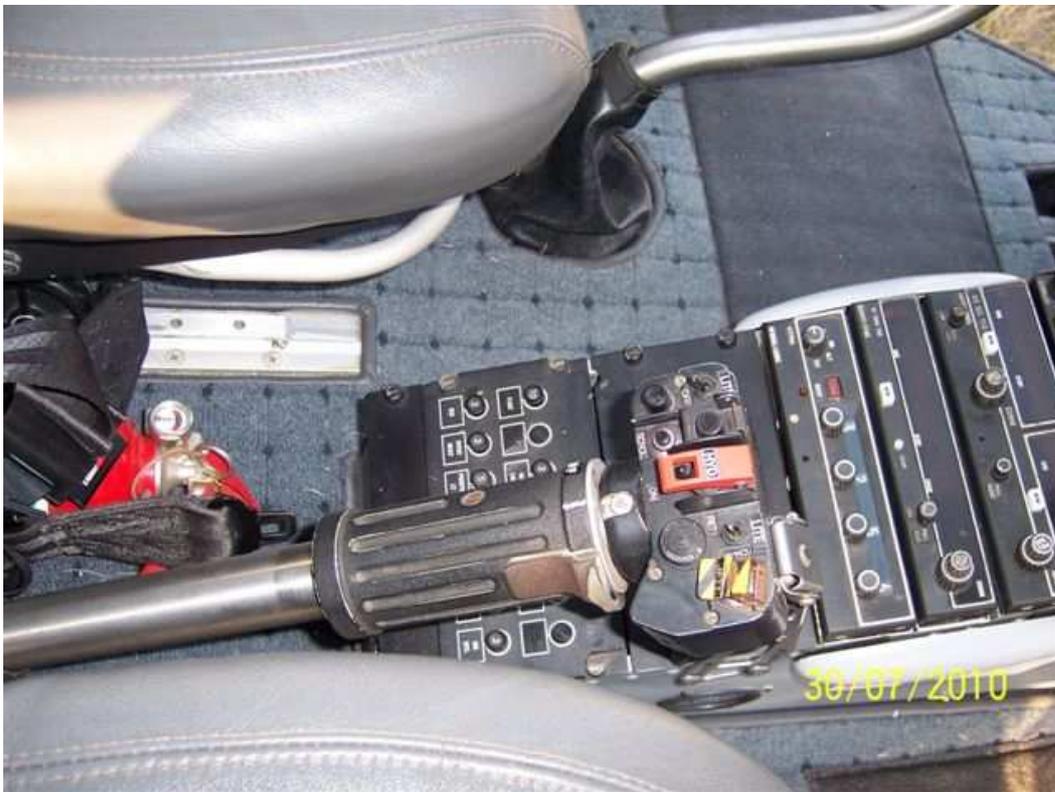
- The operation of the anticipator was checked and found operating normally.
- When moving the collective up and down and checking the indication on the quadrant of the anticipator, the reaction was normal.
- The twist grip was moved to idle position and the indication on the quadrant was 28°. See figure 6 and 7 below.

Figure 6: Twist grip at idle position.

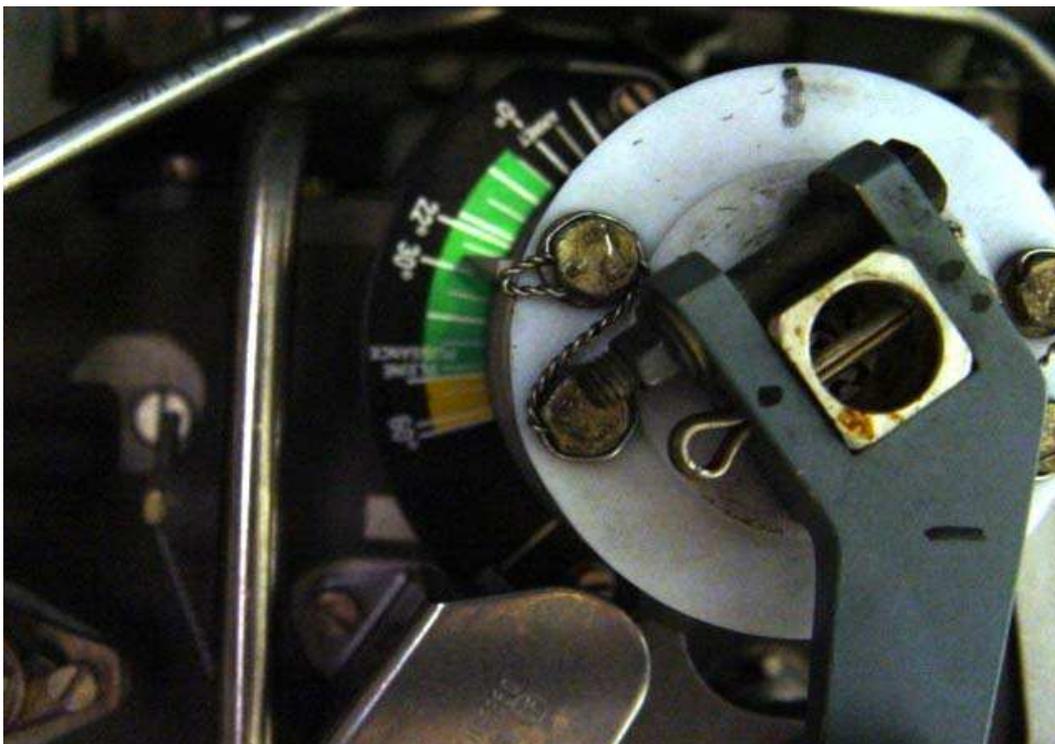
Figure 7: View of the fuel control unit (FCU) quadrant at 28°.
