## AIRCRAFT ACCIDENT REPORT AND EXECUTIVE SUMMARY

Reference:	CA18/2/3/8807	
<b>Aircraft Registration</b>	<b>ZS-RGN</b>	<b>Date of Accident</b>	21 July 2010		<b>Time of Accident</b>	1445Z
<b>Type of Aircraft</b>	Cessna 182		<b>Type of Operation</b>	Private		
<b>Pilot-in-command Licence Type</b>		Private	<b>Age</b>	67	<b>Licence Valid</b>	Yes
<b>Pilot-in-command Flying Experience</b>		Total Flying Hours	±420		Hours on Type	Unknown
<b>Last point of departure</b>		Nelspruit aerodrome (FANS) (Mpumalanga province).				
<b>Next point of intended landing</b>		Hoedspruit Civil aerodrome (Limpopo province).				
<b>Location of the accident site with reference to easily defined geographical points (GPS readings if possible)</b>						
At Bakenkop Mountain at GPS Co-ordinates determined as S24° 49. 00' E030° 55. 53' at +/- 4500 feet altitude above mean sea level (AMSL).						
<b>Meteorological Information</b>		Temperature 17°, Dew point 09°C, Surface wind 09 Knots, Broken to Overcast clouds.

**Name of Owner/Operator** : J. Diedericks  
**Manufacturer** : Cessna Aircraft Company  
**Model** : Cessna 182  
**Nationality** : South African  
**Registration Marks** : ZS-RGN  
**Place** : At Bakenko

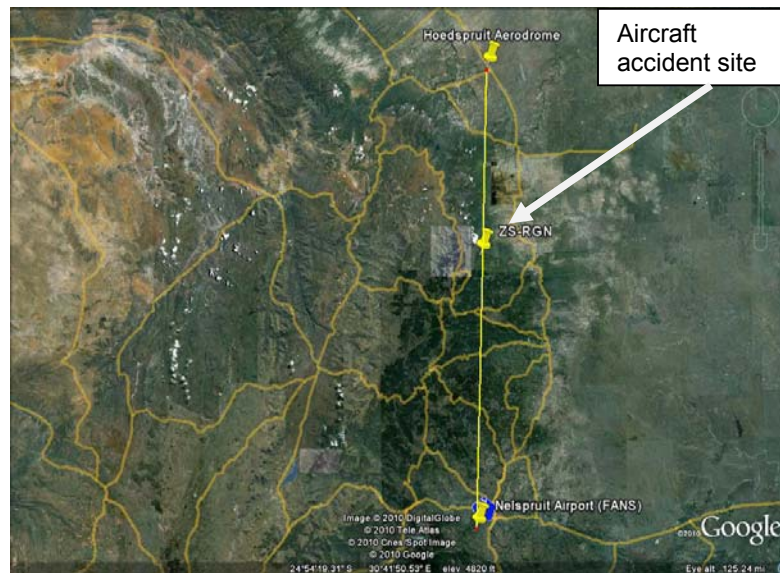
- 1.1.4 Both occupants had suffered fatal injuries and the aircraft was destroyed. The accident occurred at GPS co-ordinates determined as S24°49.00' E030° 55.53' at an elevation of 4500 feet above mean sea level (AMSL). See intended track on figure 1 below.

Figure 1: Likely track of the aircraft from Nelspruit and the accident site.

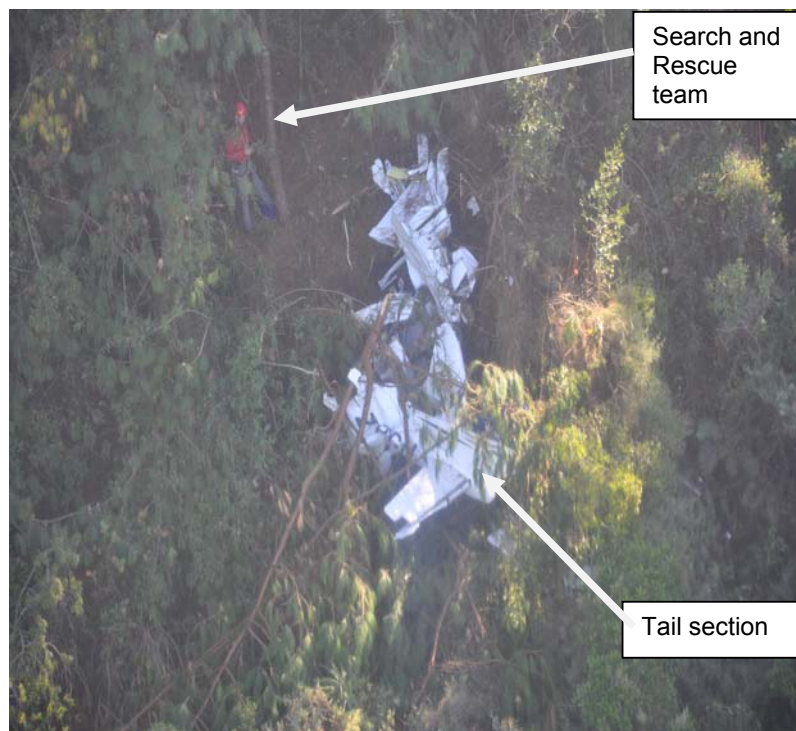
- 1.3.1 On-site inspection by the SACAA investigators showed that the aircraft was destroyed following a heavy impact with the mountain. See figure 2 below.

**Figure 2:** A view of the wreckage after the accident (aerial photograph).

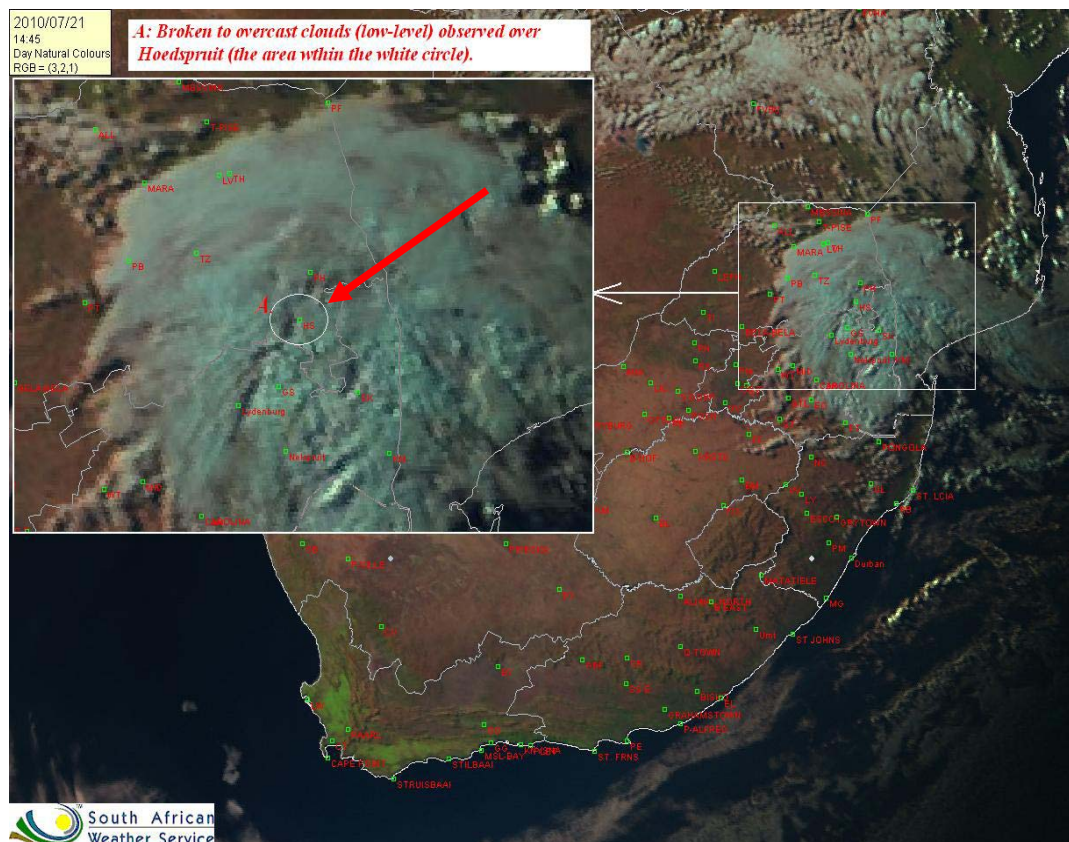
Cloud cover: No cloud reported (automatic weather station) but the satellite image shows broken to overcast clouds, and the closest manned station (Kruger Int. Airport) reported the cloud base to have been at 2000 ft AGL.

Figure 3: Satellite weather report at the time of the accident.

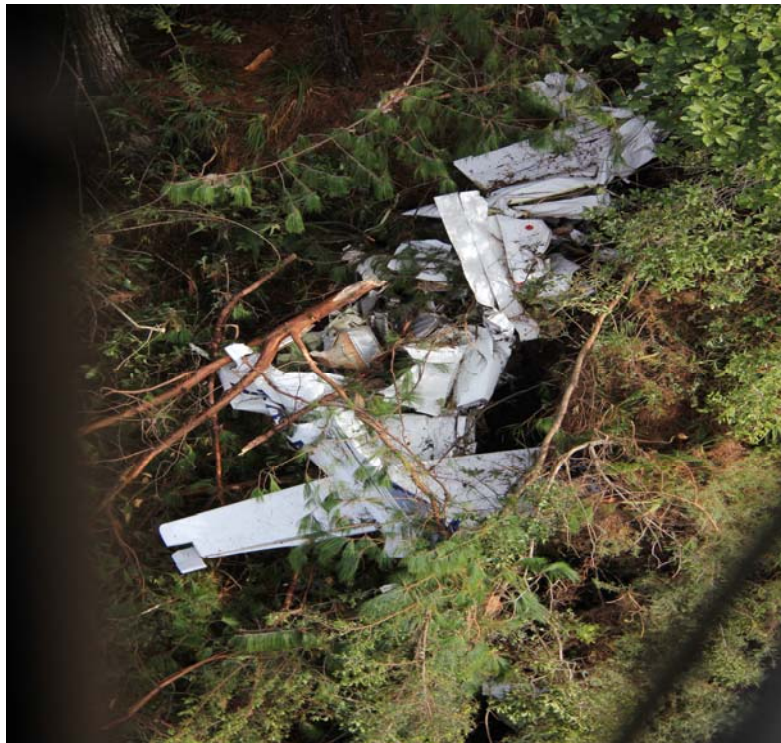
1.12.1 On-site examination of the wreckage revealed that the aircraft had broken apart on impact. The wreckage showed evidence of high speed on impact and there was no evidence of any airframe failure, flight control problems, electrical problems, power loss, or fire during the flight. The engine, the propeller, the tail section, both wings and the undercarriage were destroyed by the impact. There was evidence of fuel at the accident site and both fuel tanks had ruptured on impact. Due to the condition of the instruments it was not possible to determine the instrument readings and the position of all the switches at the time of impact. From examination of the wreckage, it was not possible to determine the position of the engine controls and fuel tank

selector. The cockpit was severely damaged on impact. See figure 4 below.

**Figure 4:** View of the wreckage on the mountain.

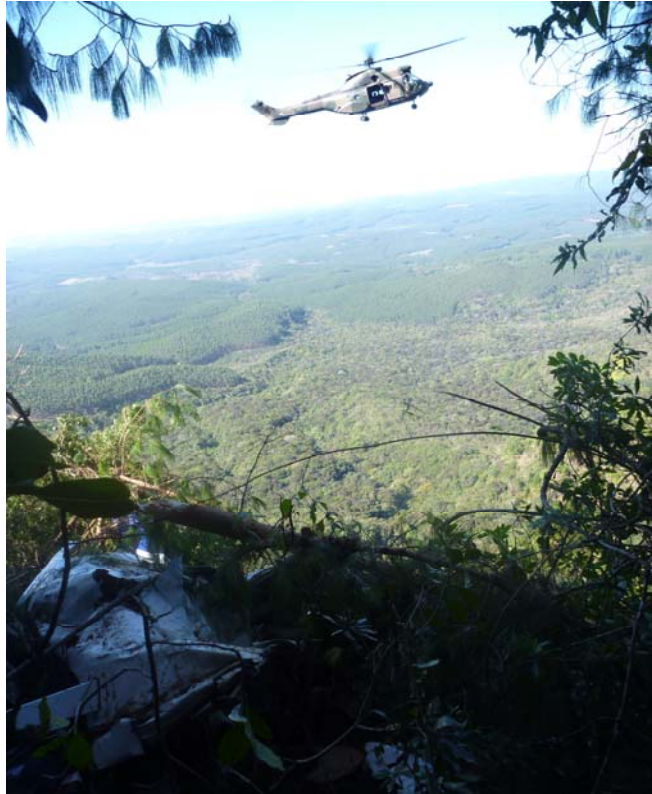
- 1.15.1 The accident was considered to be non-survivable due to the magnitude of the deceleration forces and the collapse of the cockpit/cabin area. All the seats were destroyed and the condition of the seat belt attachment and the adjustment of the seat belts couldn't be analyzed. The aircraft was not fitted with an emergency locator transmitter and the aircraft transponder was inoperative, which further hampered the Search and Rescue effort. Both occupants were found to be fatally injured and were extracted from the wreckage by the Search and Rescue team. The accident site was not accessible by foot or by road and all the people who took part had to be hoisted from the helicopter to the accident site. The South African Air force (SAAF), the South African Police Services (SAPS) and the Mountain Search

**Figure 5:** View of the terrain, the wreckage and the rescue helicopter.
