**AIRCRAFT ACCIDENT REPORT AND EXECUTIVE SUMMARY**

Reference:	CA18/2/3/8819	
<b>Aircraft Registration</b>	ZS-CVW	<b>Date of Accident</b>	13/08/2010		<b>Time of Accident</b>	0740Z	
<b>Type of Aircraft</b>	Robinson R44		<b>Type of Operation</b>	Private			
<b>Pilot-in-command Licence Type</b>		Private	<b>Age</b>	54	<b>Licence Valid</b>	Yes	
<b>Pilot-in-command Flying Experience</b>		Total Flying Hours	388.4		Hours on Type	376.2	
<b>Last point of departure</b>		South Africa - FAGM (QRA): Johannesburg/Rand					
<b>Next point of intended landing</b>		South Africa - FAEO : Ermelo					
<b>Location of the accident site with reference to easily defined geographical points (GPS readings if possible)</b>							
25 km west of Ermelo (Mpumalanga) at GPS coordinates S 26°30'35" E 29°47'30"							
<b>Meteorological Information</b>		CAVOK. Temperature 10°C. Cloud cover: Nil. Wind speed: 8kts. Wind Direction 250°					
<b>Number of people on board</b>	1+2	<b>No. of people injured</b>	0	<b>No. of people killed</b>	3

## AIRCRAFT ACCIDENT REPORT

**Name of Owner/Operator** : Colmec Carriers cc  
**Manufacturer** : Robinson Helicopter Company  
**Model** : R44 II  
**Nationality** : South African  
**R

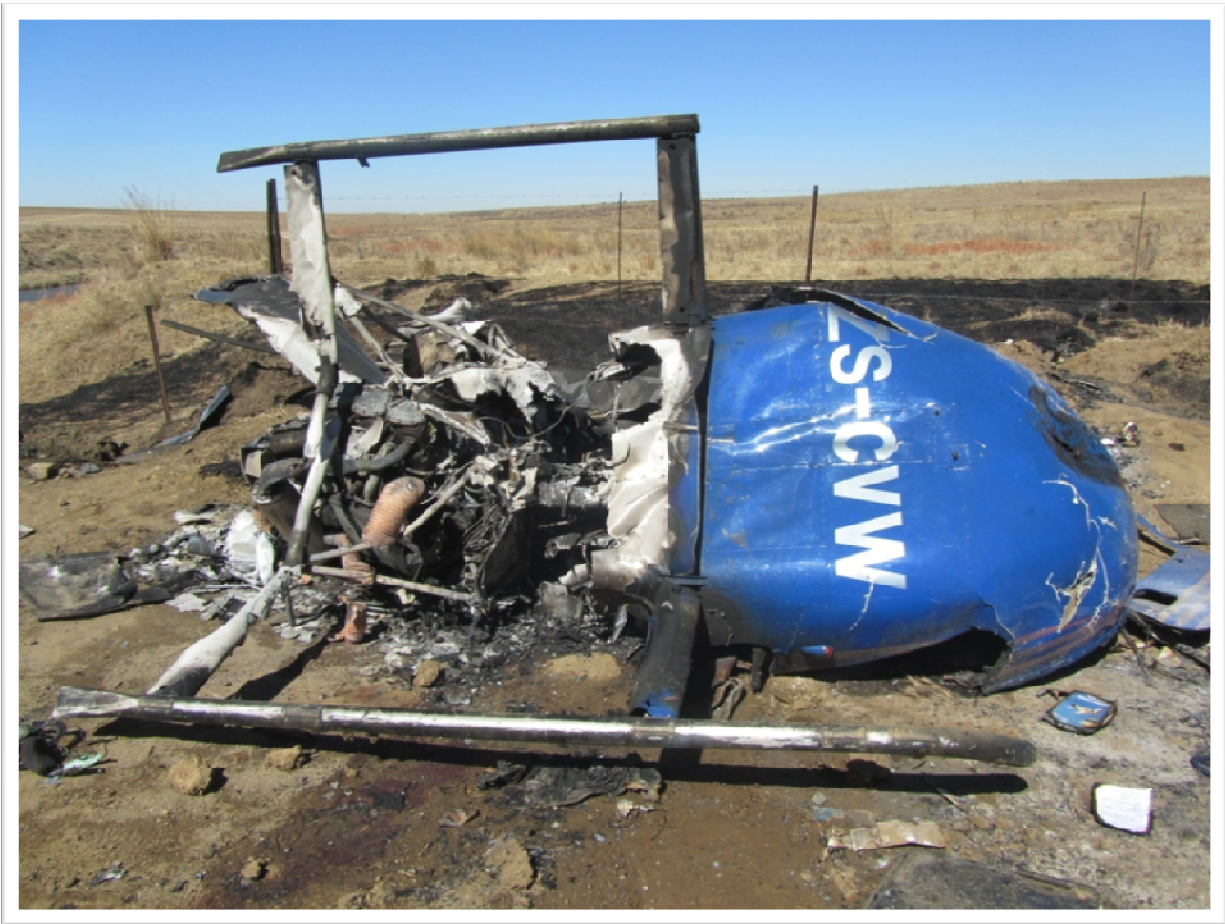
1.3.1 The helicopter was destroyed by impact forces and the post-impact fire.

Figure 1 showing the accident site.

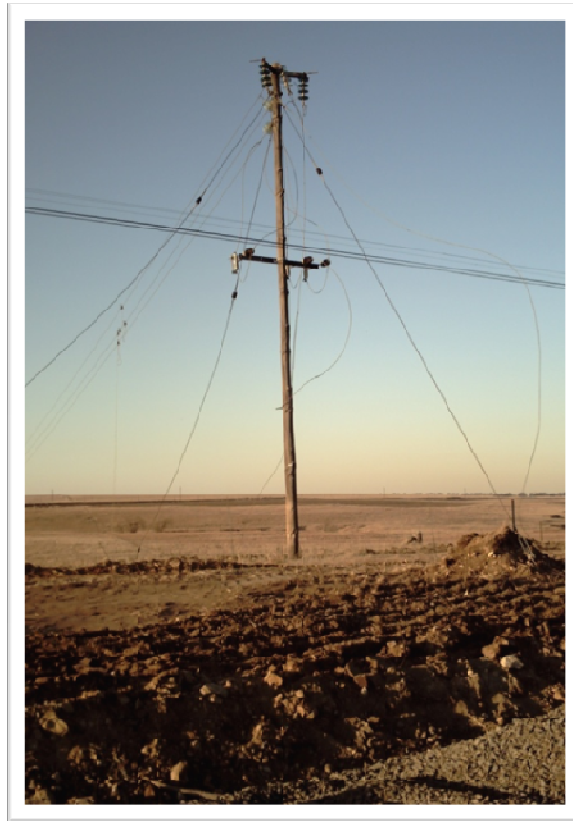
1.4.1 Other damage was caused to the electrical power cables which were severed when they were struck by the helicopter.

Figure 2 showing severed electrical power cables.

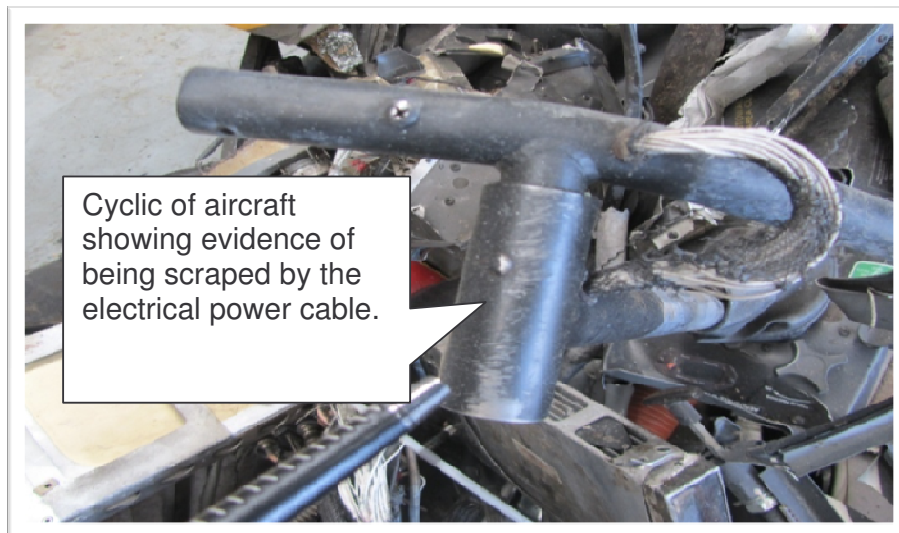
The cyclic control of the aircraft showed signs of being scraped by the electrical cables.

Figure 3 shows the impact marks on the cyclic of the helicopter.

2.1 Inspection of the aircraft's cyclic control revealed marks associated with the impact of a metal cable. Evidence of broken electrical power cables were found on the scene of the accident. The marks on the cyclic control of the helicopter were caused by the electrical power cable.

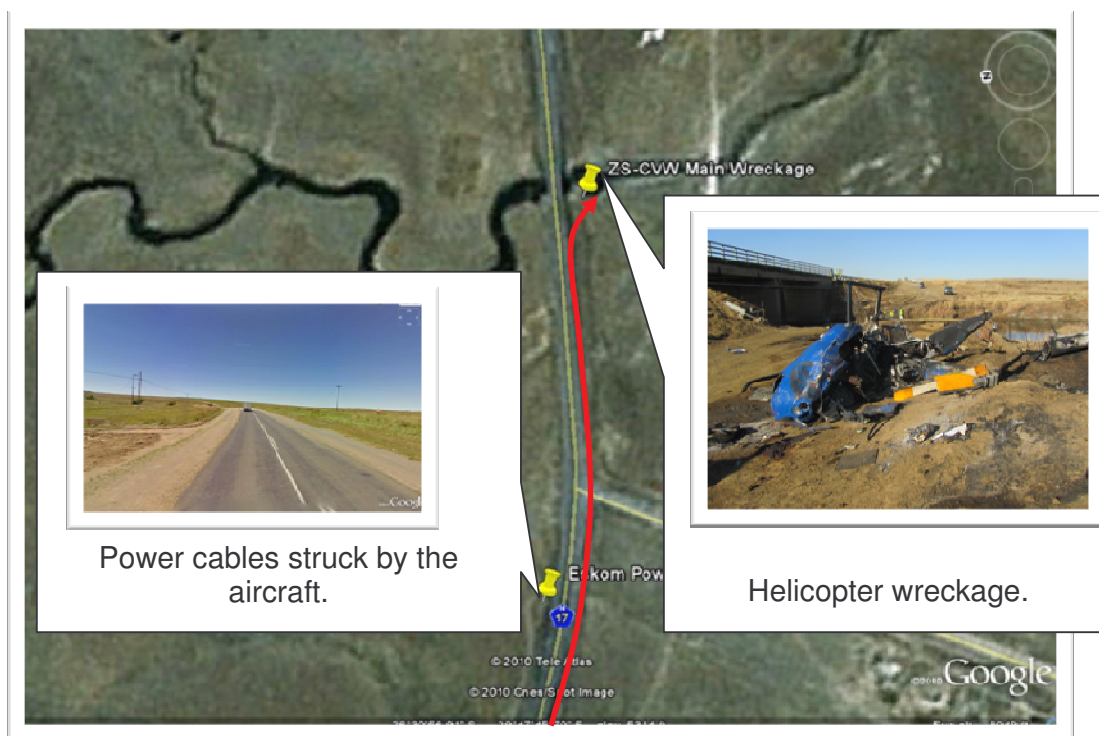
1.12.6 The first ground impact scars were found approximately 280 metres from the point of impact with the electrical power cables. The impact scars were identified as that of the right skid which collided with the barrier located on the bridge. The main rotor struck the embankment and one rotor blade broke off. Approximately 20 m forward of the main rotor, the aircraft tail boom section collided with the ground. Approximately 20 m further the main fuselage struck the ground and came to rest on its left side.

Figure 4 showing the accident sequence. The red arrow indicates the direction of the flight.
