AIRCRAFT ACCIDENT REPORT AND EXECUTIVE SUMMARY

Reference:	CA18/2/3/8821	
Aircraft Registration	ZS-NFU	Date of Accident	17 August 2010		Time of Accident	0700Z
Type of Aircraft	Piper PA-28-140		Type of Operation	Private		
Pilot-in-command Licence Type		Private Pilot	Age	19	Licence Valid	Yes
Pilot-in-command Flying Experience		Total Flying Hours	158,6		Hours on Type	17,4
Last point of departure		Beaufort West aerodrome (FABW), Western Cape				
Next point of intended landing		George aerodrome (FAGG), Western Cape				
Location of the accident site with reference to easily defined geographical points (GPS readings if possible)						
Between pole 37 and pole 38 on the DRO F2 (Droërvier Farmers 2) power line (GPS position S32°1853' E022°3748')						
Meteorological Information		Temperature: 14°C; Dew point - 6°C; Surface wind: 170°TN/3 kt				
Number of people on board	1 + 0	No. of people injured	1	No. of people killed	0	
Synopsis						
<p>The pilot stated that after takeoff from Beaufort West aerodrome and at a height of 450 feet above ground level, he turned left at a banking angle of approximately 45 degrees. While rolling out from the turn, he reached for his camera to photograph the ru

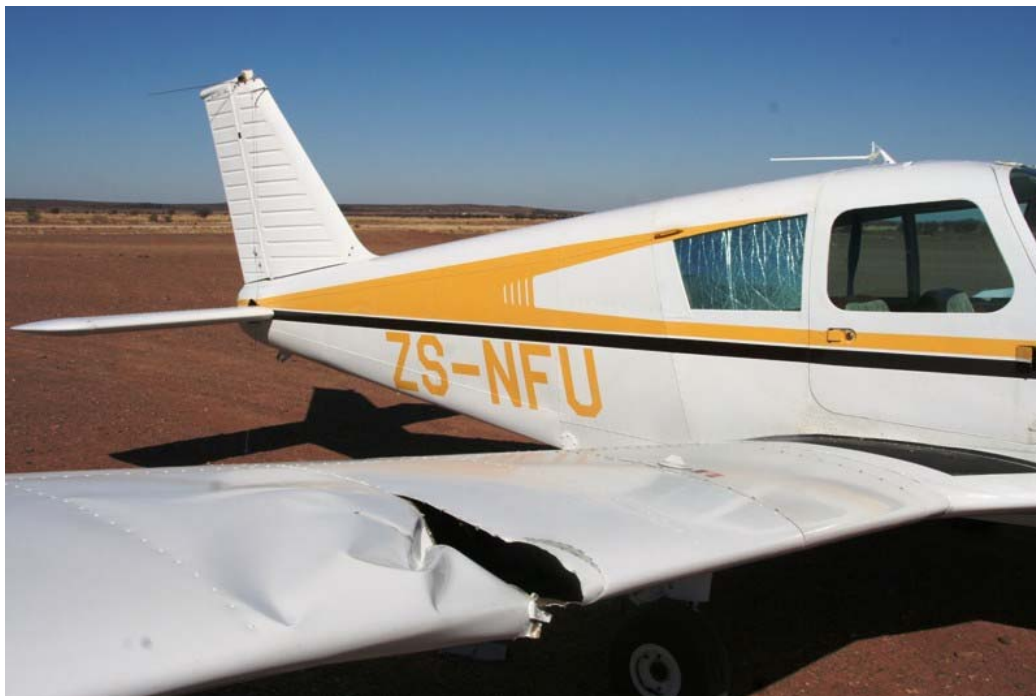
1.3.1 The aircraft sustained substantial damage from its collision with the power lines.

Figure 1. Damage to the wing.

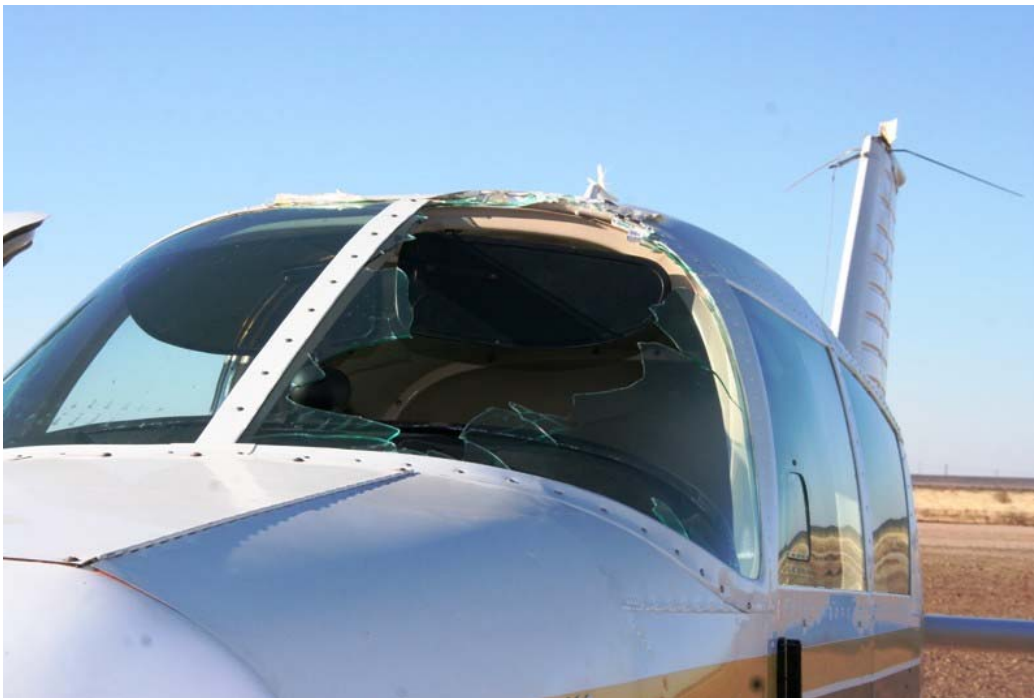
1.1.6 The impact shattered the windscreen, shards of which cut the pilot on his forehead and made it difficult for him to see ahead. He contemplated making an emergency landing on the road. However, once he managed to clear the blood from his eyes, he realised this would be impossible due to the heavy traffic. He opted instead to return to Beaufort West aerodrome where he executed an uneventful landing.

Figure 2. The shattered windscreen.

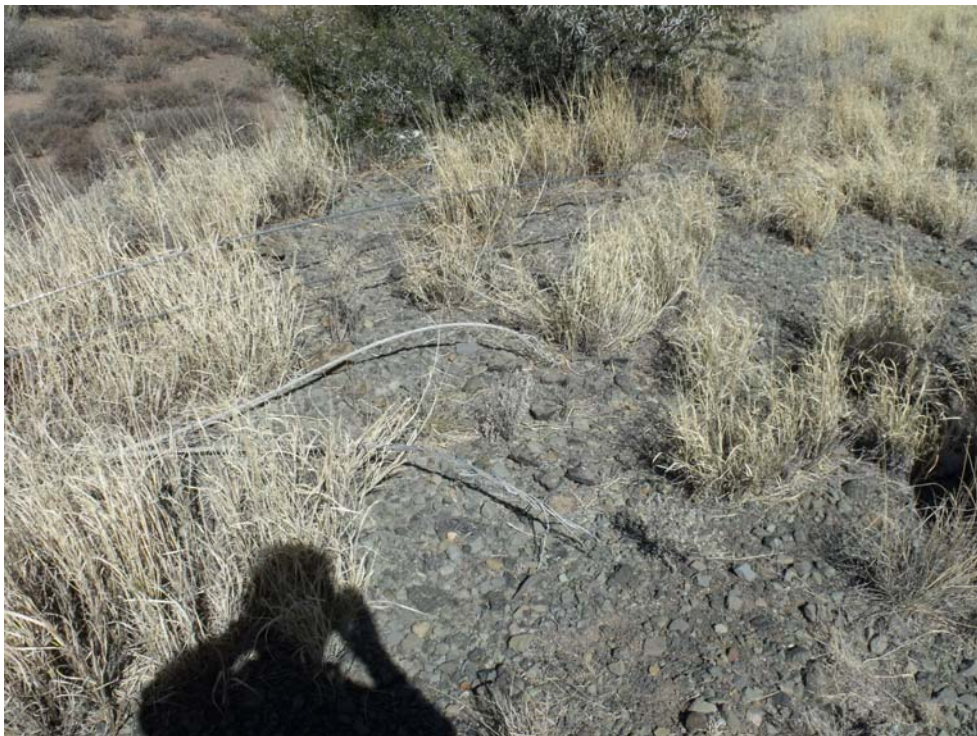
1.4.1 One power cable was severed and a second was damaged.

Figure 3. The severed power cable.

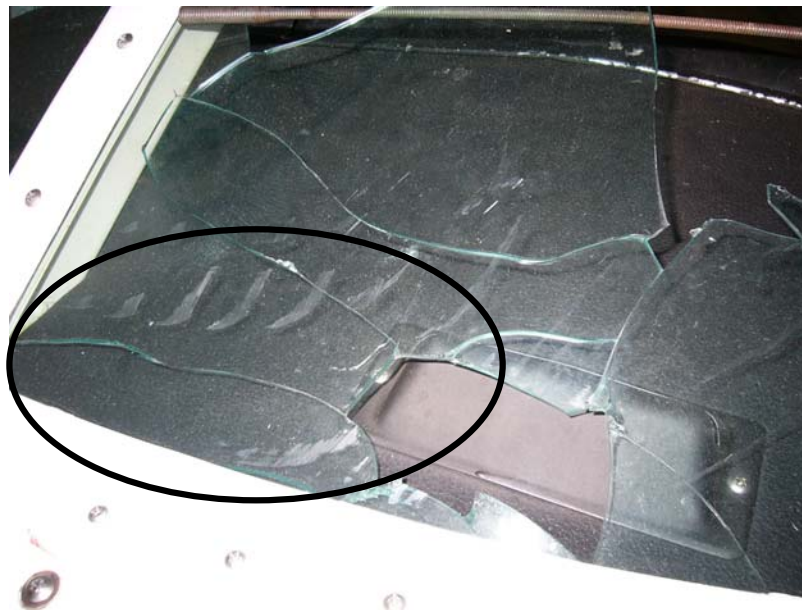
1.18.2 During the investigation, when pieces of the broken windshield (left side) were reconstructed, markings were observed on the perspex which correlated with markings on the unbroken right windshield. These indicated the impact from the power cable.

Figure 4. Marks on the broken (left) windshield similar to marks on the right windshield.
