AIRCRAFT ACCIDENT REPORT AND EXECUTIVE SUMMARY

Reference:	CA18/2/3/8822	
Aircraft Registration	ZU-ETC	Date of Accident	21 August 2010		Time of Accident	0516Z
Type of Aircraft	Cheetah XLS		Type of Operation	Private		
Pilot-in-command Licence Type		Private	Age	65	Licence Valid	Yes
Pilot-in-command Flying Experience		Total Flying Hours	638.25		Hours on Type	17.5
Last point of departure		Springs Aerodrome (FASI), Gauteng Province				
Next point of intended landing		Springs Aerodrome (FASI), Gauteng Province				
Location of the accident site with reference to easily defined geographical points (GPS readings if possible)						
In open field approximately 48 m from Runway 03 at FASI (S26° 15.020 E028° 23.536 at 1647m elevation)						
Meteorological Information		Temperature: 08 °C; Dew point: 06 °C; Wind: 340 °/04 knots; Cloud cover: Low; Visibility: Poor				
Number of people on board	1+1	No. of people injured	0	No. of people killed	2	
Synopsis

Name of Owner/Operator : DM Mackeown
Manufacturer : Rainbow Aircraft (PTY) LTD
Model : Cheetah XLS
Nationality : South African
Registration Marks : ZU-ETC
Place : Springs, Gauteng
Date : 21 August 2010
Time : 0516Z

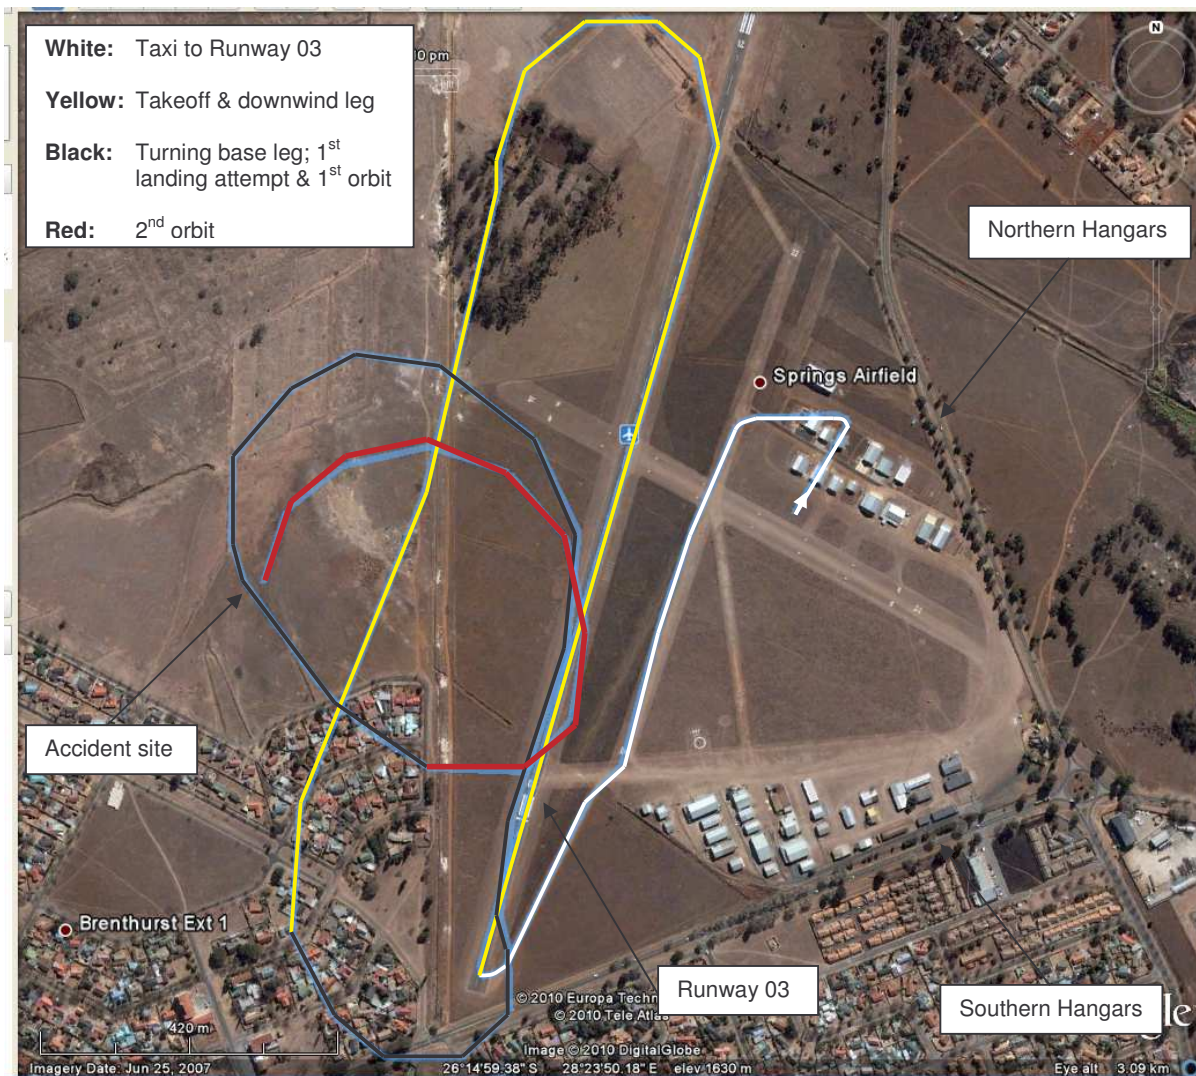
Figure 1, Shows the track of the left-hand circuit flown on the day.

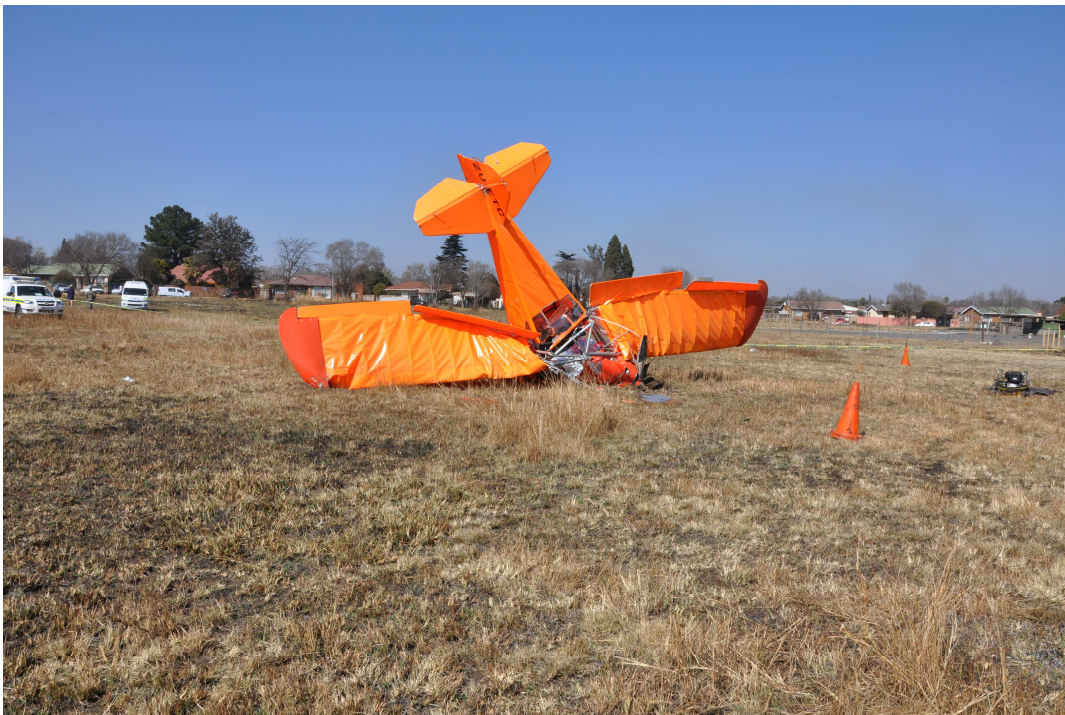
1.3.1 The aircraft was destroyed in the accident.

Photo 2: A view of the aircraft wreckage.

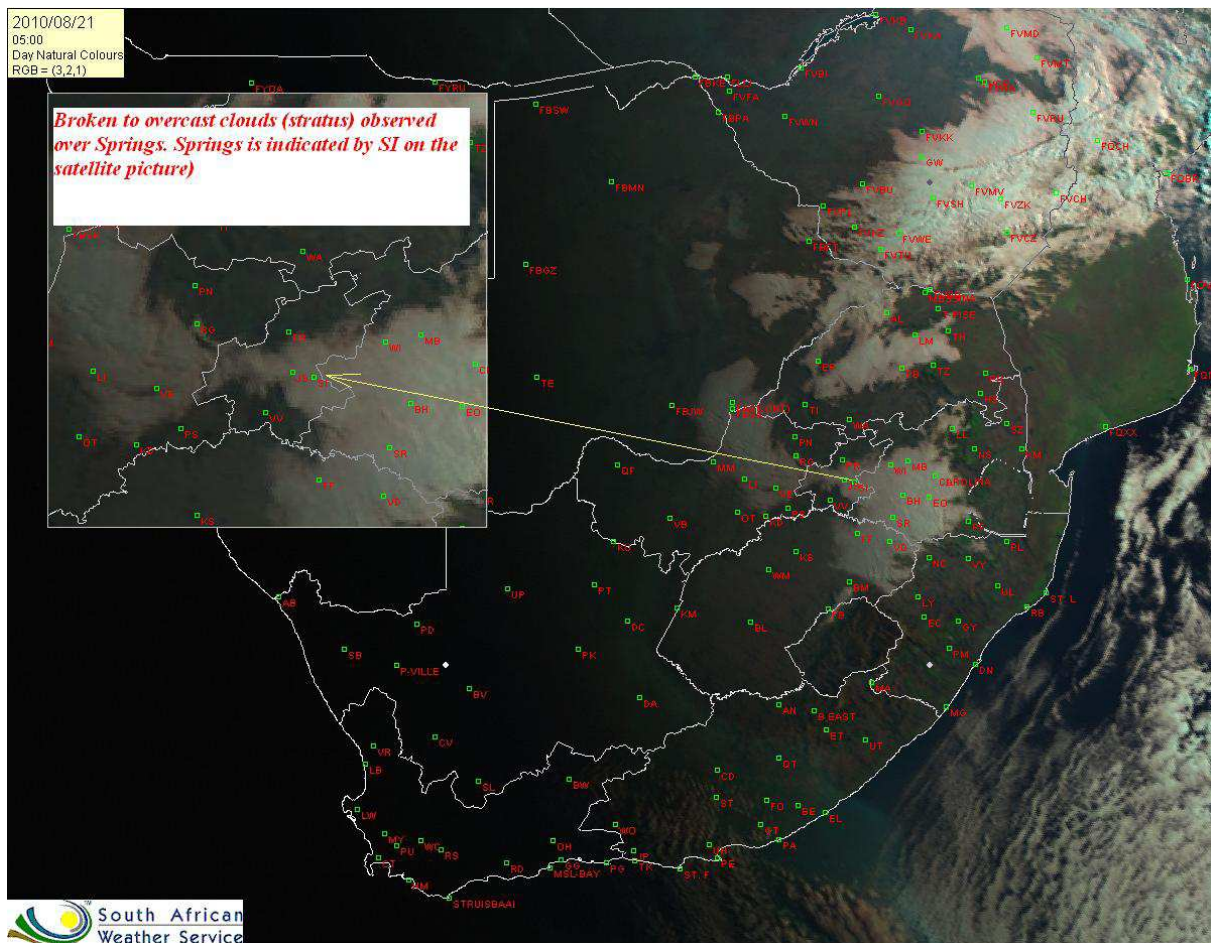
Low clouds (stratus clouds) occur over the northern parts of Limpopo Province, extending to the west and south-west, up to the southern parts of Gauteng and central Mpumalanga. Broken to overcast stratus clouds are observed over the southern parts of Gauteng in the vicinity of the aircraft incident.

Photo 3. Satellite image, indicating partly cloudy conditions at the location of the accident.

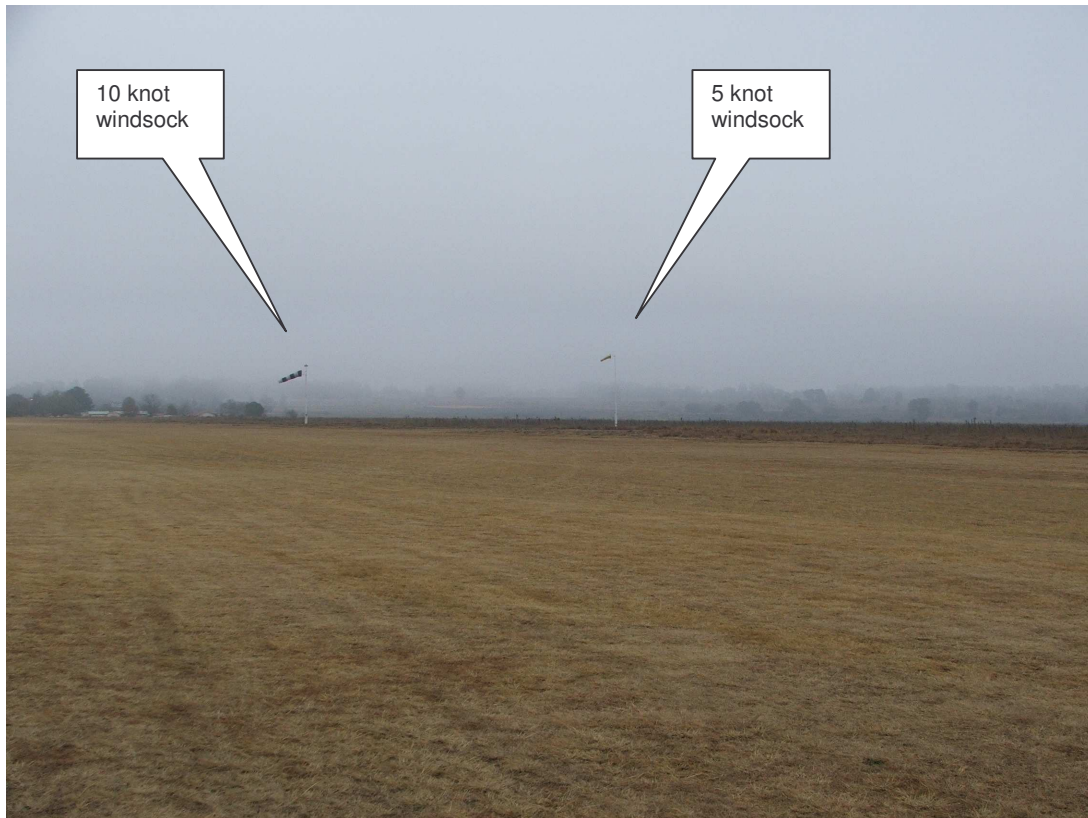
- 1.7.2 Witnesses who were at Springs Aerodrome during the accident flight reported poor visibility due to low-lying fog; Wind speeds that exceeded 10 knots were also indicated by the windsock at the airfield.

Photo 4. The weather conditions approximately 20 minutes after the accident had occurred.

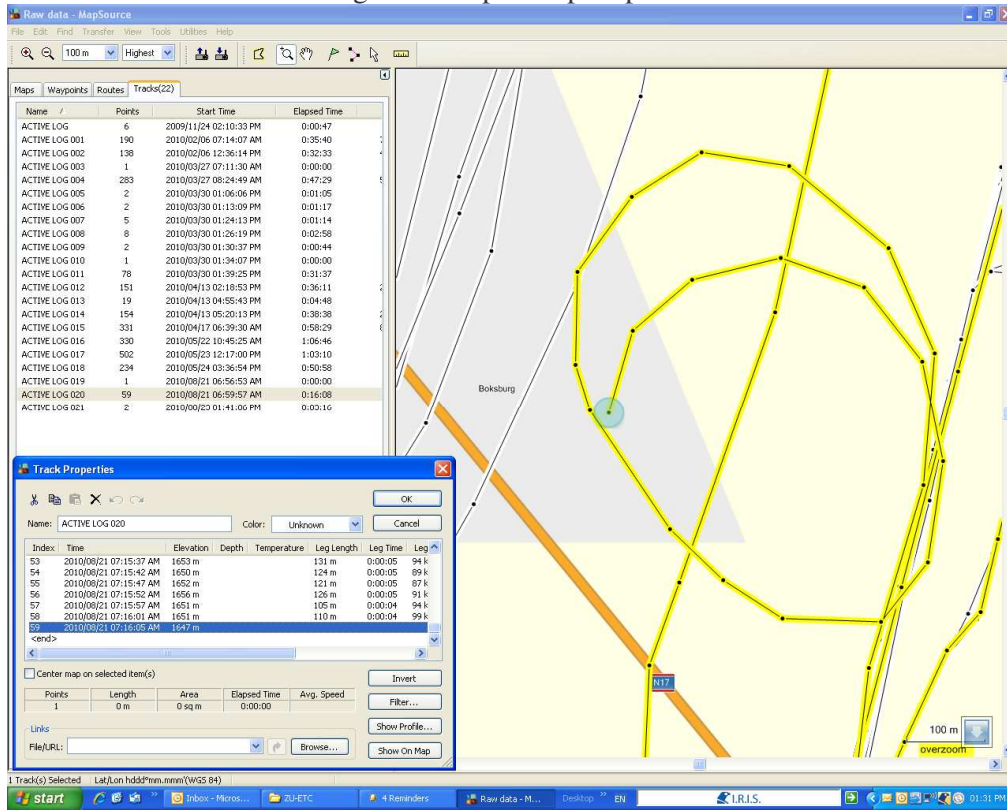
ZU-ETC Zoomed in flight track up to impact point

the right at a heading 347 degrees true at 1650m, ie 6m agl. The highest point of this final turn was 1656m, ie 12m agl and the ground speed was now about 7kmh slower than in the first orbit. During the last 10 seconds, the aircraft descended to about 7m agl and the speed increased by 10kmh to 99kmh at impact.

The impact altitude is shown as 1647m, ie 3m above take-off point. The position of impact is shown as S26 15.020 E028 23.536 and it occurred at 07:16:05. Google Earth images indicate that there may have been rising ground just on the outside of the final part of the turn
