AIRCRAFT ACCIDENT REPORT AND EXECUTIVE SUMMARY

Reference:		CA18/2/3/8830	
Aircraft Registration	ZU-DTB	Date of Accident	9 September 2010		Time of Accident	1505Z	
Type of Aircraft	DynAero MCR 4 S		Type of Operation		Private		
Pilot-in-command Licence Type		Private Pilot	Age	52	Licence Valid	Yes	
Pilot-in-command Flying Experience		Total Flying Hours	565,0		Hours on Type	339,0	
Last point of departure		Bapsfontein Fly Inn Park Aerodrome.					
Next point of intended landing		Barberton					
Location of the accident site with reference to easily defined geographical points (GPS readings if possible)							
Off the runway at Carolina Airstrip.							
Meteorological Information		Wind direction: 27°/10 kts, Temperature:18 °C, Visibility: Good, Cloud base: CAVOK.					
Number of people on board	1 + 1	No. of people injured	0	No. of people killed	0		
Synopsis							
<p>The pilot accompanied by a passenger flew the aircraft on a private flight from Bapsfontein Fly Inn Park to Barberton, when the pilot decided to do a quick stop at Carolina and landed the aircraft on Runway 27. The runway has a slight down-slope and grass surface, which prevented the brakes from working effectively and bringing

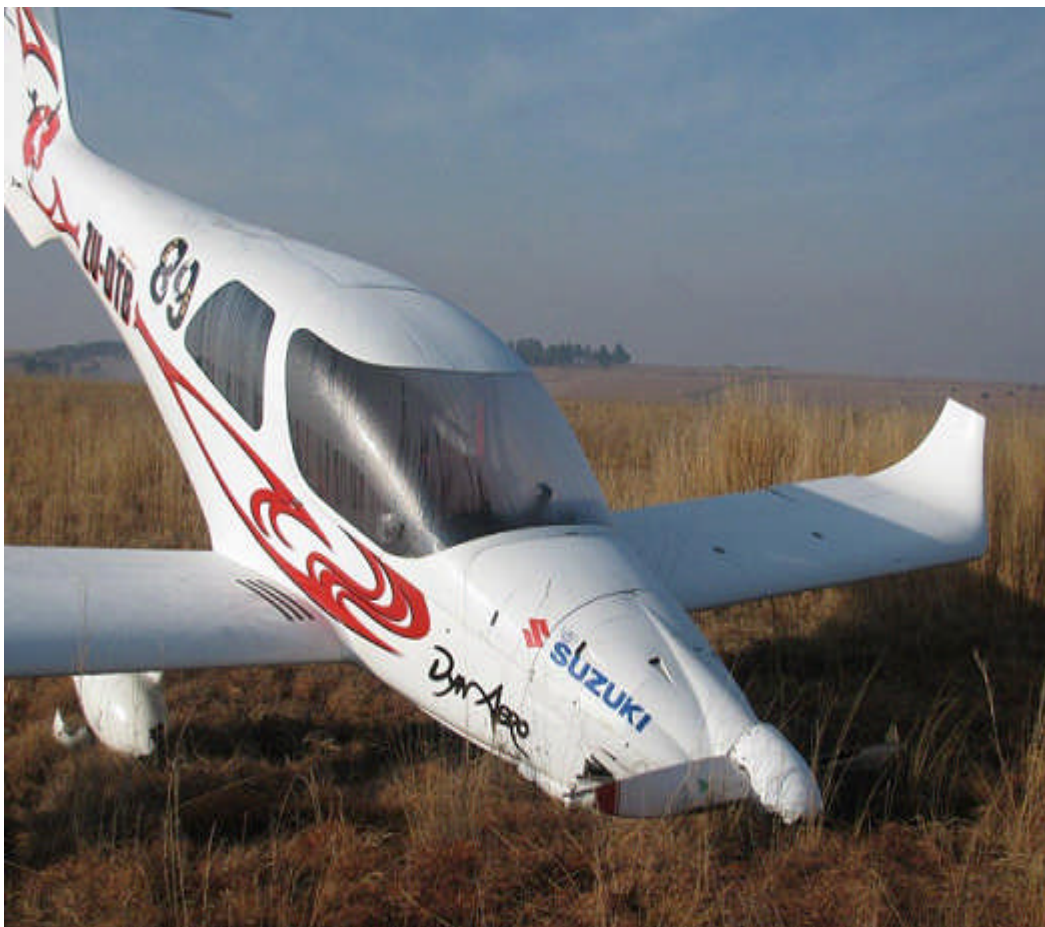
1.3.1 The aircraft sustained substantial damage in the accident.

Figure 1, shows aircraft after it came to stop off the runway.

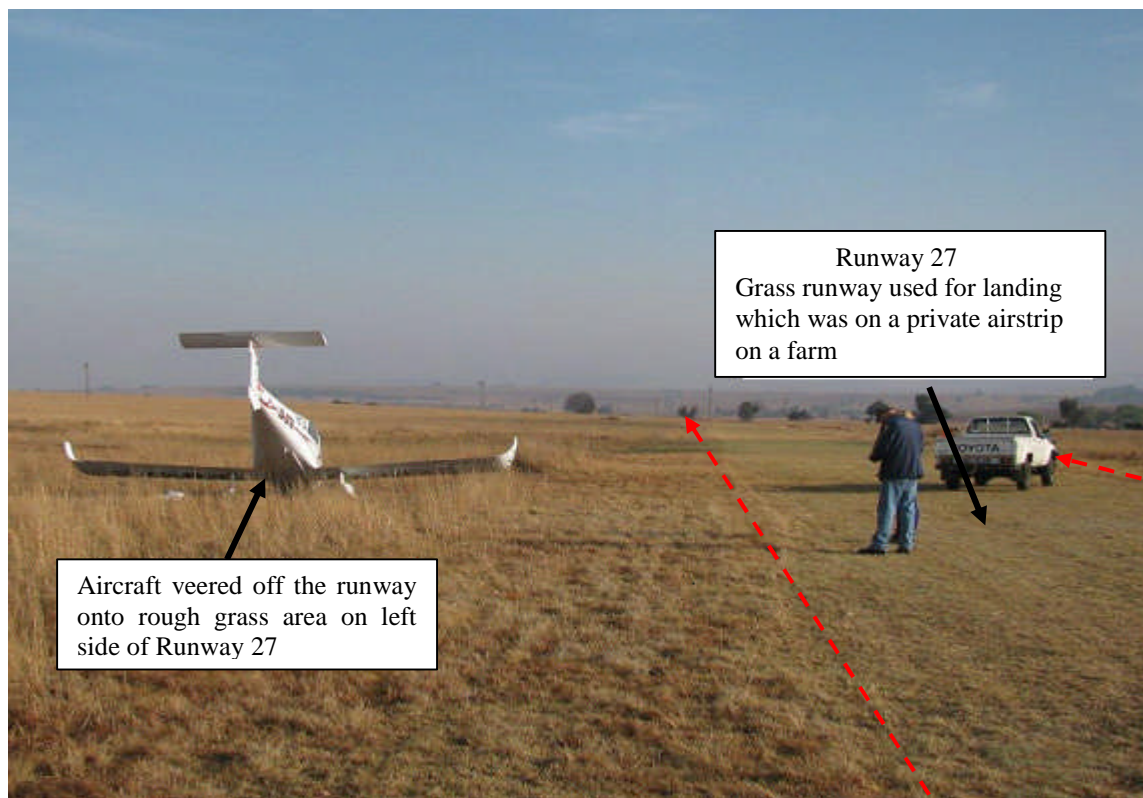
- 1.12.1 The aircraft approached the airfield from westerly direction and landed on Runway 27. The runway had a down-slope which prevented the brakes from being effective and bringing the aircraft to a stop. The pilot pulled the handbrake to assist but it resulted in the aircraft veering off the runway onto a rough grass area. The nose wheel entered in a ditch which caused the nose landing gear to collapse.

Figure 2 shows private airstrip, runway used and rough grass area where the aircraft was involved in the accident.

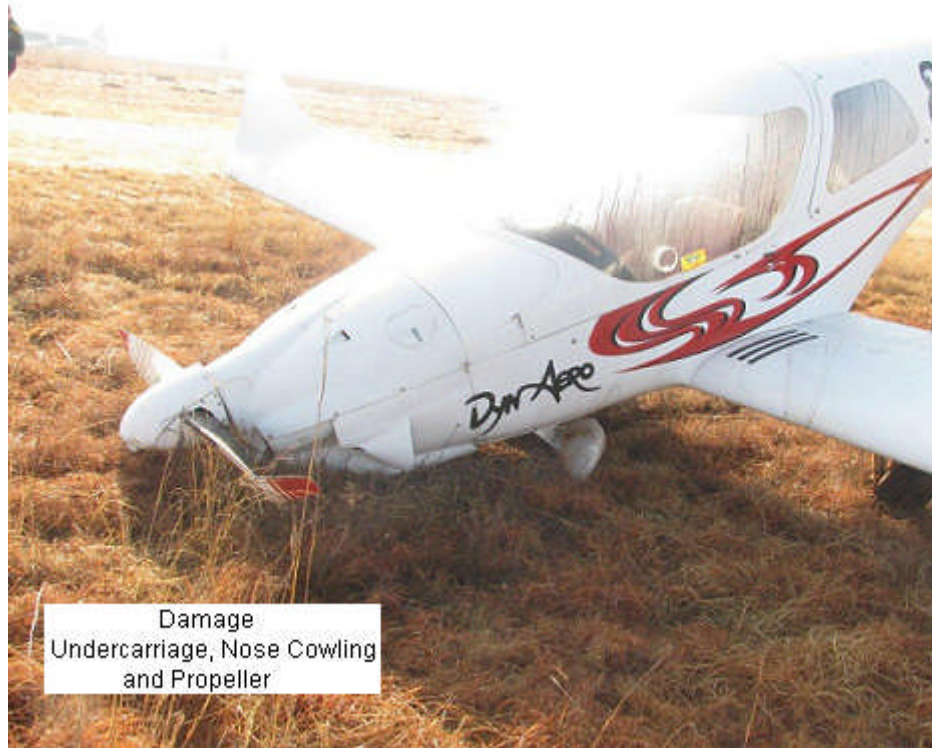
- 1.12.3 One blade of the two-bladed propeller was damaged. The propeller blade tip hit the ground and bent to the rear. The indication is that the propeller was not under power when it hit the ground. This is also an indication that the engine was most probably not running at the time of impact.

1.12.4 When the nose wheel collapsed, the nose section of the aircraft hit the ground. The bottom engine cowling and firewall was damaged.

Figure 3 shows damage caused to the aircraft.
