AIRCRAFT ACCIDENT REPORT AND EXECUTIVE SUMMARY

Reference:	CA18/2/3/8835	
Aircraft Registration	ZS-RJO	Date of Accident	17 Sept 2010		Time of Accident	0940Z
Type of Aircraft	Robinson R44 Raven II		Type of Operation		Private	
Pilot-in-command Licence Type		Private	Age	55	Licence Valid	Yes
Pilot-in-command Flying Experience		Total Flying Hours	1487.1		Hours on Type	1487.1
Last point of departure		FAGM (Rand Aerodrome)				
Next point of intended landing		FAKN (Kruger Mpumalanga Aerodrome)				
Location of the accident site with reference to easily defined geographical points (GPS readings if possible)						
GPS position S25° 42,694' E030° 2,664' @ elevation of approximately 1906m (6250 ft) AMSL near the town of Belfast in Mpumalanga						
Meteorological Information		Overcast with low cloud and low visibility, temperature approximately 15°C, no rain at the time.				
Number of people on board	1+2	No. of people injured	3	No. of people killed	0	
Synopsis

Name of Owner/Operator : Kawena Aviation (Pty) Ltd
Manufacturer : Robinson Helicopter Company
Model : R44 II
Nationality : South Africa
Registration Marks : ZS-RJO
Place : Belfast
Date : 17 September 2010
Time : 0940Z

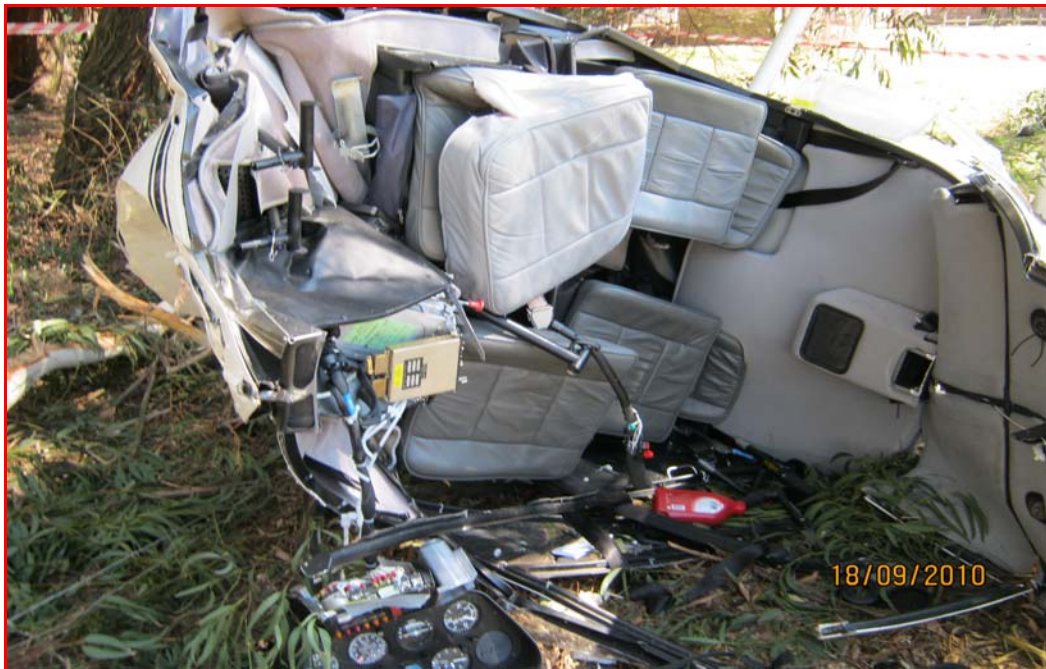
A view of the cabin area after the accident

1.15.1 All the occupants were properly restraint with safety harnesses and shoulder harnesses and none of these failed. Both the front seats failed sideways as a result of the impact forces during the accident.

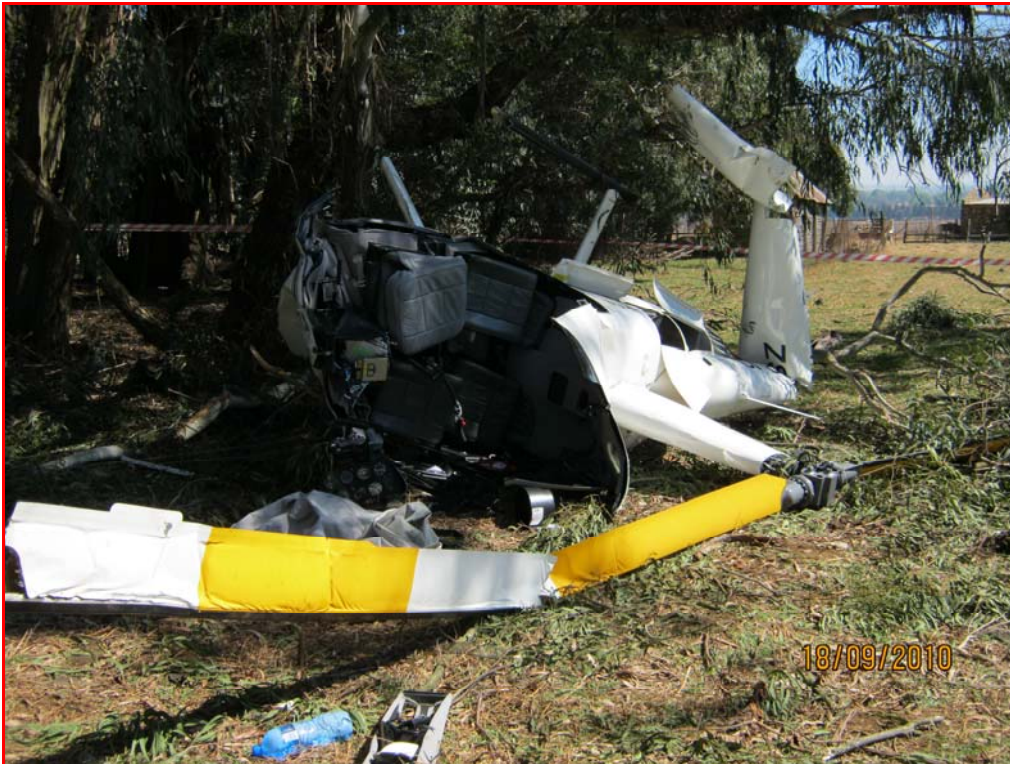
1.3.1 The helicopter was destroyed during the accident sequence.

General view of the wreckage

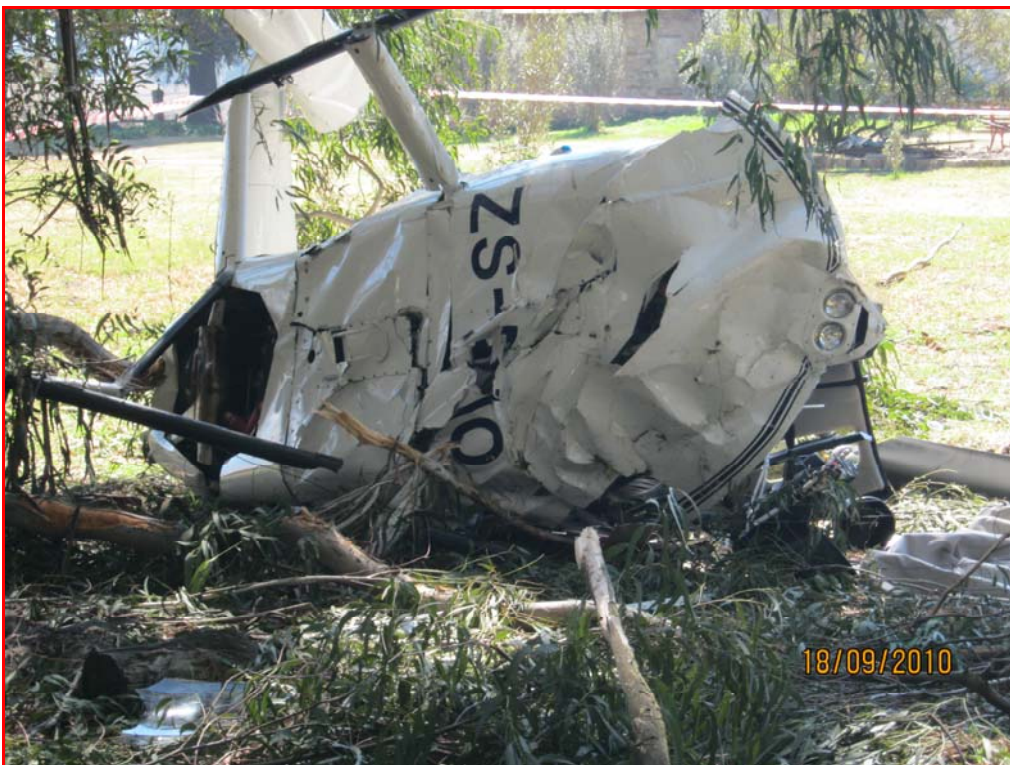
General view of the wreckage from below

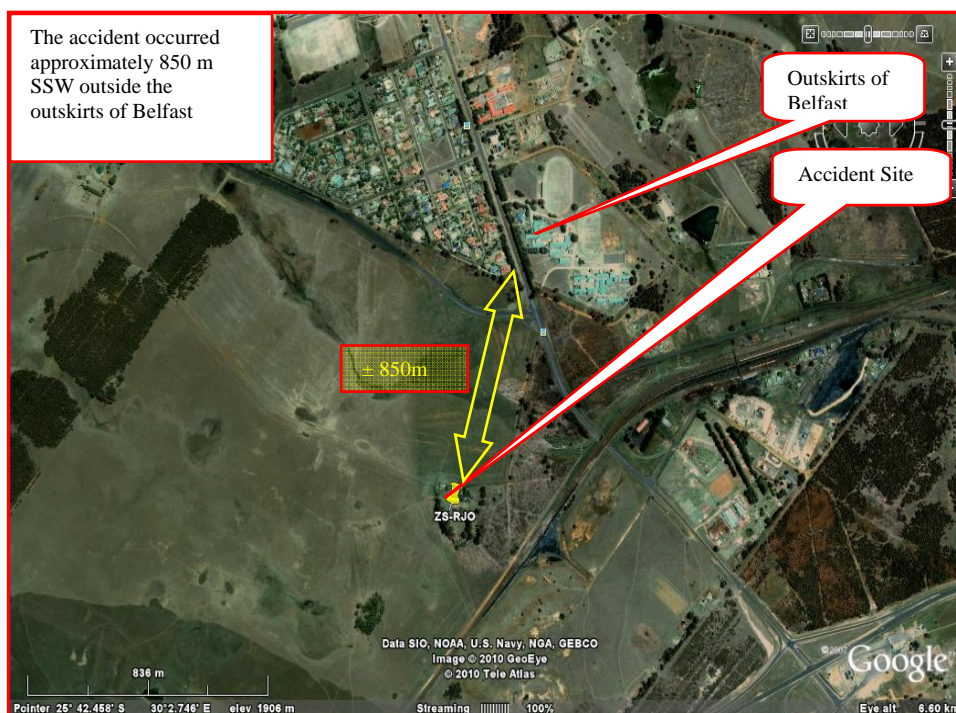
General view of area where the accident occurred

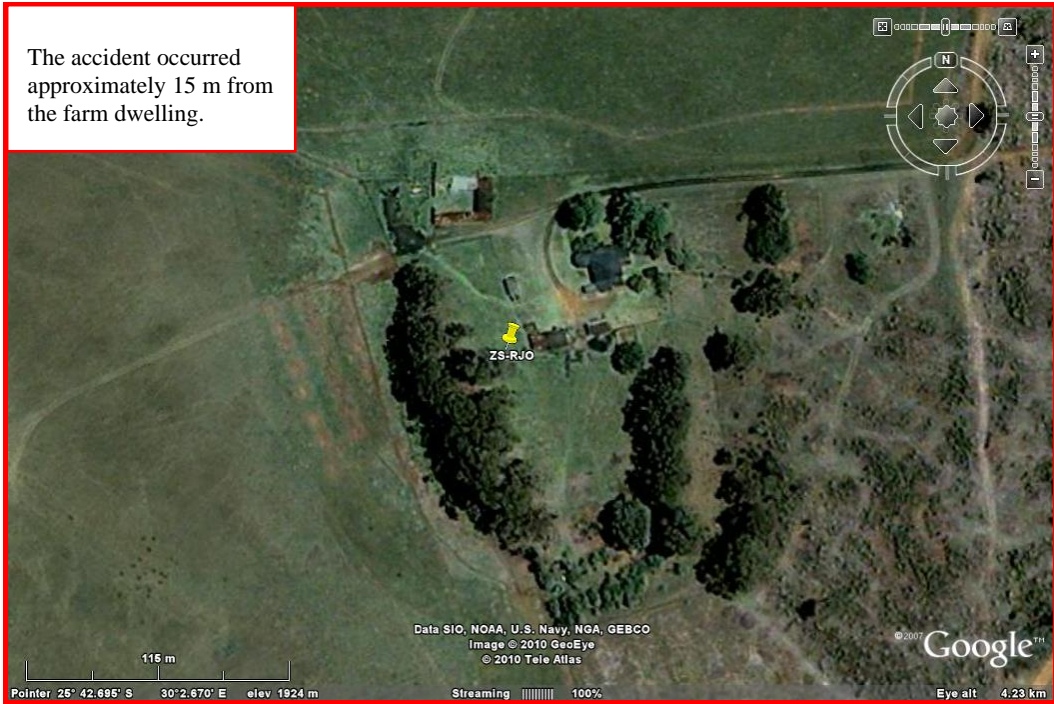
Aerial view of the crash site area

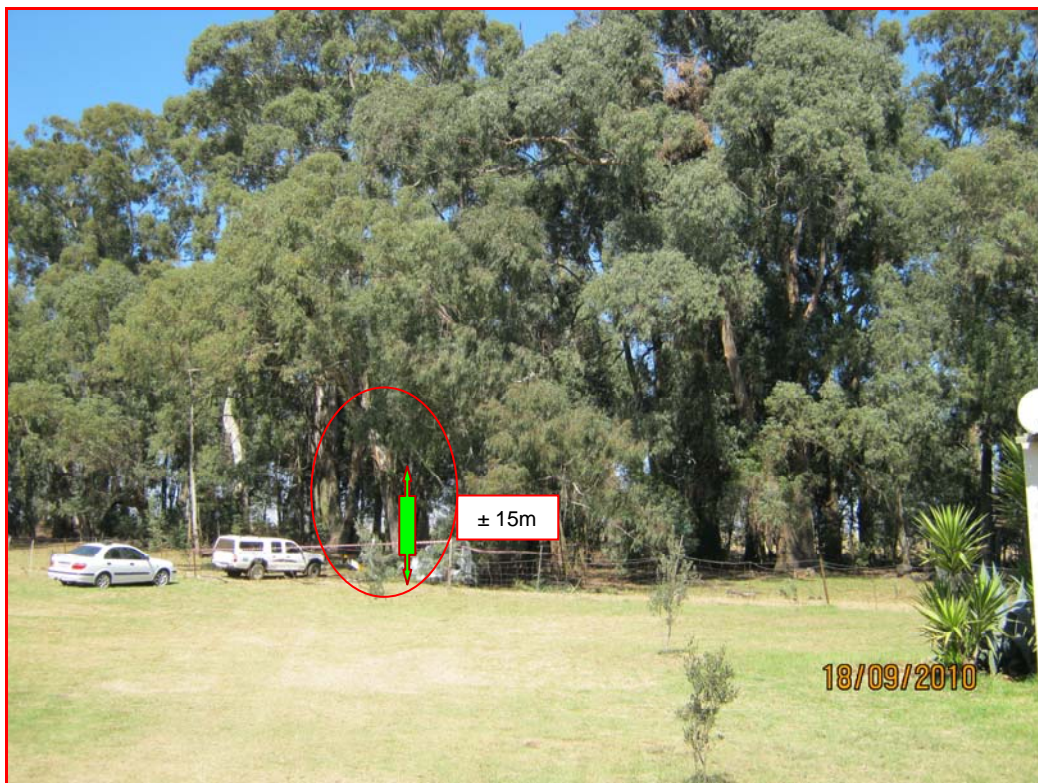
- 1.12.1 At the time of the accident, the helicopter was flying in a westerly direction at a height of approximately 20 m AGL.
- 1.12.2 It would appear that the pilot noticed the trees just before impact and attempted to turn to the left to avoid a collision. However, the main rotor made contact with the trees, followed by the tail rotor at a height estimated at 15 m AGL.

View of the trees struck during the accident sequence.

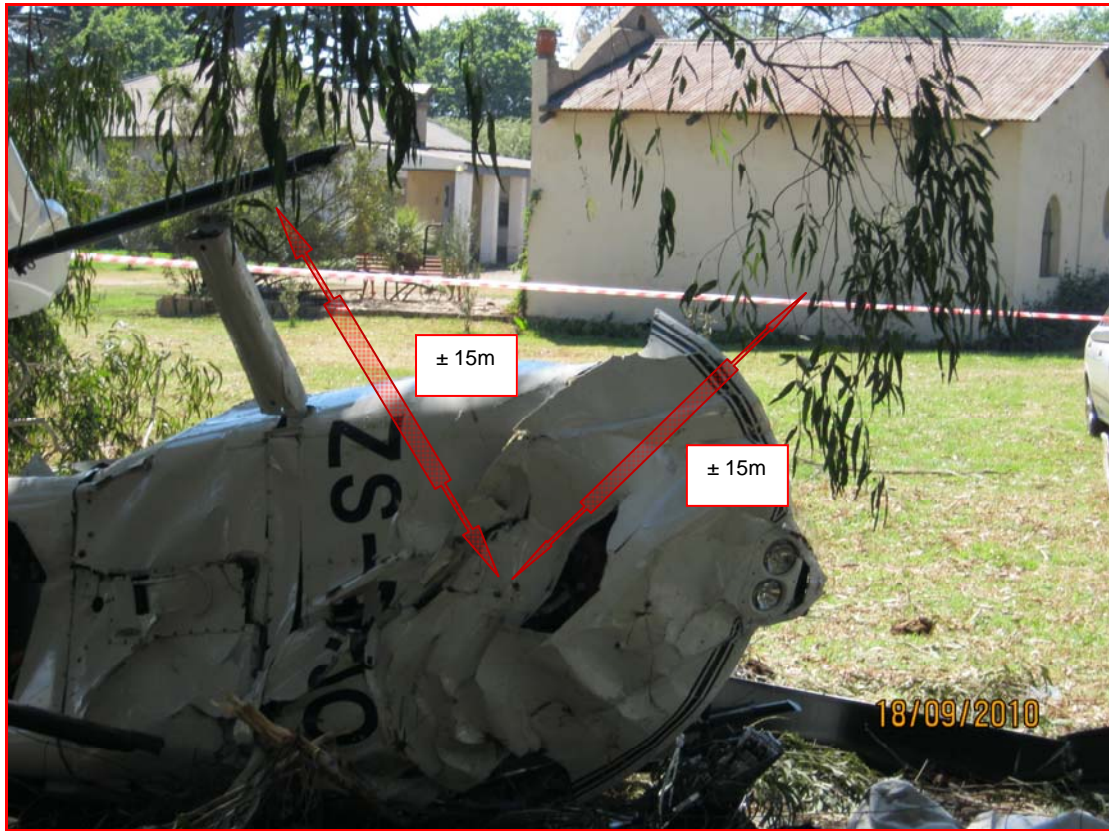
1.12.4 The accident occurred at a mere 15 m from the farm dwelling while the residents were inside the dwelling.

View of the accident site in relation to the dwellings on the farm.

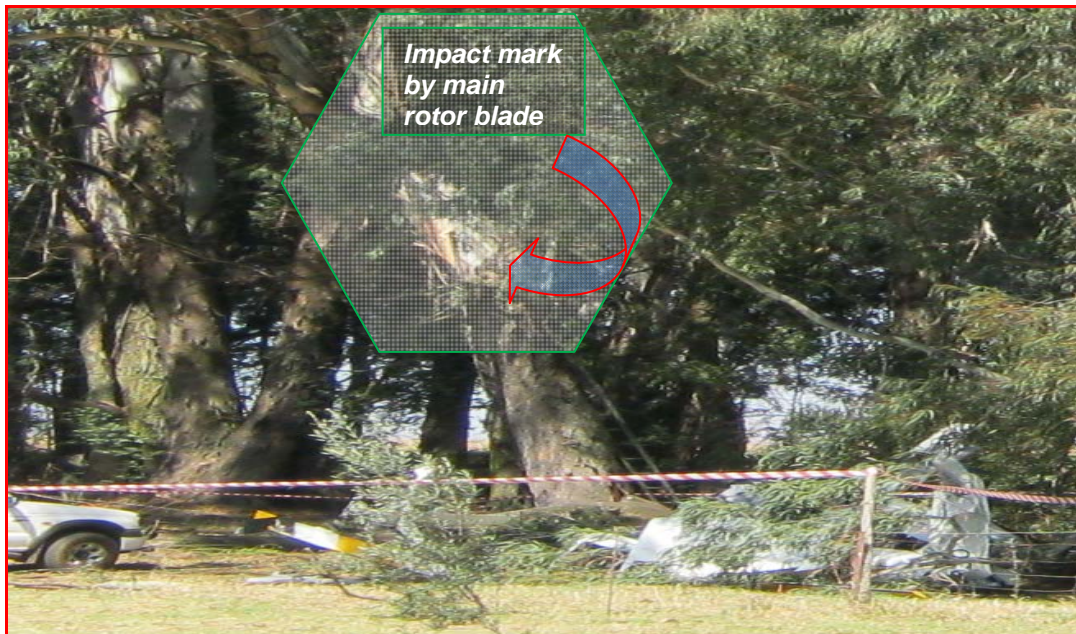
View of the impact of the main rotor with the trees.

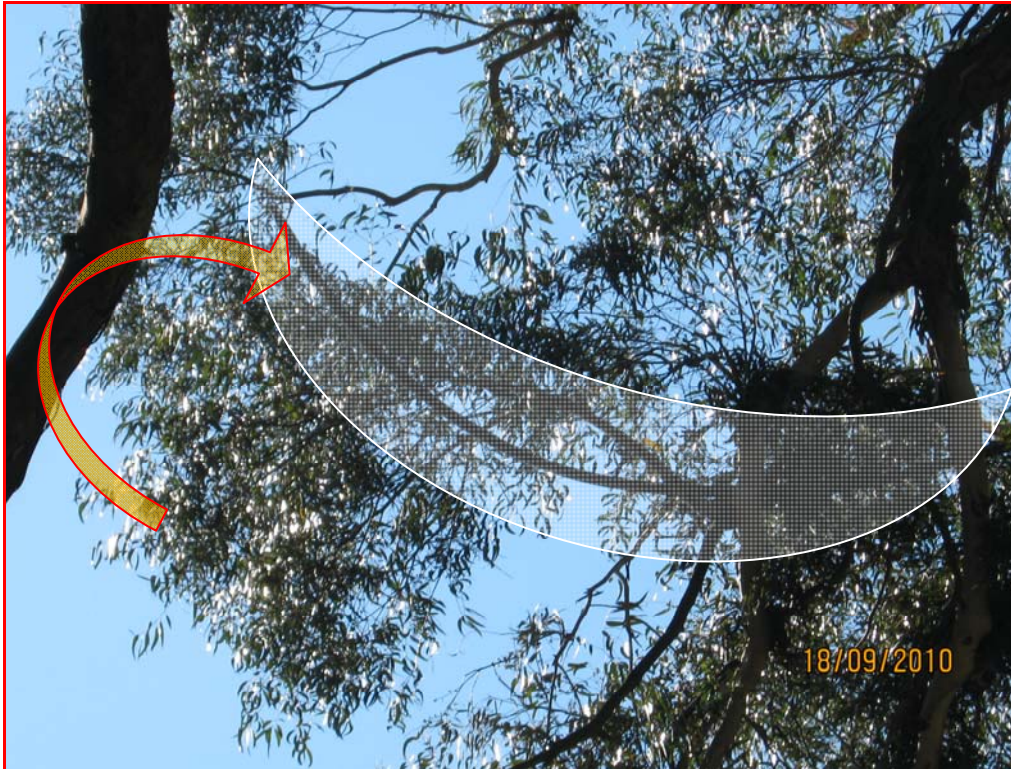
1.18.1 A piece of the tail rotor drive shaft, approximately 3 m long, was located in a tree, 15 m above the ground, almost directly above the wreckage.

Piece of the tail rotor drive shaft, 15 m up in the trees
