AIRCRAFT ACCIDENT REPORT AND EXECUTIVE SUMMARY

Reference:	CA18/2/3/8840	
Aircraft Registration	ZU-BAS	Date of Accident	27 September 2010		Time of Accident	0700Z
Type of Aircraft	Aviatika 890U		Type of Operation	Private		
Pilot-in-command Licence Type	MPL(Microlight)	Age	47		Licence Valid	Yes
Pilot-in-command Flying Experience	Total Flying Hours	473,45			Hours on Type	473,45
Last point of departure	Roodekopjes Farm					
Next point of intended landing	Roodekopjes Farm					
Location of the accident site with reference to easily defined geographical points (GPS readings if possible)						
Private farm at Roodekopjes, 37 km from Brits. GPS coordinates:(S25°23,835 ' E027°36,231 ')						
Meteorological Information	Surface wind: 290°/ 5 kts; Temperature: 24°C; Visibility: Cavok					
Number of people on board	1+0	No. of people injured	0		No. of people killed	1
Synopsis	<p>The pilot-owner, sole occupant of the aircraft, took off from his private farm on a local private flight with the intention of returning to his farm after the flight. On the way back, while the pilot prepared for landing, the aircraft collided with electric power lines. The pilot lost control and hit the ground at high sp

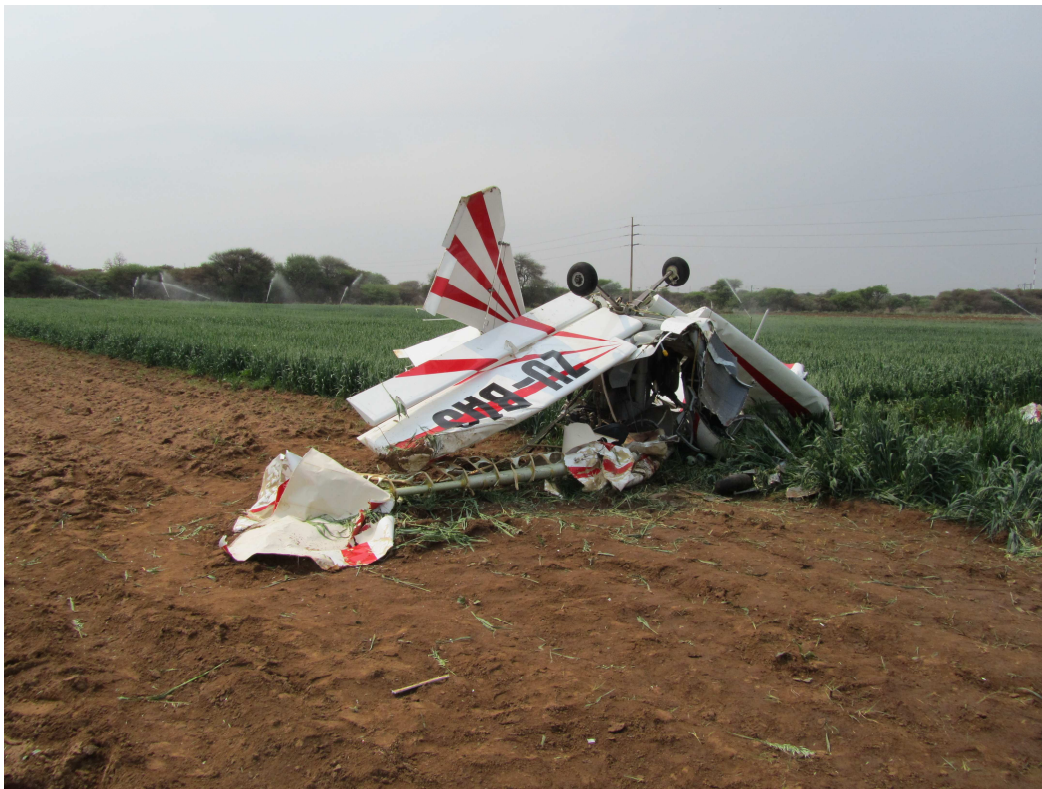
1.3.1 The aircraft was destroyed on impact.

FIGURE 2: Showing damage to the aircraft

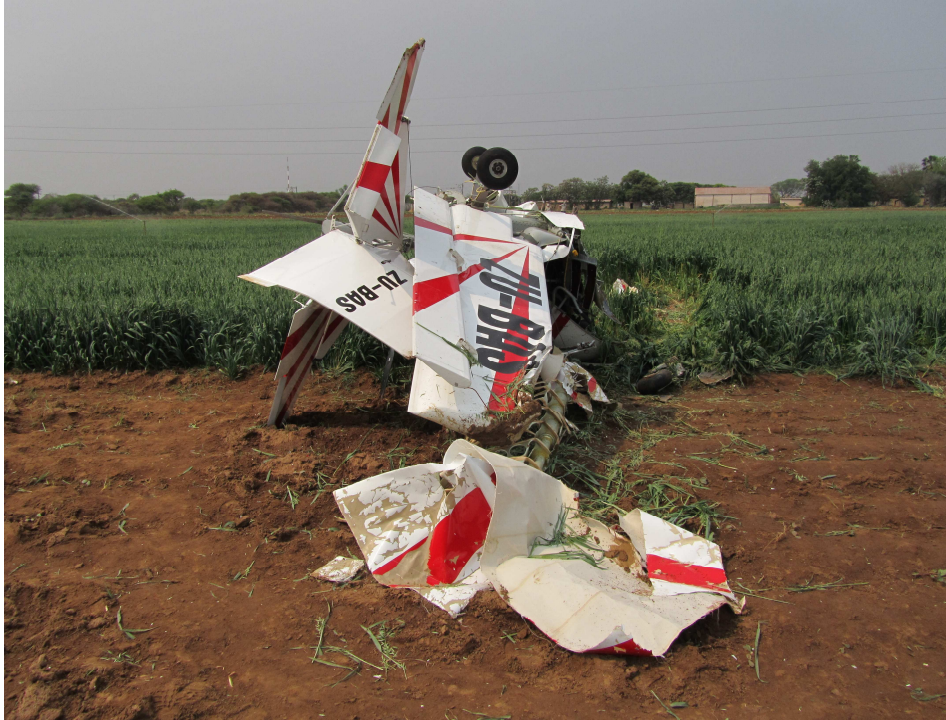
1.12.1 The accident site was a level maize field on a private farm in Roodekopjes. The aircraft hit the power lines with the right wing and lost control. After hitting the wires, the aircraft moved approximately 100 metres before crashing to the ground in a steep nose-down attitude and coming to rest in an inverted position. Pieces of the right wing structure and wing fabric were found underneath the electrical wires. The aircraft had been heading west on impact.

1.12.2 All parts and control surfaces were accounted for on the site. Although flight control cable runs were disrupted by the impact forces, pre-impact control integrity was easily established. The extent of the damage to the aircraft indicated that the aircraft struck the ground at high speed and in a steep nose-down attitude. The wreckage was contained within a three-metre radius of the final impact point, except for the piece of the wing which was found 100 metres away beneath the power lines.

FIGURE 3: Showing the wreckage site.
