# AIRCRAFT ACCIDENT REPORT AND EXECUTIVE SUMMARY

Reference:	CA18/2/3/8902	
<b>Aircraft Registration</b>	ZS-RVA	<b>Date of Accident</b>	25 February 2011		<b>Time of Accident</b>	1236Z
<b>Type of Aircraft</b>	Robinson R44 Raven II		<b>Type of Operation</b>		Aerial Survey / Observation	
<b>Pilot-in-command Licence Type</b>	Commercial	<b>Age</b>	44	<b>Licence Valid</b>	Yes	
<b>Pilot-in-command Flying Experience</b>	Total Flying Hours	4300		Hours on Type	350	
<b>Last point of departure</b>	Cape Town International Airport (FACT)					
<b>Next point of intended landing</b>	Cape Town International Airport (FACT)					
<b>Location of the accident site with reference to easily defined geographical points (GPS readings if possible)</b>						
Near Paardevlei at a position recorded as S 34° 05' 29.98" & E 018° 48' 26.78						
<b>Meteorological Information</b>						
<b>Number of people on board</b>	1+1	<b>No. of people injured</b>	2	<b>No. of people killed</b>	0

**Name of Owner/Operator** : Base 4 Helicopters  
**Manufacturer** : Robinson Helicopter Company  
**Model** : R44 II  
**Nationality** : South African  
**Registration Marks** : ZS-RVA  
**Place** : Paardevelei – Western Cape  
**Date**

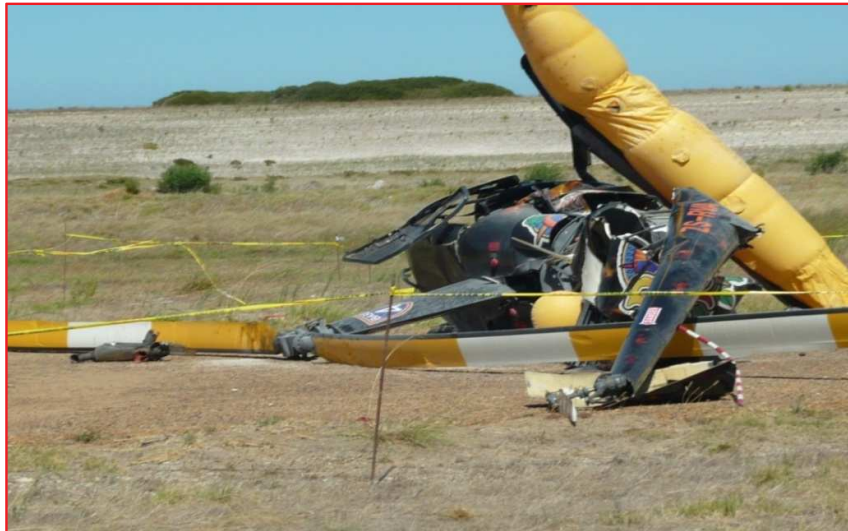
Figure 2: View of the wreckage after the accident

1.3.1 The helicopter was destroyed during the accident sequence.

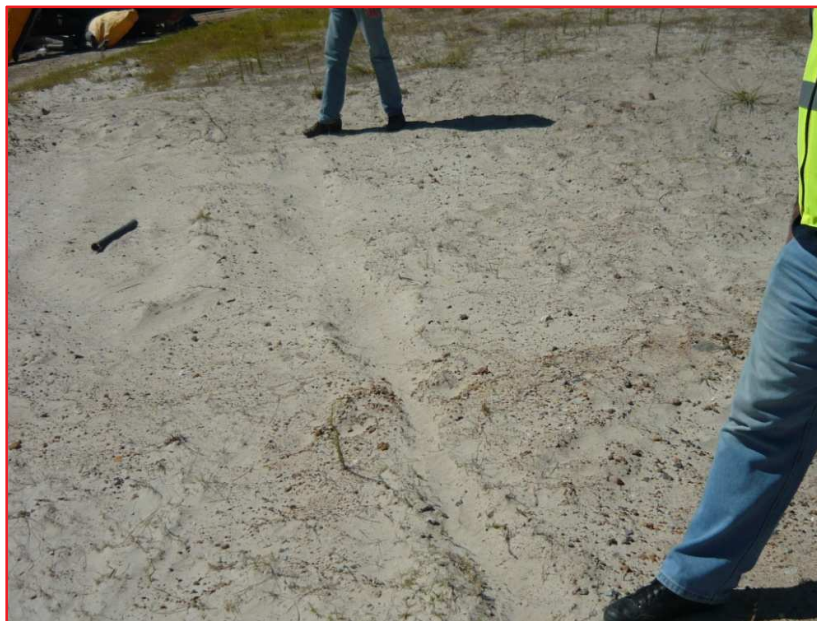
*Figure 3: The area of the accident site - combination of grass & Ground*

- 1.12.1 The area where the accident occurred comprised mainly of sand.

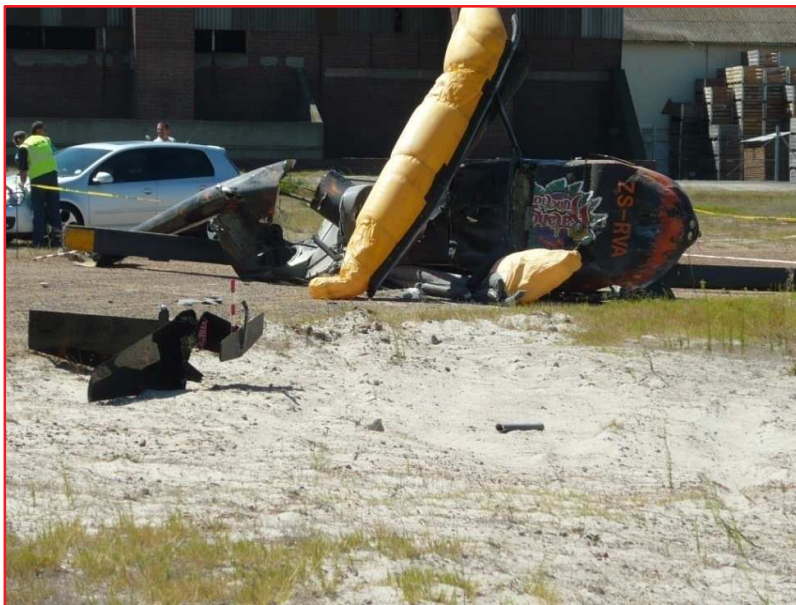
**Figure 4: The wreckage area of the accident site**

- 1.12.2 The wreckage area was confined to the initial impact marks made by the skids and the main wreckage on its' left-hand side.

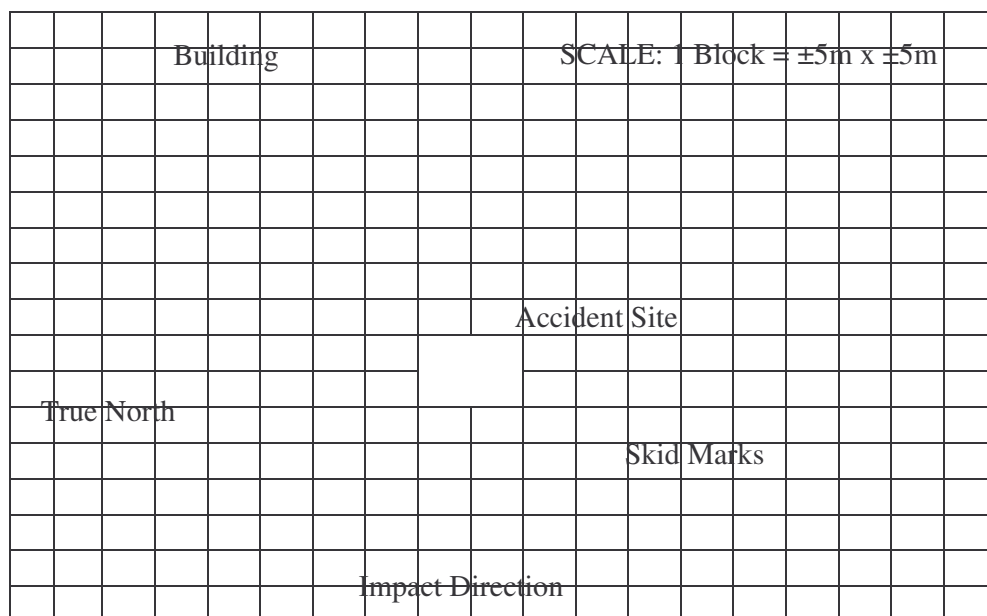
**Figure 7: Wreckage Diagram**

1.12.4 Impact occurred in a north-eastern direction, with a high rate-of-decent in a nose-up attitude whilst in a slight right-hand turn. The impact marks of the skids were approximately 15m from the main wreckage.

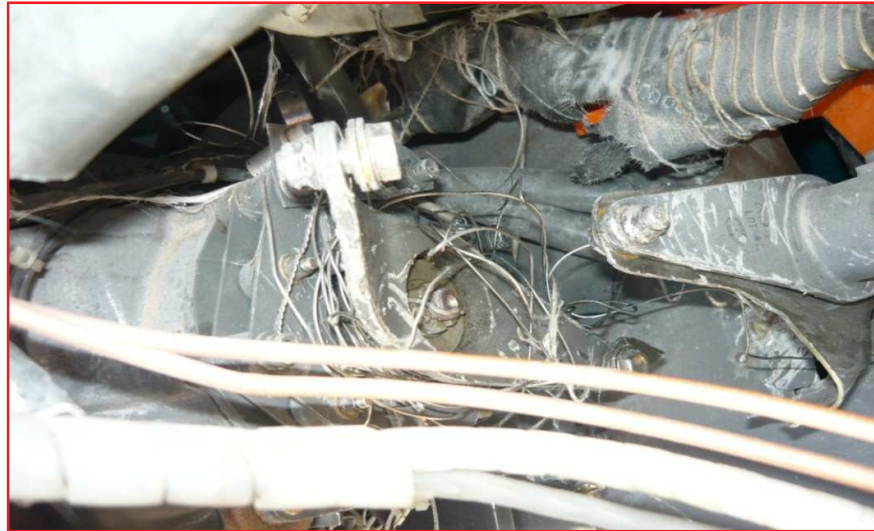
**Figure 8: Damage caused by the Flex Plate**

- 1.12.6 The flex plate on the fwd coupling failed in fatigue during flight. There after the main fuel tank, the firewall and various pipes were ruptured in the direct vicinity of the coupling by the coupling.

- 1.12.6.1 The Flex Plate, which failed in fatigue, is a component from the fwd coupling. The purpose of the fwd coupling is to transfer torsion power from the engine to the main rotor gearbox through a pulley system and drive shaft. (See fig 9)
- 1.12.6.2 When the coupling failed, it was out of balance and caused the drive belts to come off from the pulley system, which also drives the drive shaft to the tail rotor. This resulted in the tail rotor also stopping while the engine was still running. (See fig 9)

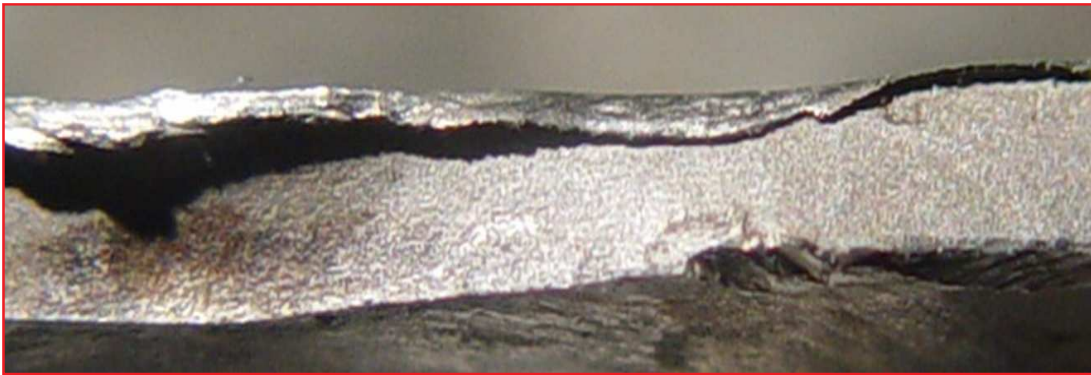
- 1.16.1 Metallurgical analysis of the fracture surface of the Flex Plate showed definite signs of fatigue. The origin is unsure as it started slightly off from the hole underneath the washer contact surface. No clear signs of corrosion induced pitting could be detected that may have resulted in the initiation of the crack. Nor was any other material related discrepancies noted.
- 1.16.2 It was considered possible that the bolt / nut might have been over-torqued which may have resulted in crack formation, most probably due to the resultant work hardening of the base material in the area of the contact surfaces, thus leading to the lower fatigue strength and possible micro-cracking that cause stress-raisers on

the surface.

- 1.16.3 At the initiation point, a nick mark is present, together with a reduction in thickness. It would appear that the nick mark had a stress-raising result.

*Figure 10: The figure above shows the fractured surface of the flex plate. The arrows indicate the area of reduction in thickness and the nick mark.*

- 2.6 The aircraft was not equipped with a flight data recorder or a cockpit voice recorder nor was it required by the relevant aviation regulations.
- 2.7 The flex plate on the fwd coupling failed in fatigue during flight. Metallurgical analysis of the fracture surface showed definite signs of fatigue. The origin is unsure as it started slightly off from the hole underneath the washer contact surface. No clear signs of corrosion induced pitting could be detected that may have resulted in the initiation of the crack. The maintenance manual requires that the flex plate must be inspected around the bolt hole area for cracks, corrosion and fretting. However, it looks like the crack initiated underneath the washer and was not detected. No material related discrepancies were noted. It was considered possible that the bolt / nut might have been over-torqued which may have resulted in crack formation, most probably due to the resultant work hardening of the base material in the area of the contact surfaces, thus leading to the lower fatigue strength and possible micro-cracking that cause stress-raisers on the surface. At the initiation point, a nick mark is present, together with a reduction in thickness. It would appear that the nick mark had a stress-raising result. According to the aircraft documentation, the aircraft was maintained as required by the manufacturer and the regulator, however, the above scenario points to inferior maintenance.

- 4.1 Ground ALL South African registered Robinson R44 and R22 helicopters with immediate effect pending a proper inspection of the forward flex plates before any further flight.
- 4.2 That the Airworthiness section of the SACAA, compile an inspection procedure / method to carry out this inspection. The method used should either be NDT or as per inspection intervals.

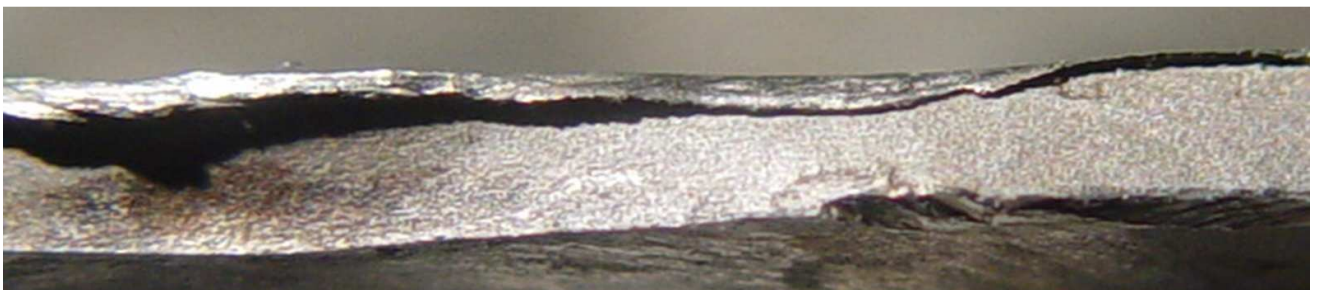
*I analysed the fracture surface from the input shaft - there is definitively signs of fatigue (see photo underneath) - the origin is slightly baffling as it usually starts in the bolt holes. In this case, slightly of from the hole underneath the washer contact surface. I could not detect any clear signs of corrosion induced pitting that may have resulted in the initiation of the crack. Nor did I noted any other material related discrepancies, up to now. The other possibilities are, based on the current results, possible over-torque of the bolt/nut that may have resulted in crack formation, most probably due to the resultant work-hardening of the base material in the area of the contact surfaces, this leading to the lower fatigue strength and possible micro-cracking that cause stress-raisers on the surface. I noted some reduction in thickness as well. Also, there seems to be a 'nick-mark (see photo) at the initiation point that could have had the same stress-raising result.*

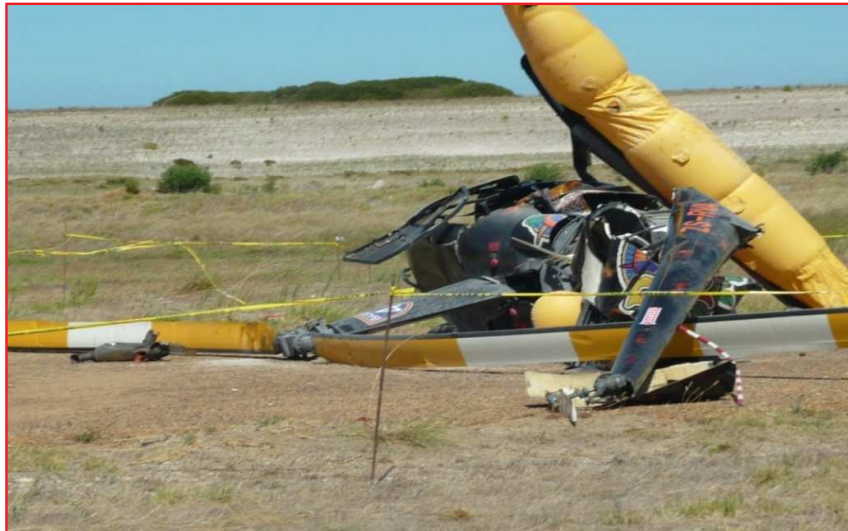
Figure 2: View of the wreckage after the accident

1.3.1 The helicopter was destroyed during the accident sequence.

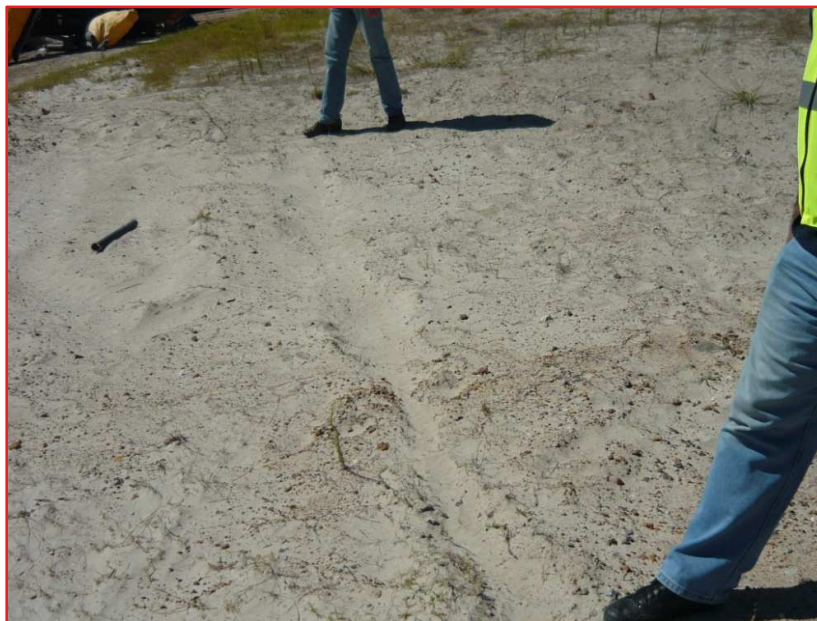
*Figure 3: The area of the accident site - combination of grass & Ground*

- 1.12.1 The area where the accident occurred comprised mainly of sand.

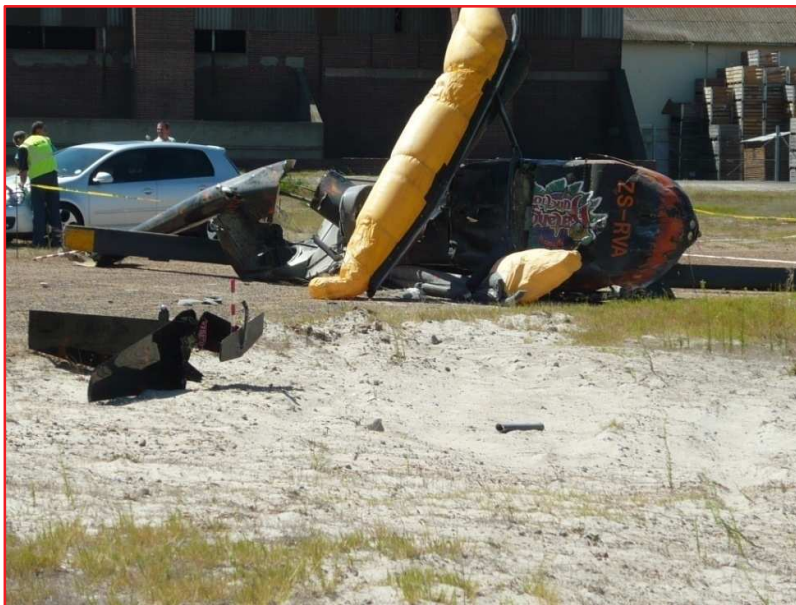
**Figure 4: The wreckage area of the accident site**

- 1.12.2 The wreckage area was confined to the initial impact marks made by the skids and the main wreckage on its' left-hand side.

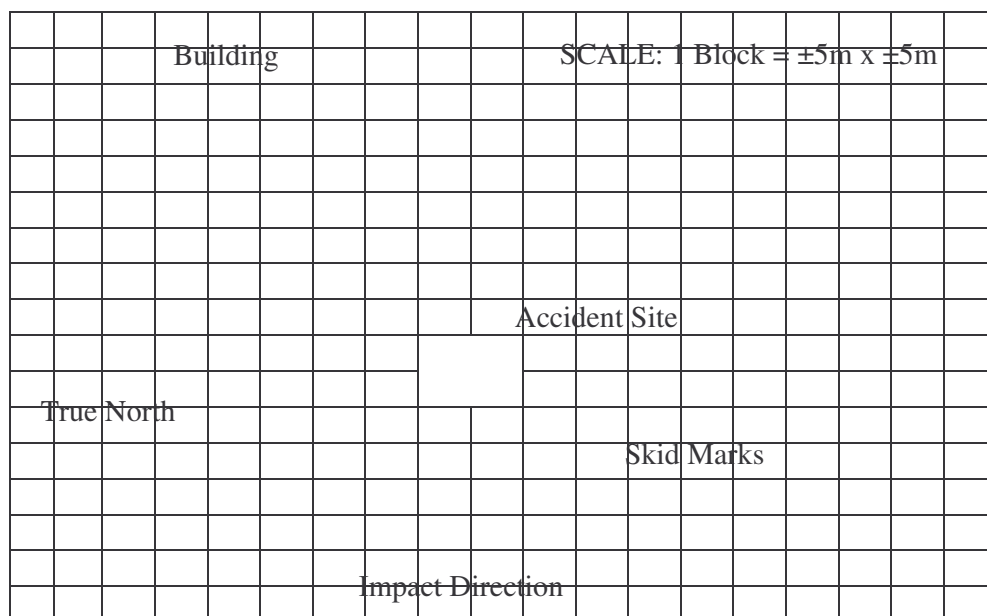
**Figure 7: Wreckage Diagram**

1.12.4 Impact occurred in a north-eastern direction, with a high rate-of-decent in a nose-up attitude whilst in a slight right-hand turn. The impact marks of the skids were approximately 15m from the main wreckage.

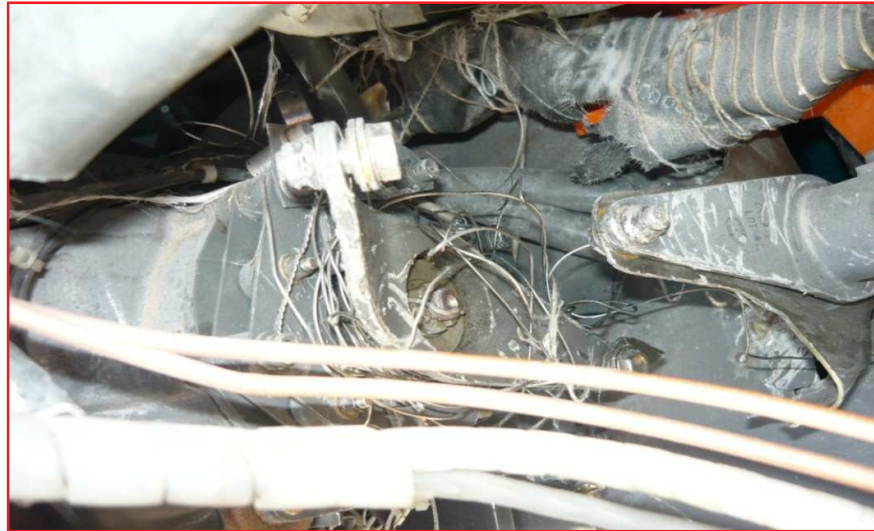
**Figure 8: Damage caused by the Flex Plate**

- 1.12.6 The flex plate on the fwd coupling failed in fatigue during flight. There after the main fuel tank, the firewall and various pipes were ruptured in the direct vicinity of the coupling by the coupling.

- 1.12.6.1 The Flex Plate, which failed in fatigue, is a component from the fwd coupling. The purpose of the fwd coupling is to transfer torsion power from the engine to the main rotor gearbox through a pulley system and drive shaft. (See fig 9)
- 1.12.6.2 When the coupling failed, it was out of balance and caused the drive belts to come off from the pulley system, which also drives the drive shaft to the tail rotor. This resulted in the tail rotor also stopping while the engine was still running. (See fig 9)

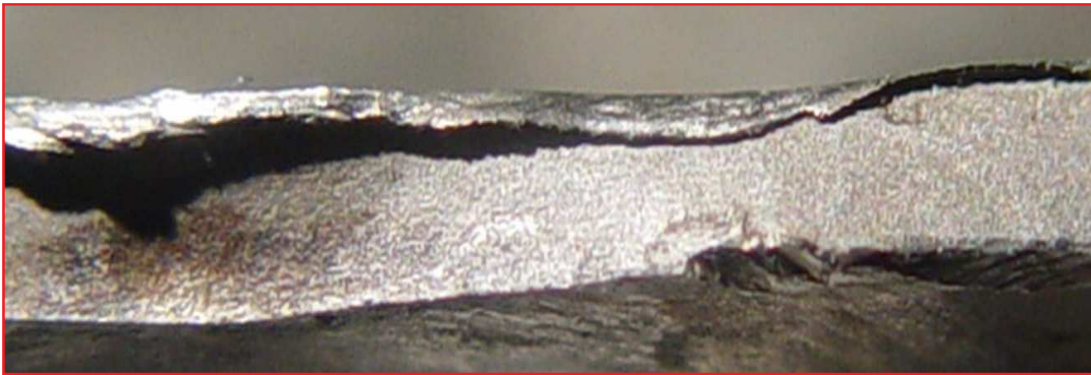
- 1.16.1 Metallurgical analysis of the fracture surface of the Flex Plate showed definite signs of fatigue. The origin is unsure as it started slightly off from the hole underneath the washer contact surface. No clear signs of corrosion induced pitting could be detected that may have resulted in the initiation of the crack. Nor was any other material related discrepancies noted.
- 1.16.2 It was considered possible that the bolt / nut might have been over-torqued which may have resulted in crack formation, most probably due to the resultant work hardening of the base material in the area of the contact surfaces, thus leading to the lower fatigue strength and possible micro-cracking that cause stress-raisers on

the surface.

- 1.16.3 At the initiation point, a nick mark is present, together with a reduction in thickness. It would appear that the nick mark had a stress-raising result.

*Figure 10: The figure above shows the fractured surface of the flex plate. The arrows indicate the area of reduction in thickness and the nick mark.*

- 2.6 The aircraft was not equipped with a flight data recorder or a cockpit voice recorder nor was it required by the relevant aviation regulations.
- 2.7 The flex plate on the fwd coupling failed in fatigue during flight. Metallurgical analysis of the fracture surface showed definite signs of fatigue. The origin is unsure as it started slightly off from the hole underneath the washer contact surface. No clear signs of corrosion induced pitting could be detected that may have resulted in the initiation of the crack. The maintenance manual requires that the flex plate must be inspected around the bolt hole area for cracks, corrosion and fretting. However, it looks like the crack initiated underneath the washer and was not detected. No material related discrepancies were noted. It was considered possible that the bolt / nut might have been over-torqued which may have resulted in crack formation, most probably due to the resultant work hardening of the base material in the area of the contact surfaces, thus leading to the lower fatigue strength and possible micro-cracking that cause stress-raisers on the surface. At the initiation point, a nick mark is present, together with a reduction in thickness. It would appear that the nick mark had a stress-raising result. According to the aircraft documentation, the aircraft was maintained as required by the manufacturer and the regulator, however, the above scenario points to inferior maintenance.

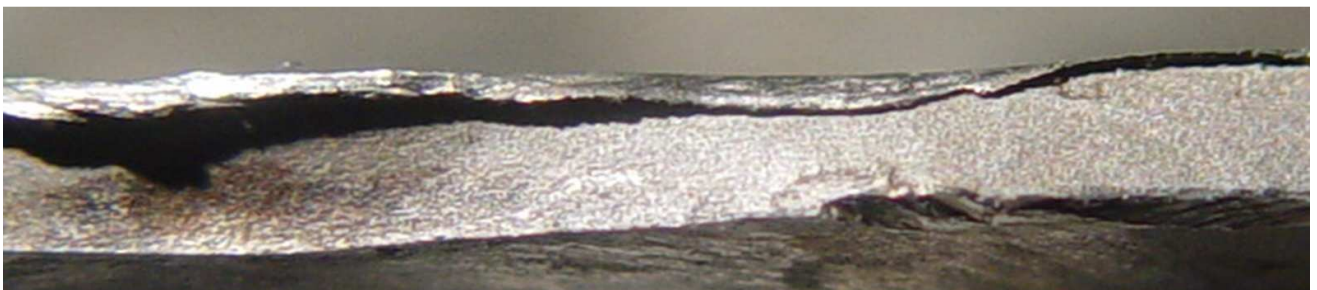
*I analysed the fracture surface from the input shaft - there is definitively signs of fatigue (see photo underneath) - the origin is slightly baffling as it usually starts in the bolt holes. In this case, slightly of from the hole underneath the washer contact surface. I could not detect any clear signs of corrosion induced pitting that may have resulted in the initiation of the crack. Nor did I noted any other material related discrepancies, up to now. The other possibilities are, based on the current results, possible over-torque of the bolt/nut that may have resulted in crack formation, most probably due to the resultant work-hardening of the base material in the area of the contact surfaces, this leading to the lower fatigue strength and possible micro-cracking that cause stress-raisers on the surface. I noted some reduction in thickness as well. Also, there seems to be a 'nick-mark (see photo) at the initiation point that could have had the same stress-raising result.*
