## AIRCRAFT ACCIDENT REPORT AND EXECUTIVE SUMMARY

| | | | | Reference: | CA18/2/3/8953 | |
| <b>Aircraft Registration</b> | <b>ZS-HTY</b> | <b>Date of Accident</b> | 3 August 2011 | <b>Time of Accident</b> | 0700Z | |
| <b>Type of Aircraft</b> | Robinson R44 Raven II | | <b>Type of Operation</b> | Private Flight | | |

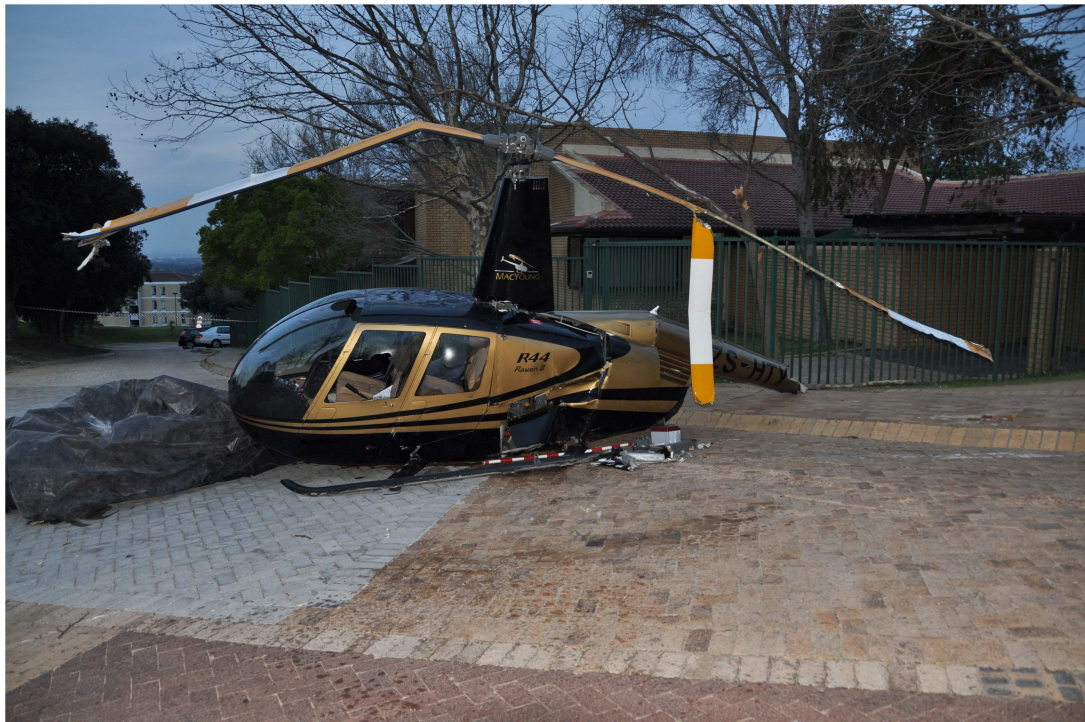
1.3.1 The helicopter sustained substantial damage. **See Fig 1.**

**Figure 1** Damage caused to the helicopter as seen after the helicopter was repositioned back onto its skids..

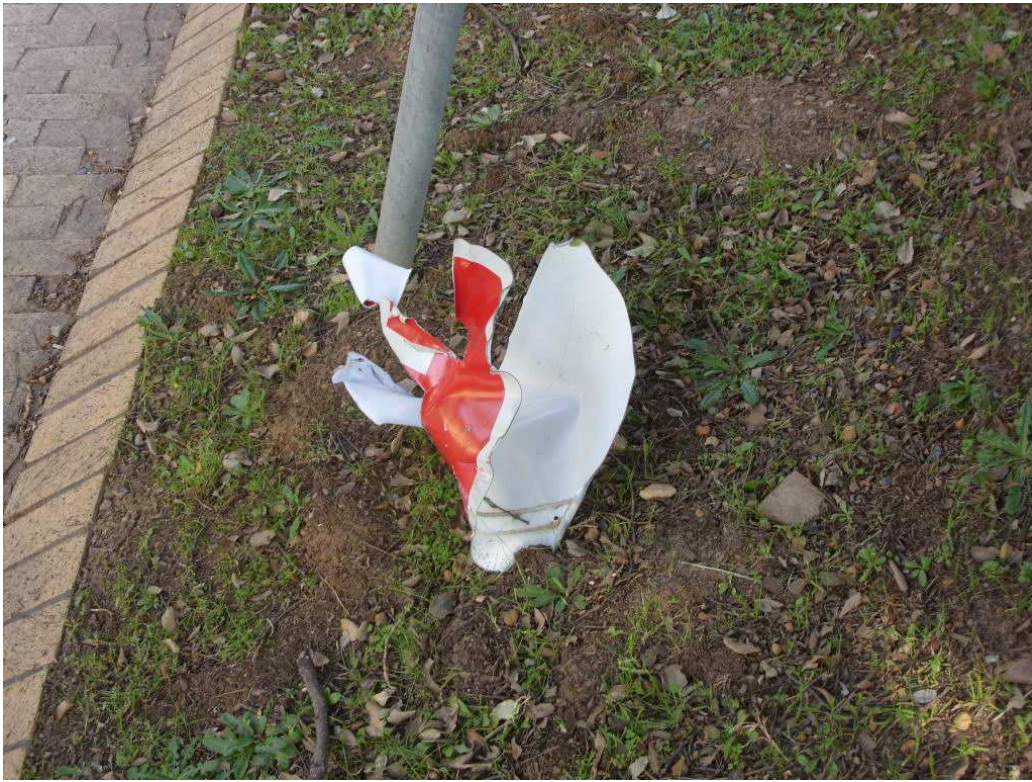
1.4.1 Minor damage was caused to the surrounding vegetation, a perimeter fence and a road sign. **See Fig 2.**

**Figure 2** Damage caused to a road sign.

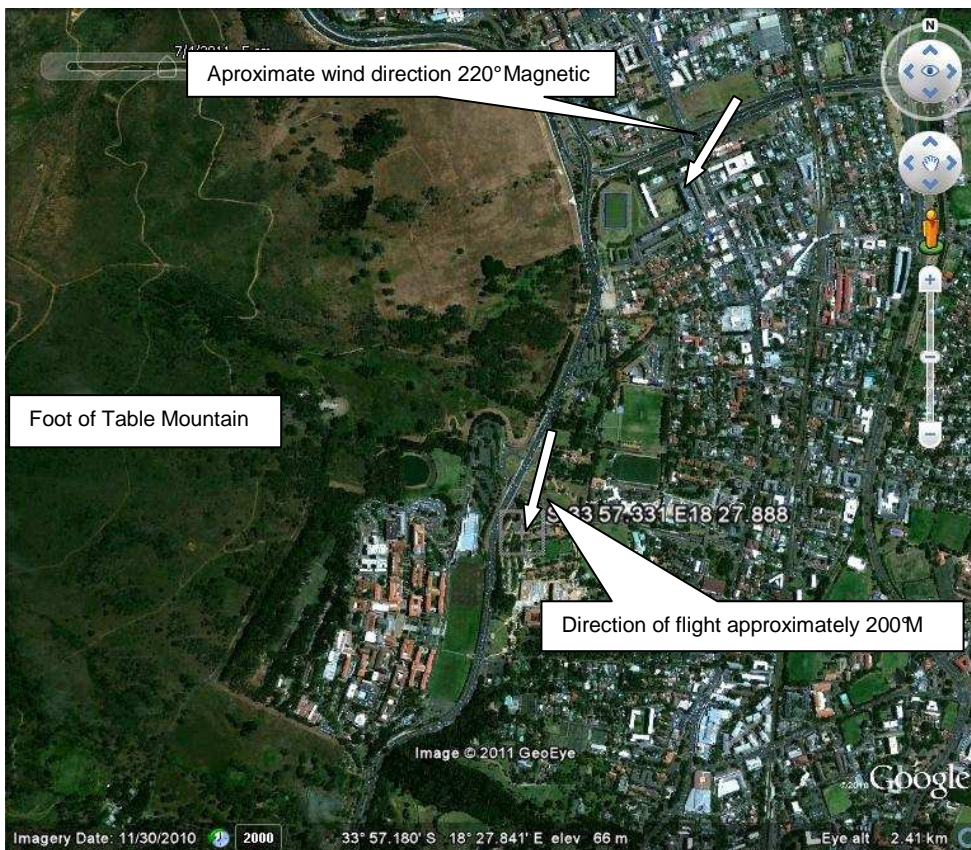
The final flight path was flown in a direction of approximately 200° Magnetic. **See Fig. 3.**

**Figure 3a.** Direction of flight and approximate wind direction indicated by the arrows.

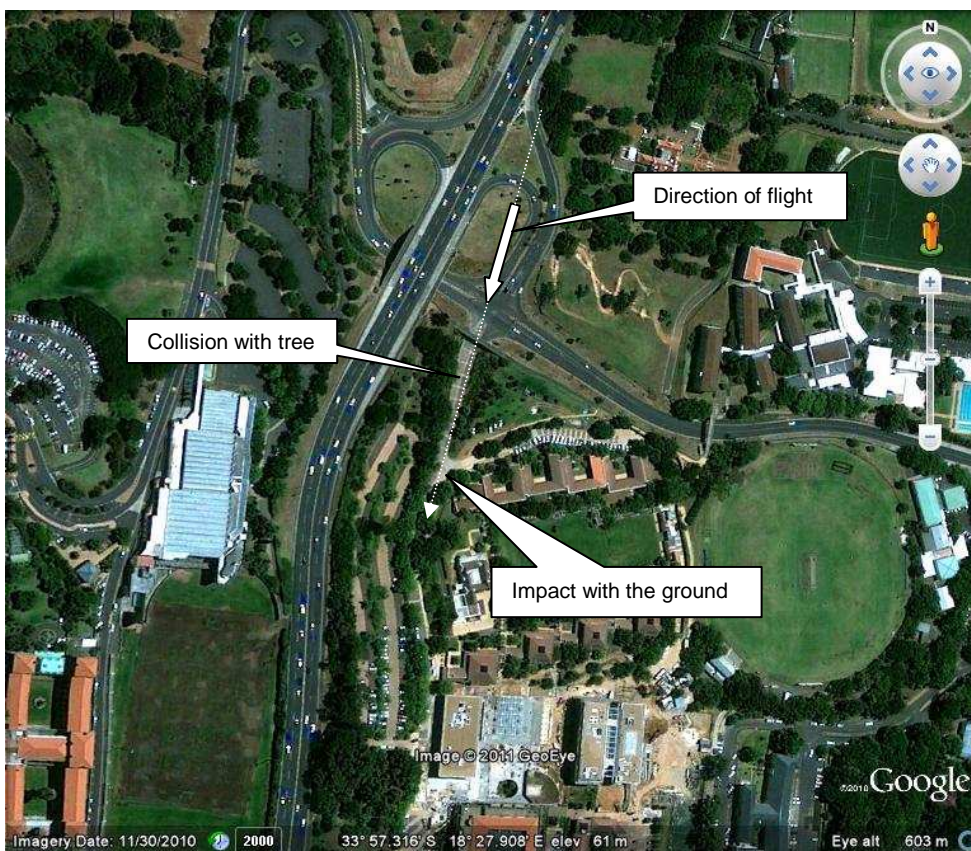
**Figure 3b.** Final flight path.
